Archaeological Condition Assessment and Ground-Penetrating Radar (GPR) Surveys for Agua Mansa Cemetery, San Bernardino County, California

Technical Report 24-26
Statistical Research, Inc.
Redlands, California

April 2024

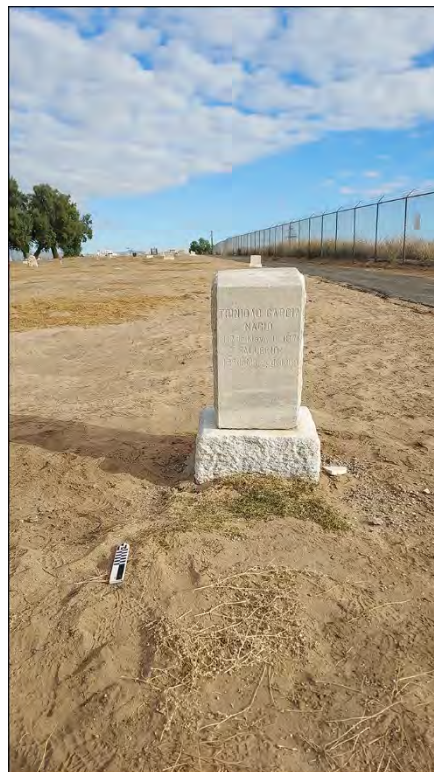
Feature PD: 8**Name:** Trinidad Garcia**Dates:** May 17, 1871–March 25, 1909**Monument type:** die on base**Enclosure:** none**Damage type(s):** ground loss, open joints**Repair type(s):** concrete stabilized**Description:**

This grave is marked with a die-on-base monument. Both the headstone and base are made of white marble. The headstone has a rectangular arch, and the base has a flat top. The sides and back of the headstone as well as the sides, front, and back of the base are rock pitched. The front of the headstone is polished and engraved with “TRINIDAD GARCIA/NACIO/el 17 de Mayo de 1871/FALLECIO/el 25 de Marzo de 1909”. The top of the headstone is polished and has a cross-within-a-circle motif engraved on it. Although the monument is in excellent condition, the joint between the headstone and base is open, and the ground surface around the monument has eroded away. The base appears to have been stabilized with concrete.

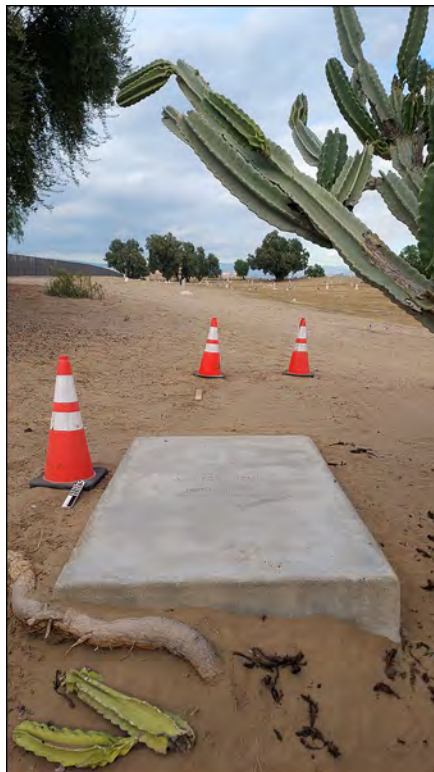
Feature PD: 52**Name:** Irene Lopez**Dates:** February 29, 1904 (death)**Monument type:** vaulted obelisk upon tomb**Enclosure:** none**Damage type(s):** cracked, disassembled—loss**Repair type(s):** none**Description:**

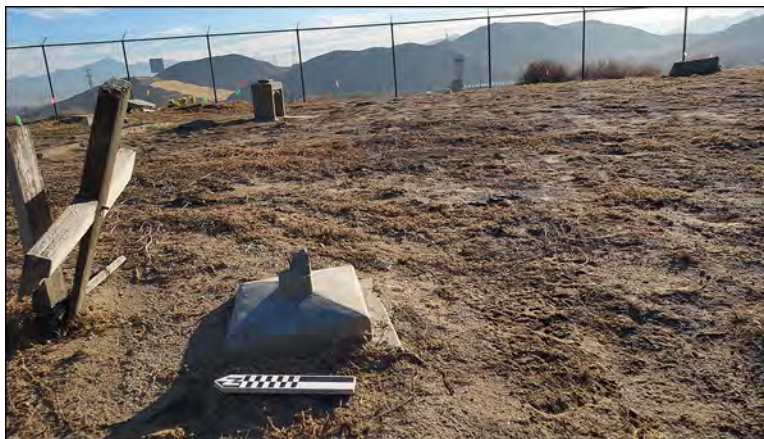
Feature PD: 715**Name:** Anac[. . .]to [. . .]sas**Dates:** January 6, 1940 (death)**Monument type:** block**Enclosure:** none**Damage type(s):** fragmentation—loss, erosion, burrowing-animal disturbance, spalling**Repair type(s):** none**Description:**
