Archaeological Condition Assessment and Ground-Penetrating Radar (GPR) Surveys for Agua Mansa Cemetery, San Bernardino County, California

Technical Report 24-26
Statistical Research, Inc.
Redlands, California

April 2024

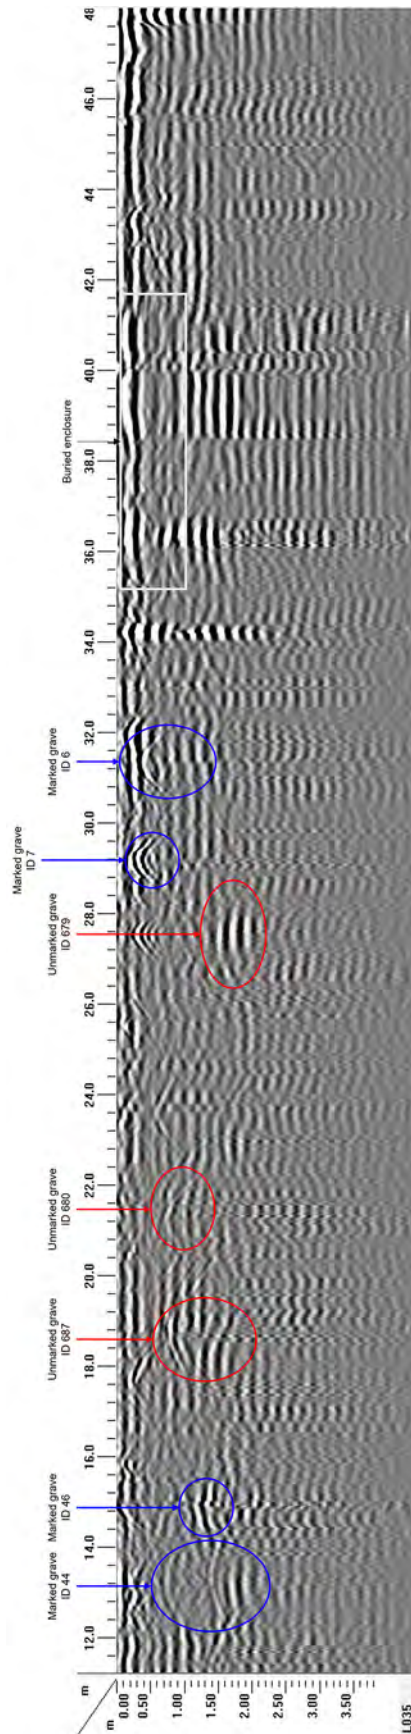
At Agua Mansa Cemetery, the graves commonly appear in the reflection profiles as point-source hyperbolic reflections (Figure 4). Point-source hyperbolas are produced by single objects in the ground, and burials can produce these types of reflections when radar waves reflect from the sides or bottoms of shafts, coffins/caskets, or voids (Conyers 2006, 2012). Although there was some variation in the cemetery, there was also some notable consistency in the overall geometry, width, and depth of the hyperbolic reflections (Figure 5). At Agua Mansa Cemetery, the majority of the graves were identified at depths of about 1.2–2.0 m (4.0–6.5 feet). In addition, possible graves were identified in profile as hyperbolic reflections in at least two, but not more than five, consecutive profiles. Smaller objects, like rocks, will typically only appear in one profile, whereas larger features, like tree roots, utilities, and rodent burrows, will appear in many adjacent profiles. Noncultural features like tree roots and rodent burrows can impact graves, but they also tend to be shallower than and have different geometries from graves (Figure 6). This is also true of utilities and irrigation lines, which are also present at Agua Mansa Cemetery (Figure 7).

Figure 4. Ground-penetrating-radar (GPR) reflection profile from Grid 2, showing the hyperbolic reflections from unmarked and known, marked graves; data from the marked graves were subsequently used to help identify unmarked graves.

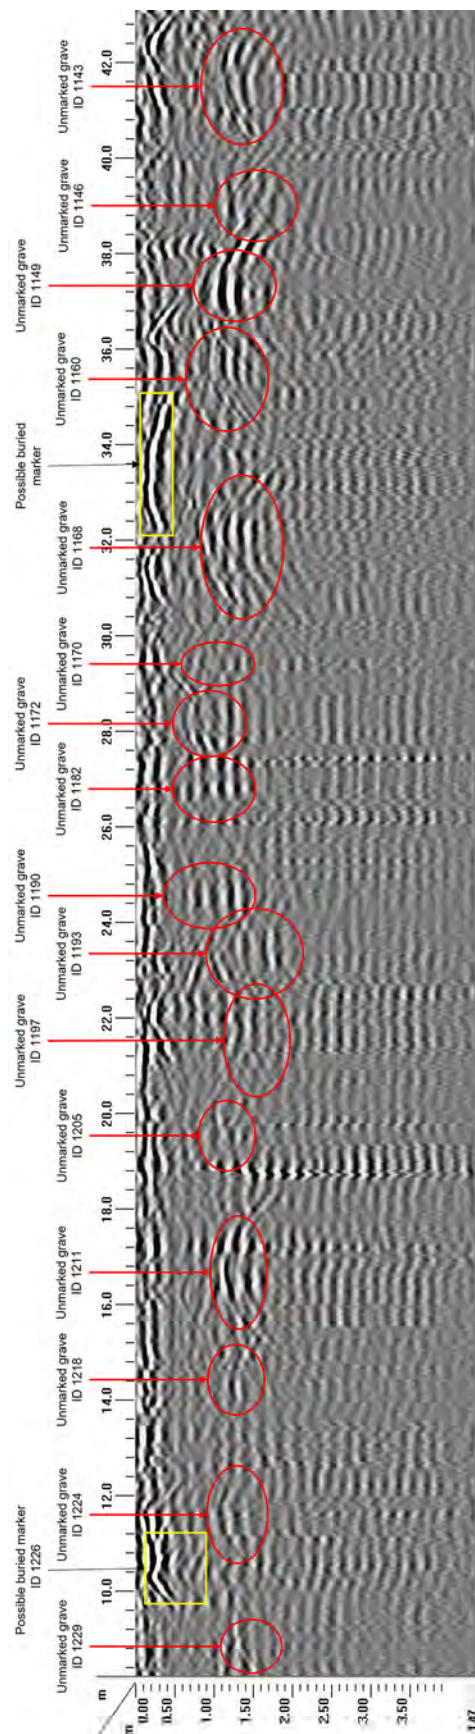
Identifying buried slabs or markers (the second type of primary features mentioned above) was done through reflection and depth analysis. Because slabs are made very different materials than the sandy sediments surrounding them, they tend to produce high-amplitude reflections. Furthermore, their placement and geometry in the ground means that they will appear as distinct, planar reflections that are much shallower than the graves, which were identified at much greater depths (see Figure 5).

Figure 5. Ground-penetrating-radar (GPR) reflection profile from Grid 1, showing the hyperbolic reflections from a row of unmarked graves. Also seen are the shallower planar reflections from two possible buried markers or slabs.

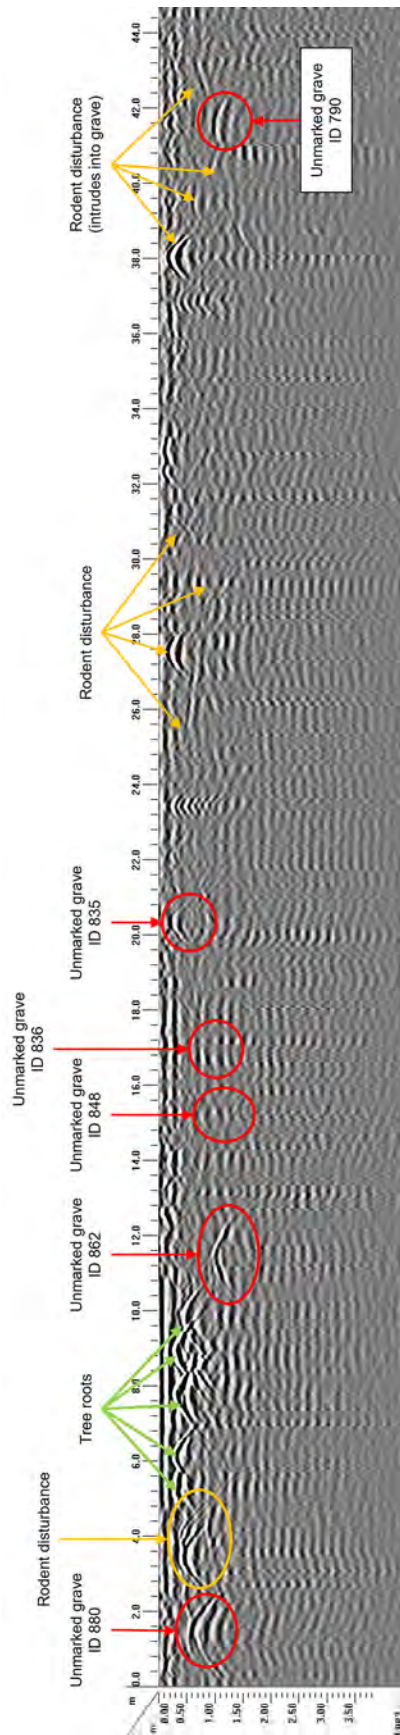
Figure 6. Ground-penetrating-radar (GPR) reflection profile from Grid 2, showing the hyperbolic reflections from unmarked graves and the brighter, often shallower, hyperbolic reflections from tree roots and rodent burrows, which often can be seen intersecting graves.

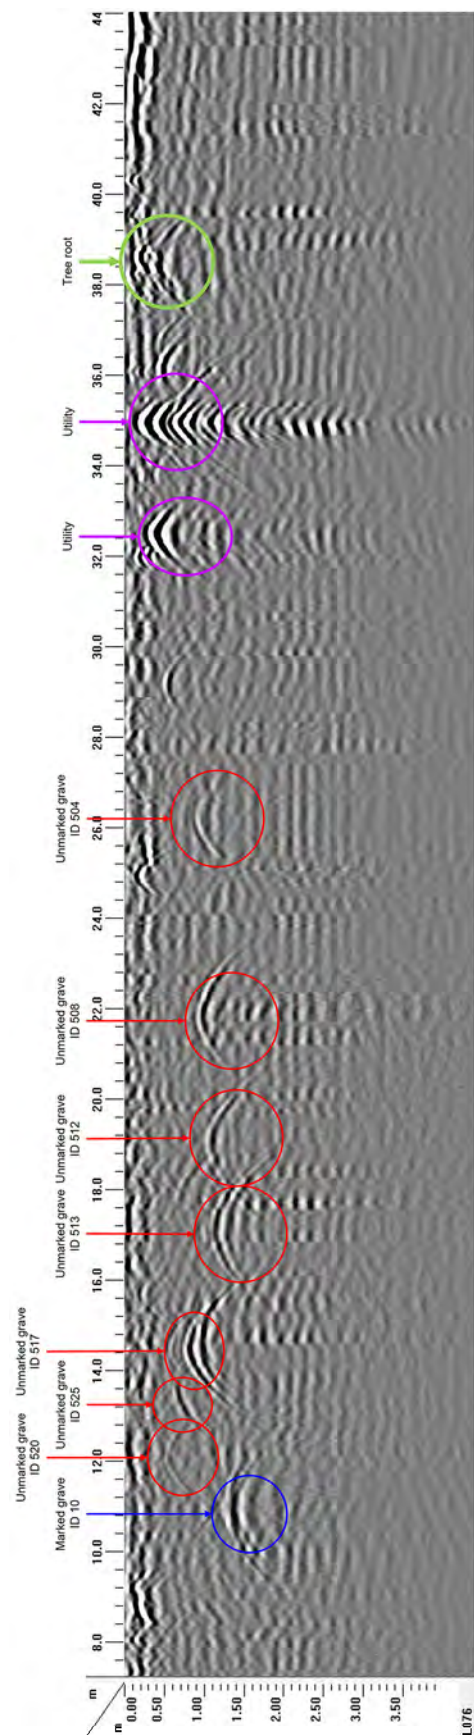
Figure 7. Ground-penetrating-radar (GPR) reflection profile from Grid 7, showing the hyperbolic reflections from marked and unmarked graves, as well as the bright, shallow reflections from utility lines.

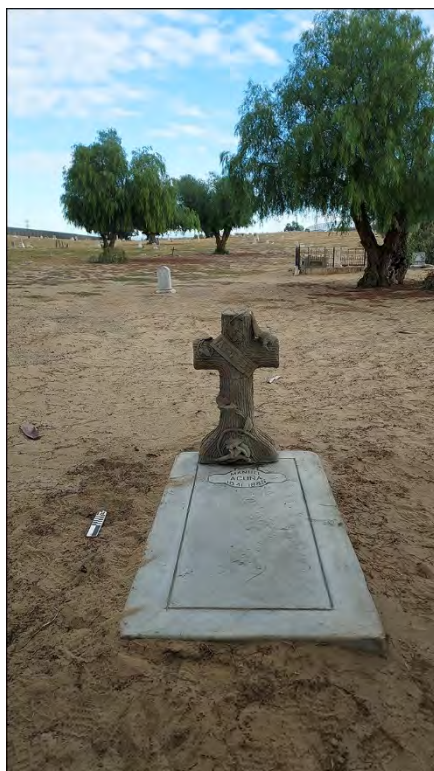
The grave of Manuel Acuña is marked with a brown concrete tree trunk placed off-center on a concrete ledger. The tree-trunk monument is patterned after a cross wrapped in ivy and vines. A dove is draped over the crosspiece of the cross, with its right wing lifted against the vertical portion. A rectangular banner with “AT-REST” is angled across the front of the cross. The concrete ledger is relatively undecorated, with “MANUEL/ACUÑA/1841 1885” inscribed at the head of the slab and a small geometric design.

In terms of condition, the monument and ledger are well preserved. Only minimal damage was observed. A horizontal crack through the center of the vertical portion of the marker and small cracks in the ledger were observed, and the head of the dove had been broken off.

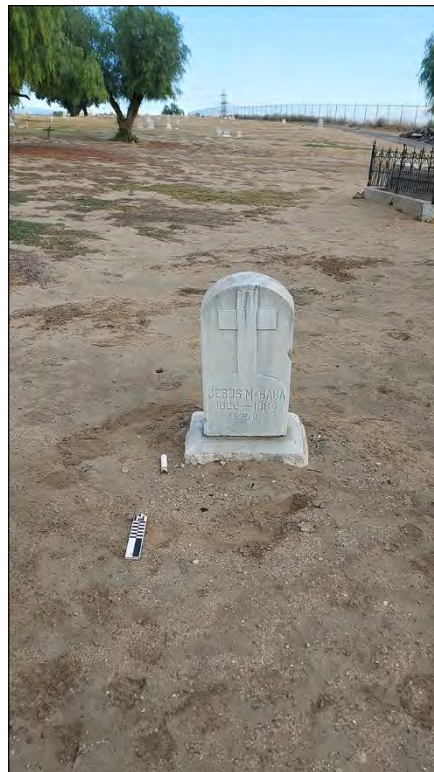
Feature PD: 6**Name:** Jesus M^A Baca**Dates:** 1822–1884**Monument type:** die on base**Enclosure:** none**Damage type(s):** spalling, open joints**Repair type(s):** mortar fills**Description:**

This grave is marked with a die-on-base monument. Both the headstone and base are made of white marble. The headstone has a basket arch and is shaped on all sides. The base has a chamfered top with rock-pitched sides, front, and back. Damage to the monument is minimal; some spalling was observed on the headstone, as well as an open joint between the headstone and base. One of the larger spalled areas had been repaired with mortar. The front of the headstone is decorated with a bas-relief cross on a hill motif with “JESUS M^ABACA/1822-1884/E.P.D.” engraved below the cross.

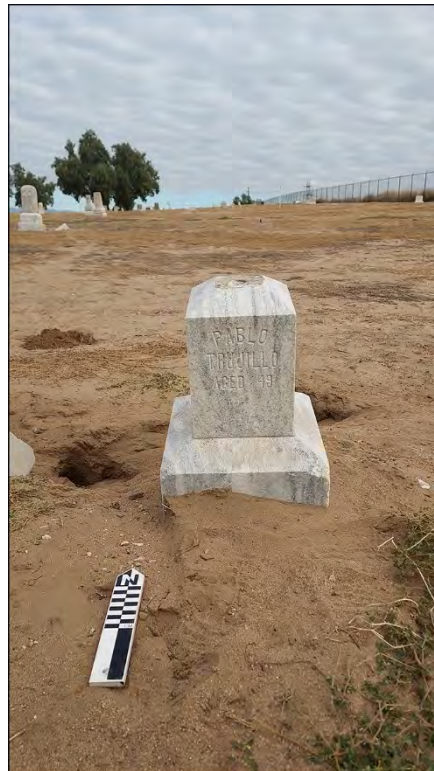
Damage type(s): buried/sunk, burrowing-animal disturbance, disassembled—loss, open joints, spalling, tilted/fallen

This grave is marked by the subbase and middle section of a marble obelisk or pedestal. The tops of both components are chamfered, and the middle section is inscribed with the deceased's name and age at death: "PABLO TRUJILLO/ AGED 49". The pillar portion of the monument is missing, and the base is buried. Overall, the monument is tilted toward the south. Furthermore, the gap between the middle section and the subbase is unsealed, and chips of stone have spalled off the corners of the subbase. Large animal burrows are visible adjacent to the monument.

Repair type(s): none

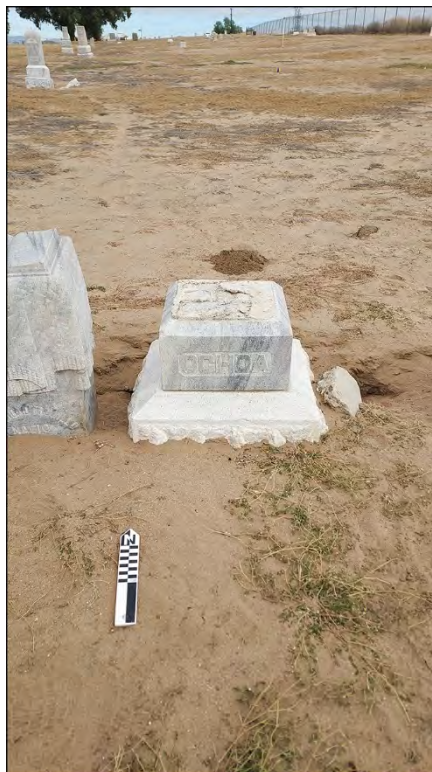
Damage type(s): buried/sunk, burrowing-animal disturbance, disassembled—loss, open joints

This grave is marked by the subbase and base of a marble obelisk or pedestal. The tops of both components are chamfered, and the base has rock-pitched sides, front, and back. The subbase is made of gray marble, and the base is white marble. The subbase is inscribed with “OCHOA” in bas relief. The pillar portion of the monument is missing, and the base is partially buried. Furthermore, the gap between the subbase and base is unsealed, and large animal burrows are visible adjacent to the monument. Remains of the cement sealant are visible on the upper surface of the subbase.

Repair type(s): none

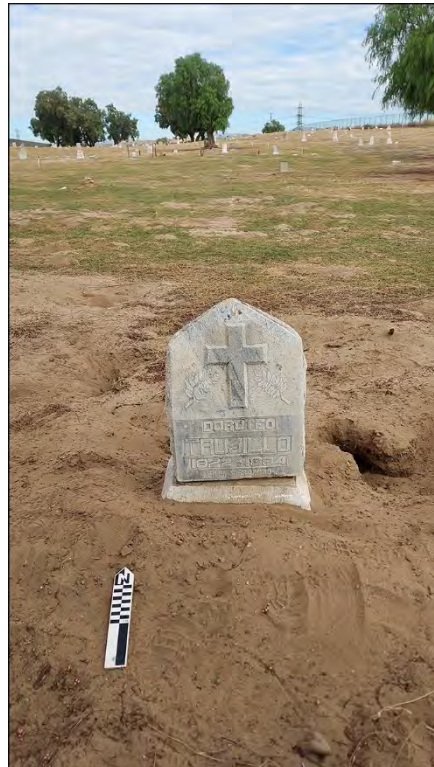
Feature PD: 22**Name:** Doroteo Trujillo**Dates:** 1822–1884**Monument type:** die on base**Enclosure:** none**Damage type(s):** abrasion, burrowing-animal disturbance, open joints**Repair type(s):** none**Description:**

This grave is marked with a die-on-base monument. The headstone component of the monument is composed of gray marble, and the base is white marble. The sides and back of the headstone and the sides, front, and back of the base are all rock pitched. The general shape of the headstone is pentagonal, with the apex of the pentagon at the top. The upper half of the face of the headstone is slightly angled back, giving the monument a beveled profile, and the top of the base is chamfered. Although the monument is in relatively good condition, it is surrounded by extensive animal-burrowing disturbance, and the headstone is slightly rotated on the base because of the lack of a seal between the headstone and the base. Additionally, the top front of the base exhibits a long abrasion across the surface.

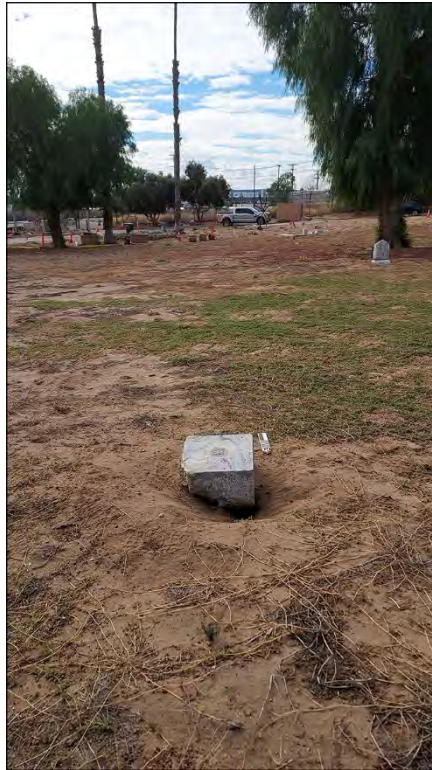
Damage type(s): buried/sunk, burrowing-animal disturbance, disassembled—loss

This feature consists of a component of a disassembled marble monument. The component appears to be inverted and partially buried in an area that has been dug out by a burrowing animal. The component is approximately square in cross section; two of the partially buried sides are rock pitched, and the other two sides are polished. In the center of the side exposed on the surface are the remains of a stone peg that has snapped off flush with the surface, indicating that the component was once part of a compound monument.

Repair type(s): none

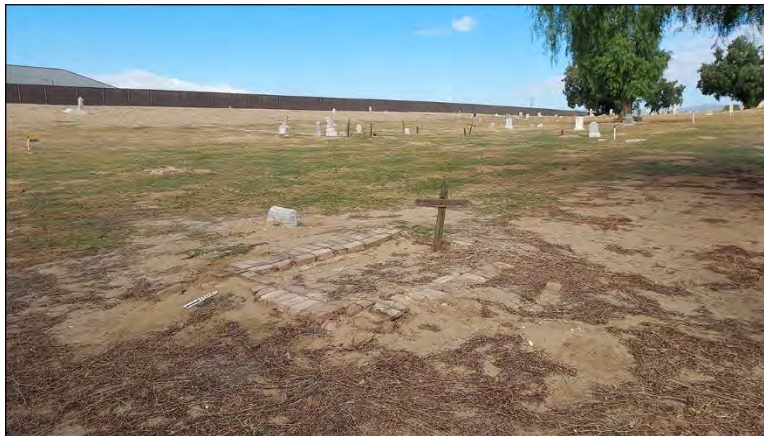
Damage type(s): buried/sunk (coping), erosion (coping and cross)

This grave is marked with a wooden cross at the northern end of an approximately 8.0-by-5.5-foot area bound by red-brick coping. The wooden cross is of two 0.75-inch-thick wooden boards held in place with a screw or bolt. The cross bears no name or inscription. The red-brick coping and cross are eroding, and the coping is also becoming buried in places. It is unclear when the cross was installed at this grave.

Repair type(s): none

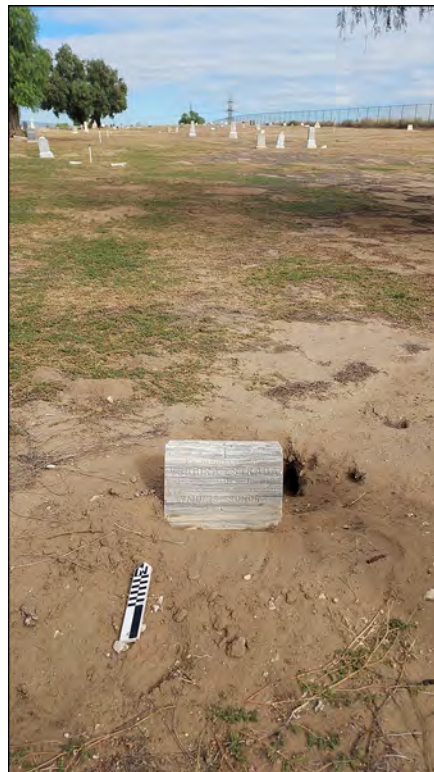
Damage type(s): abrasion, buried/sunk, burrowing-animal disturbance, spalling

This grave is marked by a single marble scroll monument. The grave marker is sinking into the ground, and no base could be observed. Some chips and scratches were observed on the surface, particularly the corners and edges, and burrows were observed immediately adjacent to the marker. The general design of the monument is that of a scroll lying over a beveled block of stone. A cross is carved into the top of the headstone, and the following inscription is carved across the surface:

Repair type(s): none

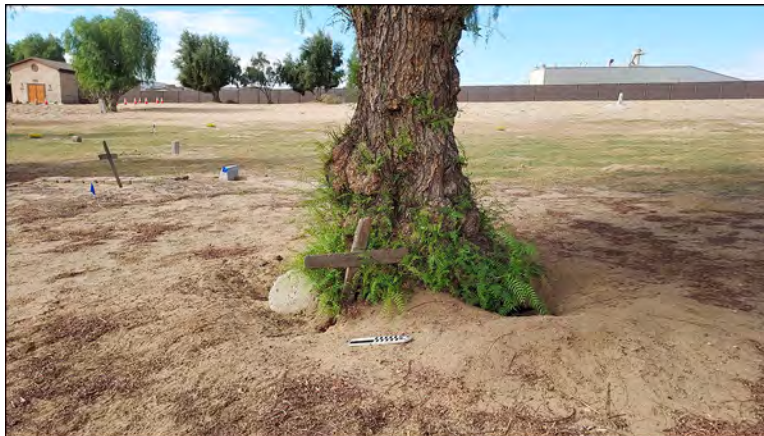
Damage type(s): burrowing-animal disturbance, erosion, vegetation

This grave is marked with a single wooden cross. The cross is in poor condition and is against the base of a pepper tree. Numerous animal burrows are observed in the immediate vicinity. Next to the cross is a partially buried conical piece of concrete that has been displaced onto its side. The general appearance of the concrete suggests that it was once a footing, perhaps for the cross or some other marker. The wooden cross is of two 0.75-inch-thick wooden boards held in place with a screw or bolt. The cross bears no name or inscription.

Repair type(s): none

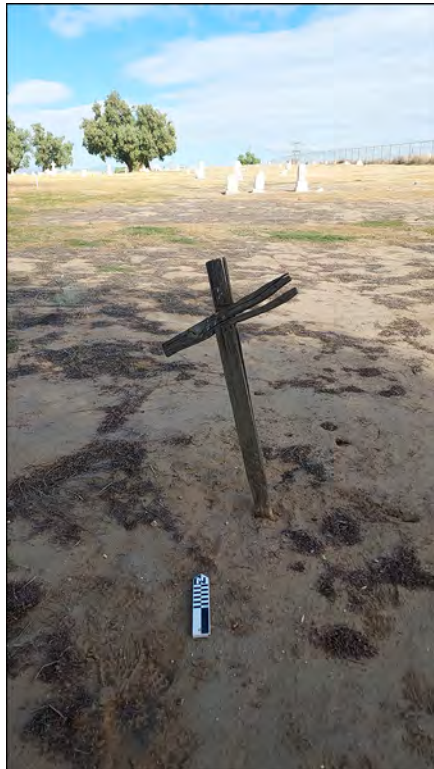
Damage type(s): erosion

This grave is marked with a single wooden cross. The cross is in poor condition; the boards that compose it are splitting and fragmenting. The wooden cross is of two 0.75-inch-thick wooden boards held in place with a screw or bolt. The cross bears no name or inscription.

Repair type(s): none

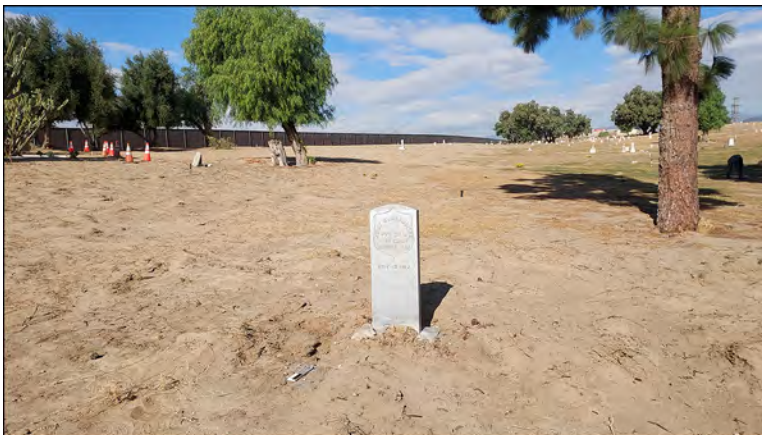
Damage type(s): none

This grave is marked by a marble government-issue—Civil War—type headstone set in a concrete base. The headstone is in excellent condition, with no obvious damage. It is unclear whether the headstone is original, but the lack of damage and the relatively pristine appearance suggest that it is more recently placed. The headstone bears the following inscription in bas relief: “JOSE GUSTAMENTE/PVT CO D/I BN CALIF/NATIVE CALIF”. Beneath the inscription, the death date for the individual is inscribed, “NOV 10 1912”.

Repair type(s): none

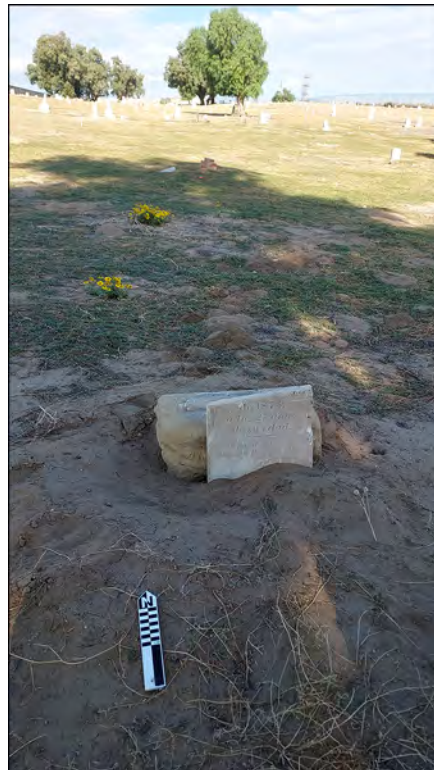
Damage type(s): burrowing-animal disturbance, fragmentation—loss, spalling

This grave is marked with a tab-in-socket headstone. The headstone portion is composed of marble, and the base appears to be sandstone. The sides, front, and back of the base are rock pitched. The headstone has broken away from the base as well across the center, and the upper half of the headstone is missing. Some chipping was observed along the edges of the headstone. Several small animal burrows were observed around the marker. The margins of the headstone face are decorated with column decorations. On the face of the headstone is the following inscription:

Repair type(s): none

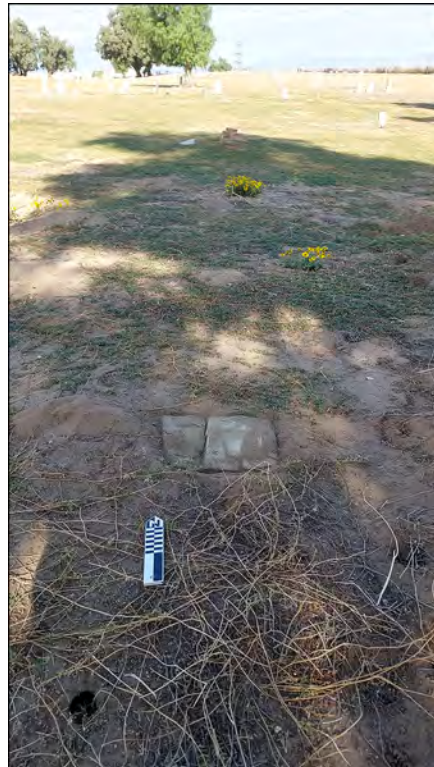
Damage type(s): buried/sunk, disassembled—loss, fragmentation—no loss

This feature consists of an isolated sandstone base. The base has been flipped over and is broken along its short axis. Both halves of the base are present, but any evidence of the headstone is absent. The base is partially buried.

Repair type(s): none

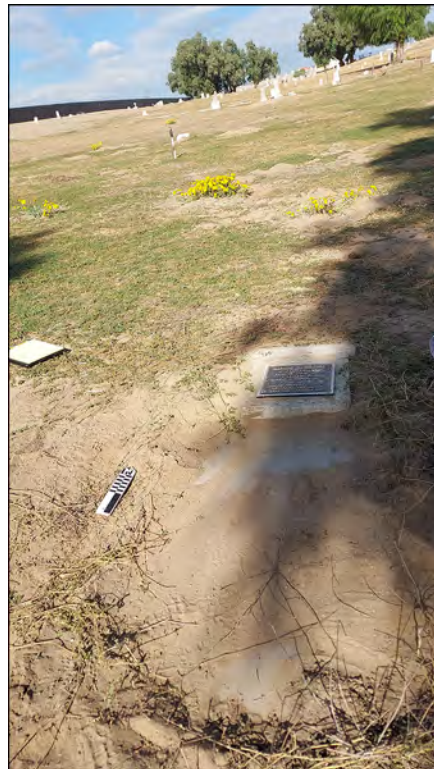
Damage type(s): buried/sunk, detachment—loss, tilted/fallen

Repair type(s): none

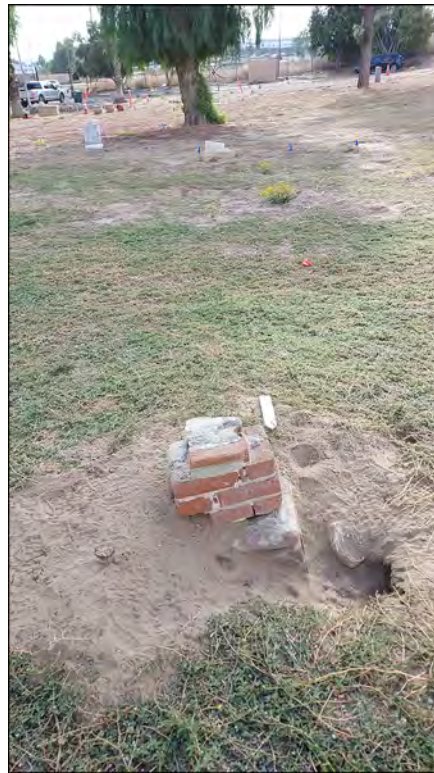
Damage type(s): buried/sunk, burrowing-animal disturbance, spalling

This monument appears to be a buried box tomb composed of red brick and mortar. Visible on the surface is the northwestern corner of the box tomb and a four-course-high stack of red brick and mortar that might represent the base of a marker. No name or other identifying information was visible on any components of this monument. Portions of the bricks have spalled off, and the tomb is almost entirely buried. An animal burrow is immediately adjacent to the feature.

Repair type(s): none

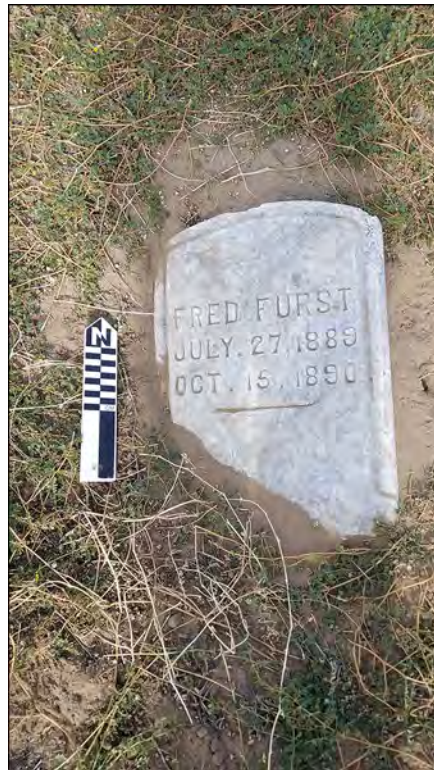
Damage type(s): buried/sunk, spalling, tilted/fallen

This grave is marked by a marble headstone. The monument has fallen and is partially buried. No base was visible; it may be buried. Some chipping was observed along the top margin of the headstone. The visible surfaces of the headstone are undecorated, except for a groove along the top and side margins. The monument has the following inscription: “FRED FURST/JULY. 27, 1889/OCT. 15, 1890”.

Repair type(s): none

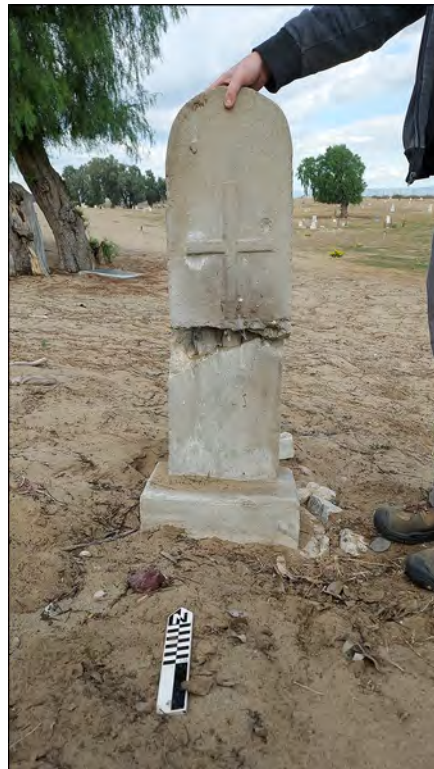
Damage type(s): cracked, fragmentation—no loss

This grave is marked with a concrete die-on-base monument. The monument bears no name or other identifying information for the deceased. The front of the headstone portion is decorated with a cross. The monument is cracked completely through the midsection of the headstone, but the upper fragment of the headstone is still attached by rebar.

Repair type(s): none

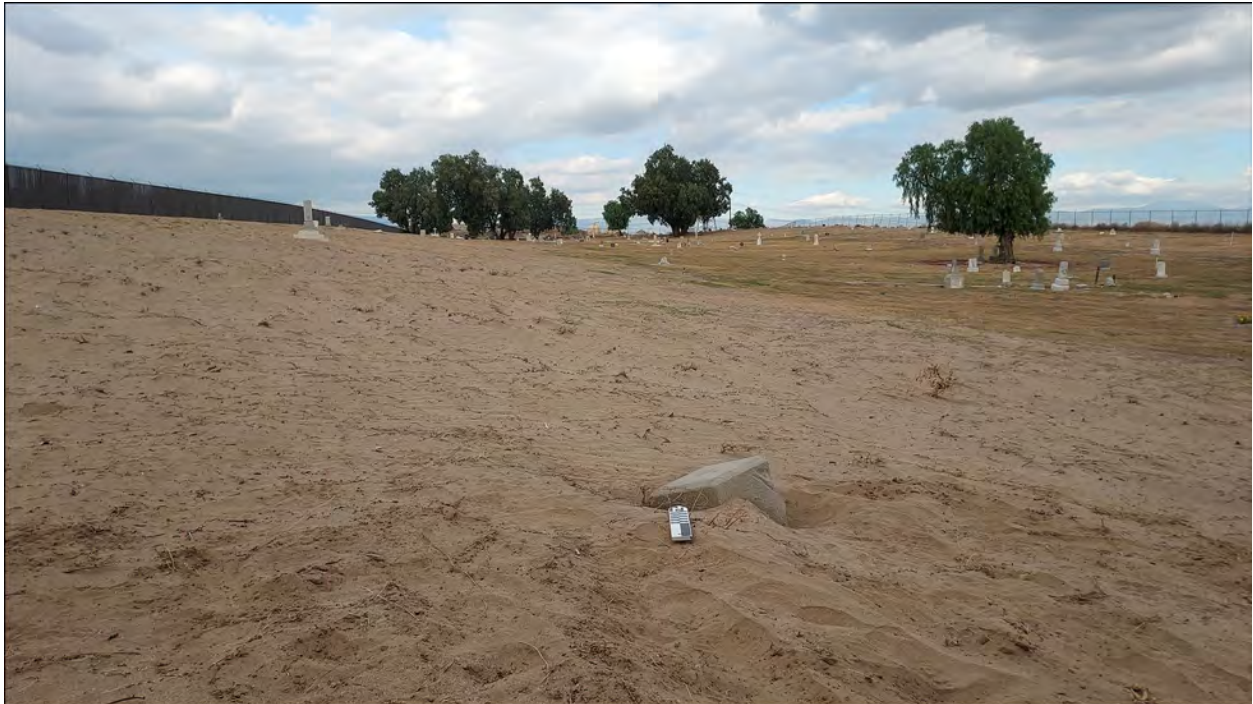
Damage type(s): buried/sunk, disassembled—loss, spalling

This feature consists of a small (12-by-12-by-9-inch), square concrete block that may be a disassembled portion of a monument or a corner or lot marker. The top of the block is chamfered but bears no inscriptions or other information. The block is partially buried and appears to have been damaged along one corner from being struck while buried. No other components associated with this monument were visible.

Repair type(s): none

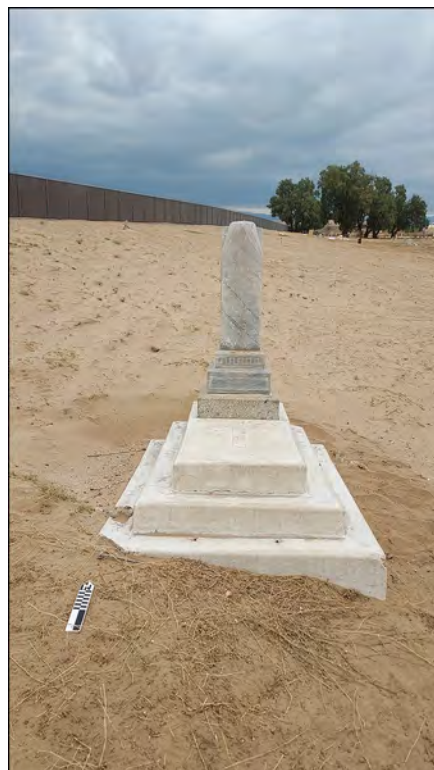
Feature PD: 52**Name:** Irene Lopez**Dates:** February 29, 1904 (death)**Monument type:** vaulted obelisk upon tomb**Enclosure:** none**Damage type(s):** cracked, disassembled—loss**Repair type(s):** none**Description:**

This grave is marked with a large, three-tier concrete tomb with a marble-and-granite obelisk on top of the tomb, at its head. The obelisk pillar, subbase, and base are composed of marble and sit upon an additional base component composed of granite; the subbase and both bases are chamfered. A steel bar extends from the top of the obelisk pillar, indicating that it once held an additional component, possibly an urn or cross. The surface of the upper tier of the tomb is inscribed with a cross, and several surface cracks are visible in several locations on the tomb. The front panel of the obelisk is inscribed with the following:

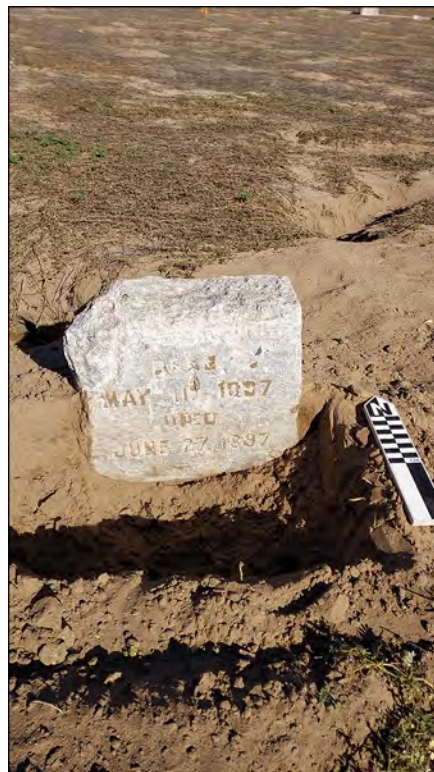
Damage type(s): buried/sunk, burrowing-animal disturbance, fragmentation—loss

This grave is marked with a fragment of a headstone showing the birth and death days of the individual. It is unclear whether this monument was only a headstone or this fragment was part of a compound monument. The profile of the monument is slightly beveled. Most of the fragment was buried at the time of encounter. The fragment is inscribed with “BORN/MAY 11. 1897/DIED/JUNE 27.1897”.

Repair type(s): none

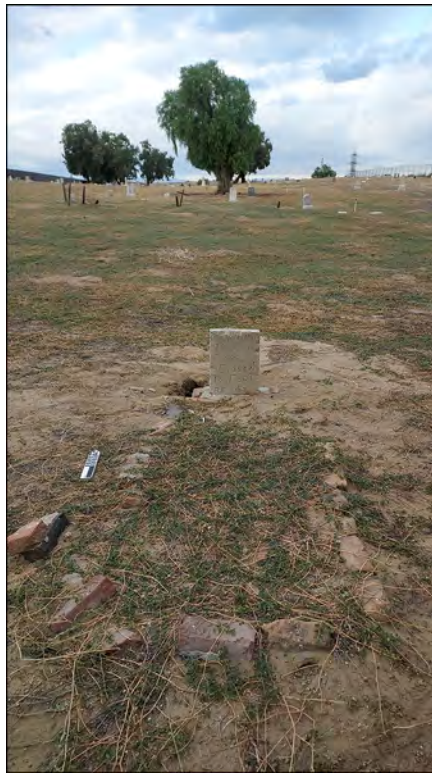
Damage type(s): burrowing-animal disturbance, erosion, spalling, vegetation

This grave is marked with a concrete die-on-base monument and a single line of unmortared brick coping. The grave is overgrown with vegetation, and the surfaces of the bricks are eroded. A large animal burrow is immediately adject to the monument, and the top of the headstone is chipped. The base of the monument is attached to the coping with concrete. The following epitaph was inscribed in alternating uppercase and lowercase letters on the headstone: "REqUERD-/ OS de SU/PAdRE/CRISAN-/TO CONT/REPAS"; no name or dates were inscribed.

Repair type(s): none

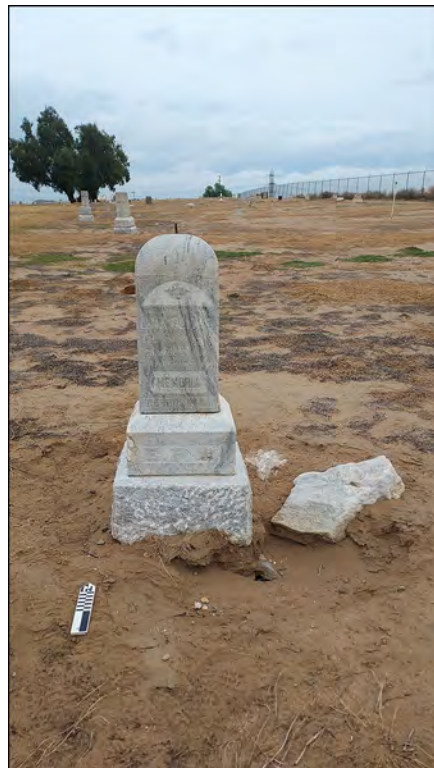
Damage type(s): burrowing-animal disturbance, disassembled—loss, ground loss, spalling

This grave is marked with a marble obelisk. This obelisk is rectangular in form and has a rounded top. The base and subbase are chamfered, and the front, back, and sides of the base are rock pitched. A metal spike extending from the top indicates that the top component for this monument, such as an urn or cross, is missing. The ground around the base of the monument has subsided, likely from the presence of a large animal burrow. Some spalling was observed on a corner of the subbase; an attempt to repair this spalling with mortar was likewise observed. The front of the monument was decorated with a crown motif with linear/geometric designs along the bottom of the front, sides, and bottom of the back of the pillar portion of the obelisk. Although the inscription is faint and some lines could not be read, inscribed on the front of the pillar of the obelisk was the following:

Repair type(s): mortar fills

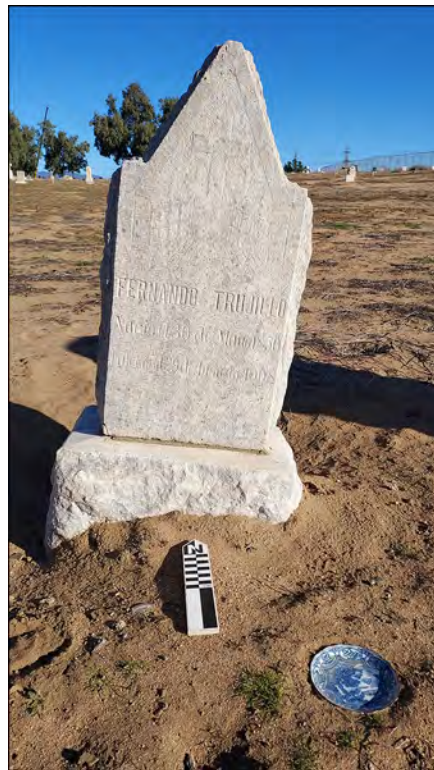
Damage type(s): tilted/fallen

This grave is marked with a marble die-on-base monument. The top of the headstone portion of the monument is steeply arched, with narrow shoulders on both sides. The sides and back of the headstone and the front, back, and sides of the base are all rock pitched. The entire monument is tilted to the east. A small, 5-inch-diameter decorative plate is located at the base of the monument. The same type of plate was found in association with Feature 62 (Maclovio A. Trujillo). The upper half of the headstone is inscribed with a cross-and-gate motif. Below that motif is the following inscription:

Repair type(s): none

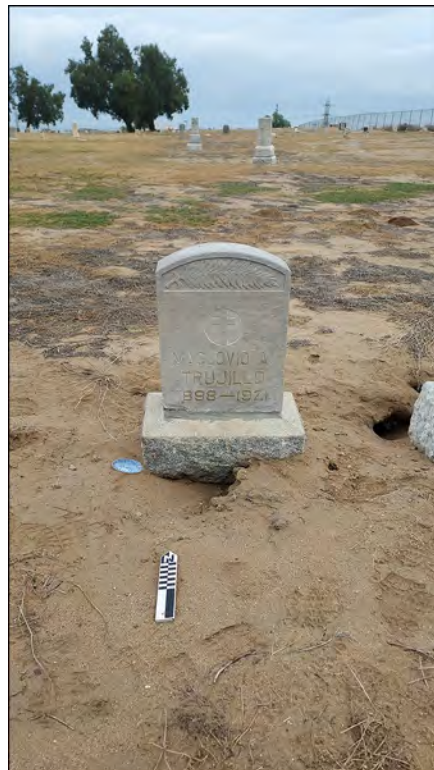
Feature PD: 62**Name:** Maclovio A. Trujillo**Dates:** 1898–1921**Monument type:** die on base**Enclosure:** none**Damage type(s):** burrowing-animal disturbance, disassembled—loss**Repair type(s):** mortar fills**Description:**

This grave is marked with a die-on-base monument. The headstone component of the monument is marble, and the base is made of granite. The front, back, and sides of the base are rock pitched. Based on the overall preservation and clarity of the inscription, it appears that the headstone for the monument was replaced with a modern equivalent and reset on the original base. A large animal burrow was located at the base of the monument. A small, 5-inch-diameter decorative plate is at the base of the monument. The same type of plate was found in association with Feature 60 (Fernando Trujillo). The face of the headstone is inscribed with a wheat-stalk motif along the top, over a cross motif. The fragment is inscribed with “MACLOVIO A./TRUJILLO/1898–1921”.

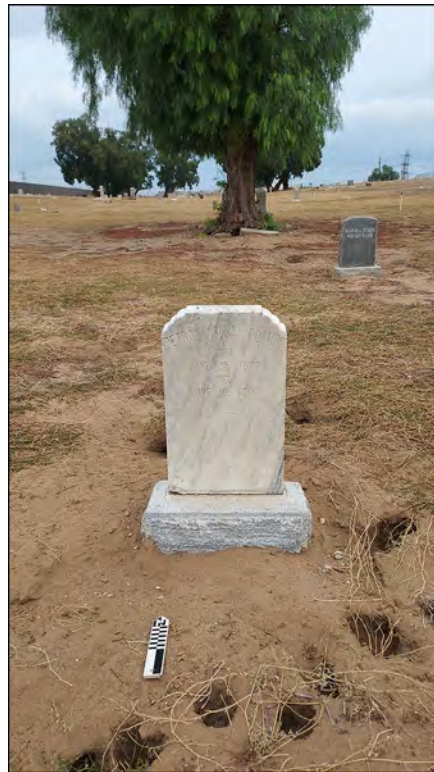
Damage type(s): abrasion, burrowing-animal disturbance, open joints

This grave was marked with a marble die-on-base monument. The headstone component is shaped and finished on all sides with the scalloped shoulders on the arch. The base is chamfered with rock-pitched sides, front, and back. The ground around the monument is covered in animal burrows. Additionally, the surface of the face of the headstone has several abrasions, and the joint between the base and headstone is open. The headstone is inscribed with the following: “PETRA ACUNA OCAMPO/ BORN/JUNE 29. 1870/DIED/JUNE 10. 1907”.

Repair type(s): none

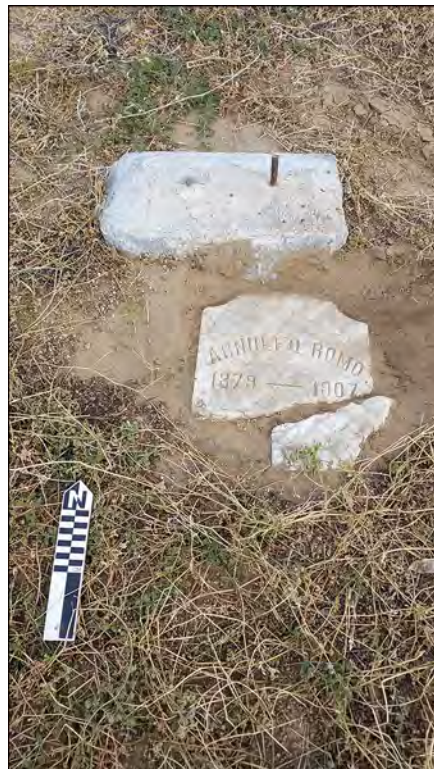
Damage type(s): disassembled—no loss, fragmentation—loss

This grave is marked by a marble die-on-base monument. The headstone component has been removed from the base and lies shattered on the ground in front of it. The fragments of the headstone are undecorated, but the inscription is still legible, reading, “ARNULFO ROMO/1879–1907”.

Repair type(s): none

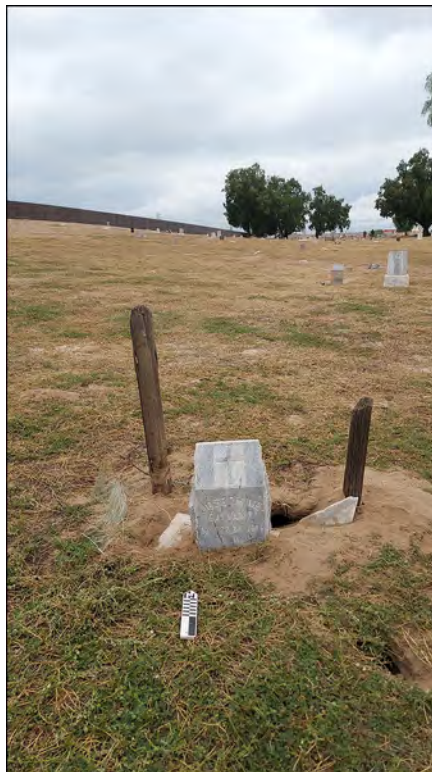
Damage type(s): buried/sunk, burrowing-animal disturbance, open joints, tilted/fallen

This grave is marked by a marble die-on-base monument. The monument is tilted and partially buried. Large animal burrows are next to the monument. The joint between the headstone and base is completely open, and the headstone has rotated. Two wooden posts flank the grave, possibly the remains of crosses or railings. Broken pieces of marble are embedded in the ground nearby, with no discernible inscription. The sides and back of the headstone are rock pitched, and the top of the headstone is beveled with a cross inscribed on the beveled portion. Below the cross is the following inscription: "JOSEPHINE/GALVANO/ Died 22 Dec. 1908/Aged 10 Months".

Repair type(s): none

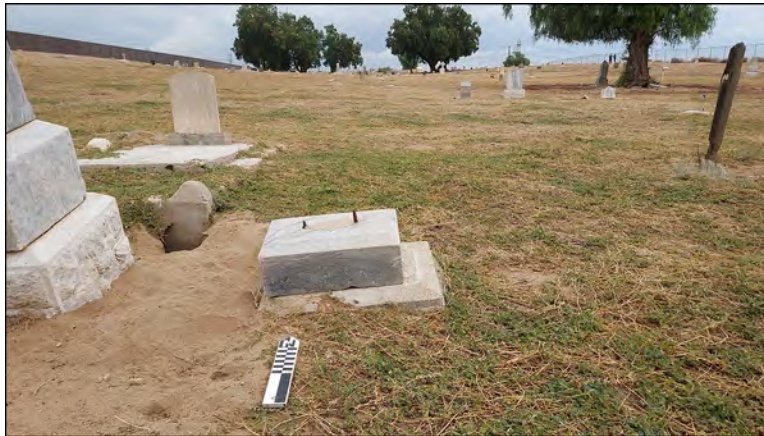
Damage type(s): burrowing-animal disturbance, disassembled—loss, open joints, tilted/fallen

This grave is marked with the subbase and base of a pedestal or obelisk of unknown type. The subbase is shaped and polished. It is made of granite and has a chamfered top with rock-pitched sides, front, and back. The pillar portion of the monument is missing, and the components that are present are tilted. Because of an open joint between the subbase and base, the subbase base is sliding off. There is no visible inscription.

Repair type(s): none

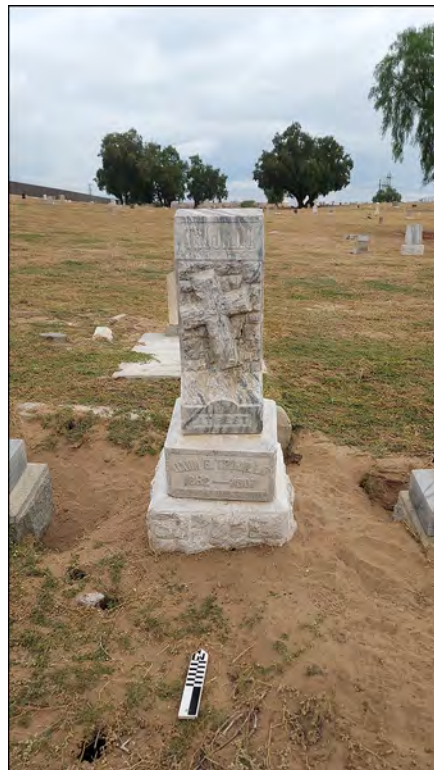
Damage type(s): burrowing-animal disturbance, open joints, tilted/fallen

This grave is marked with an ornate marble obelisk. The front of the pillar portion of the obelisk is decorated with a large cross carved in a wood texture over a blocky patchwork pattern. At the top of the pillar, “TRUJILLO” is inscribed, and at the bottom of the pillar, “AT REST” is inscribed. The subbase and base are composed of a lighter shade of marble, and both are chamfered; the subbase is completely shaped and polished, and the base has rock-pitched sides, front, and back. On the front of the subbase is the following inscription: “JAUN [*sic*] E. TRUJILLO/1852–1907”. Open joints were observed between components. Several burrows were observed next to the monument. The monument is tilting forward.

Repair type(s): none

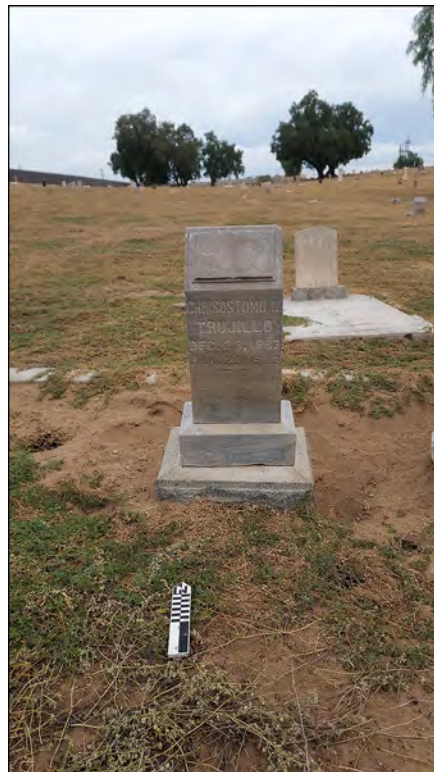
Damage type(s): abrasion, burrowing-animal disturbance, open joints, tilted/fallen

This grave is marked with a pulpit marker. The pillar portion and subbase are composed of marble, and the base is made of granite. Both the subbase and base are chamfered; the sides, front, and back of the base are rock pitched. No inscription was observed on the open book on the pulpit marker, but the front of the marker is inscribed with the following: “CHRISOSTOMO N./TRUJILLO/DEC. 23, 1883/JAN. 23, 1903/Let his soul rest in peace”. Numerous abrasions were observed on the back of the monument. Several animal burrows are next to the monument. The monument is tilted forward. The joints between components are open.

Repair type(s): none

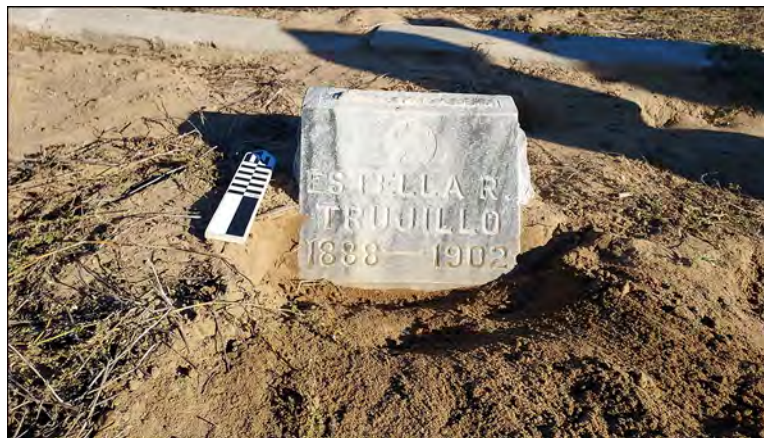
Damage type(s): buried/sunk, burrowing-animal disturbance

This grave is marked by a marble slant marker monument. The monument is partially buried in the ground, and animal burrows were observed adjacent to the monument. The sides, top, and back have rock-pitched surfaces surrounded by areas that are shaped. It is unclear whether this monument is original, but the preservation suggests that it might have been placed more recently than the recorded death year of the deceased. The monument is decorated with a cross motif above the following inscription: “ESTELLA R./TRUJILLO/1888–1902”.

Repair type(s): none

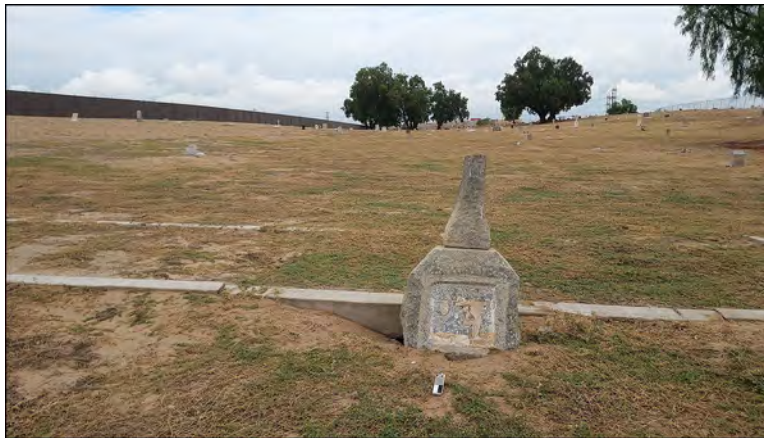
Damage type(s): burrowing-animal disturbance, disassembled—loss, fragmentation—loss, open joints, tilted/fallen

This grave is marked with a roughly hexagonal granite boulder. A broken spire, possibly the bottom of a cross, extends from the top of the main body of the monument. In the center of the front of the monument is a square-shaped depression carved from the rock face where a plaque appears to have been set but is no longer present. The joint between the spire and body of the monument is open, and the monument is tilted backward. The ground around the monument has several animal burrows.

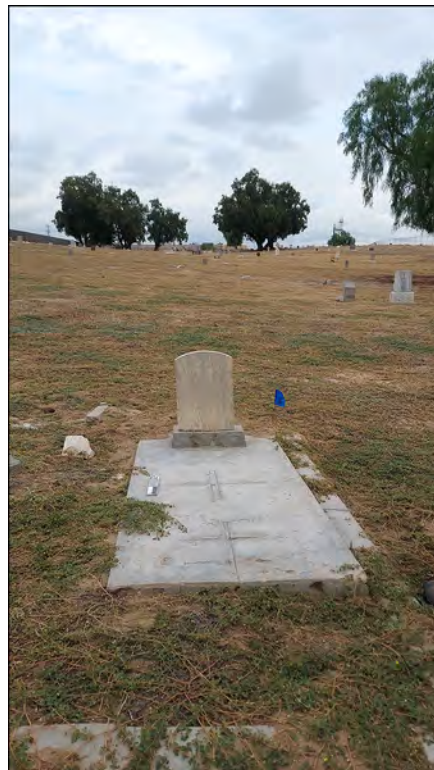
Feature PD: 80/82/84

Damage type(s): cracked, disassembled—loss, fragmentation—loss, open joints

This grave is marked with a marble die-on-base monument that was placed on a larger concrete ledger. The headstone portion of the monument appears to be the original headstone that was inserted into a concrete base. The ledger has several small cracks. The original headstone base is missing. It is unclear whether the headstone was broken from the base or was disassembled. The joint between the headstone and base is unsealed.

The monument was located within an approximately 50-by-9-foot area of coping (Feature 82). No other graves were observed within the coping, but their markers may be buried. The coping was undecorated, except for concrete posts at each corner, which were each peaked with a flat-topped pyramid. Adjacent to this grave within the coping were three fragments of other markers (Feature 84): an undecorated chunk of marble, a concrete segment possibly from a cross, and a small, concrete pedestal or column textured like wood or a tree trunk that was broken at ground level.

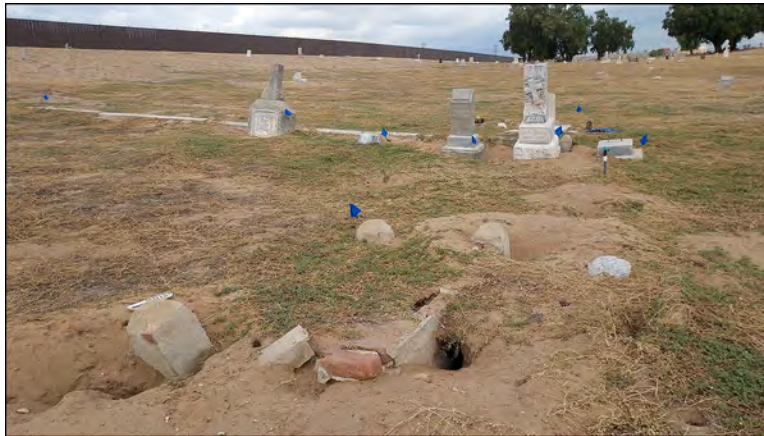
Feature PD: 86

Damage type(s): buried/sunk, burrowing-animal disturbance, cracked, erosion, tilted/fallen

This grave is marked with an 82-by-41-inch area of brick-and-mortar coping on the surface. There are no monuments on the surface. The area is completely cut through with animal burrows that have exposed buried portions of a burial vault as well as brought coffin hardware and human bone to the surface. The corner posts of the coping are composed of concrete and are topped with flat-topped pyramidal concrete caps. The brick is heavily eroded and cracked, and the structure as a whole is sinking and tilting to the west.

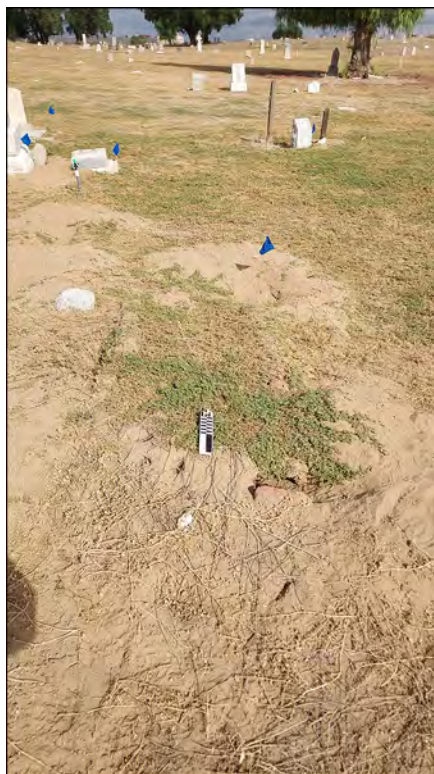
Feature PD: 88

Damage type(s): buried/sunk, burrowing-animal disturbance, cracked, erosion, tilted/fallen

Similar to Feature 86, this grave is marked with a 59-by-32-inch area of brick-and-mortar coping on the surface. There are no monuments on the surface. The area is completely cut through with animal burrows that have exposed buried portions of a burial vault. The brick is heavily eroded and cracked, and the structure as a whole is sinking and tilting.
