Archaeological Condition Assessment and Ground-Penetrating Radar (GPR) Surveys for Agua Mansa Cemetery, San Bernardino County, California

Technical Report 24-26
Statistical Research, Inc.
Redlands, California

April 2024

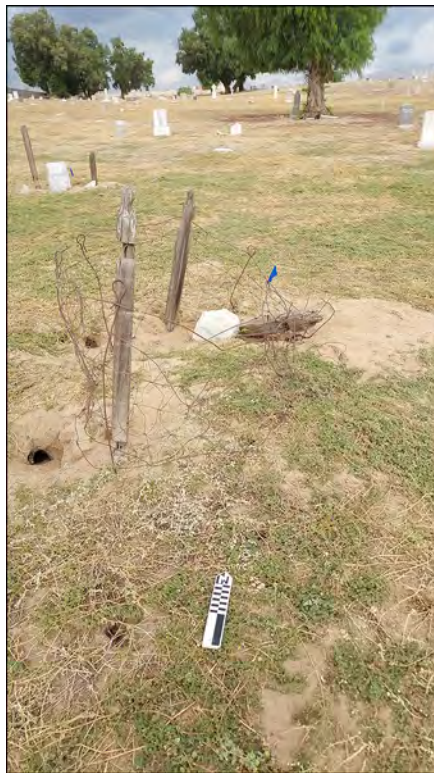
Feature PD: 90

Damage type(s): buried/sunk, burrowing-animal disturbance, fragmentation—loss, tilted/fallen

This grave is marked with a small marble headstone. The top, back, and sides of the headstone are rock pitched. The headstone is surrounded by medium-gauge steel fencing with three approximately 4-foot-tall wooden posts. The posts have tapered tops, like bedposts. Numerous animal burrows are around the headstone. The headstone itself is partially buried and tilted, and one of the corners is missing. The posts for the fencing are likewise falling over, and the fence is twisted and bent. The headstone is decorated with a cross motif has the following inscription: “FLORENCE/MARTINEZ/1903–1906/AGED 3 YRS”.

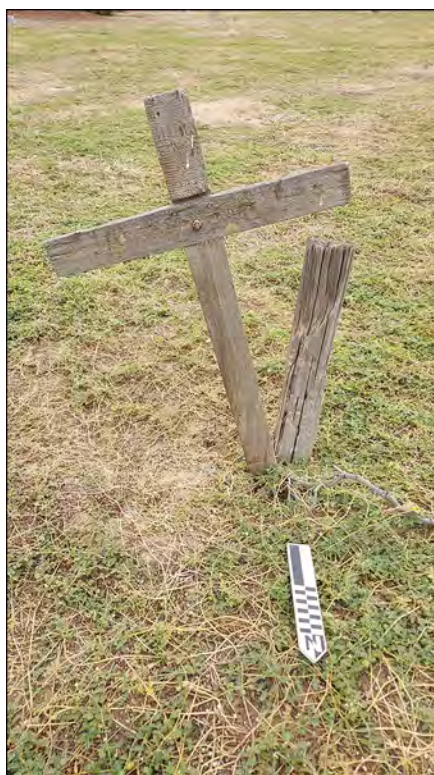
Feature PD: 92

Damage type(s): erosion, tilted/fallen

This grave is marked with a wooden cross. The cross is poorly preserved and tilted to one side. A 4-by-4-inch post was located immediately adjacent to the cross and may be the remains of another marker in this location. The wooden cross is of two 0.75-inch-thick wooden boards held in place with a screw or bolt. The cross bears no name or inscription.

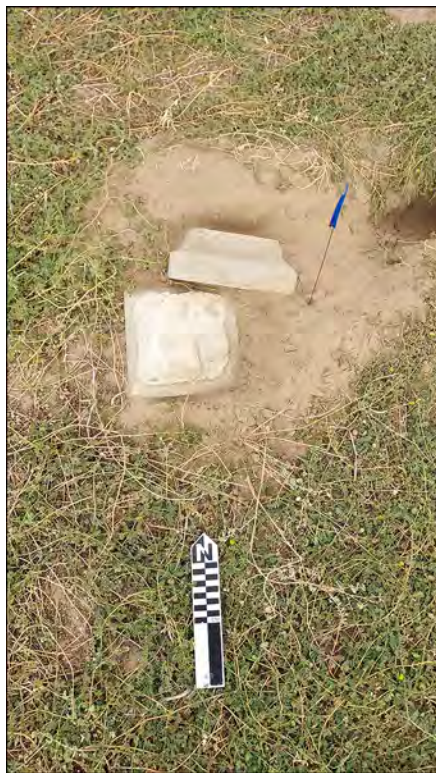
Feature PD: 94

Damage type(s): burrowing-animal disturbance, disassembled—loss, tilted/fallen

This feature is a pair of 9-by-9-inch concrete bases. Cement residue on the tops of the bases indicates that each once supported additional components, perhaps a vase or a cross. Neither base bears any indication as to which grave it might have belonged. An animal burrow is adjacent to the bases. Both bases are missing other components of the monument and are tilted.

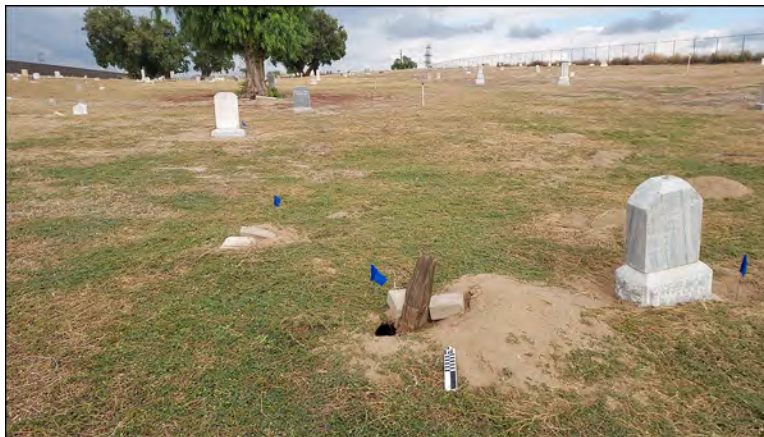
Feature PD: 96

Damage type(s): burrowing-animal disturbance, disassembled—loss, tilted/fallen

This feature consists of a pair of approximately 7-by-7-inch concrete bases and an associated 22-inch wooden post. Neither base bears any indication as to which grave it might have belonged. An animal burrow is adjacent to the bases. Both bases are missing other components of the monument. The wooden post is tilted.

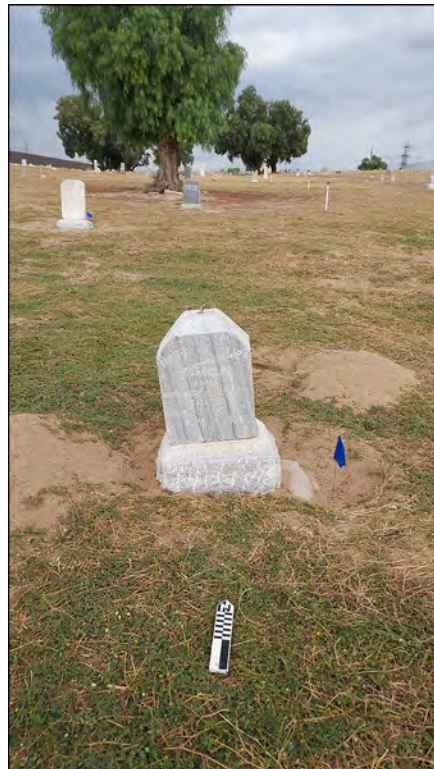
Feature PD: 98

Damage type(s): burrowing-animal disturbance, disassembled—loss, open joints, tilted/fallen

This grave is marked with a marble die-on-base monument. The headstone portion of the monument is trapezoidal in shape, with a flat apex at the top to allow for the placement of a top component, possibly a cross or vase; this third component is missing. The base is rock pitched on the front, back, and sides and has a chamfered top. The headstone is undecorated but bears the following inscription:

An animal burrow is adjacent to the monument, and the monument is tilted. The joint between the base and headstone is open. The base appears to be stabilized with concrete.

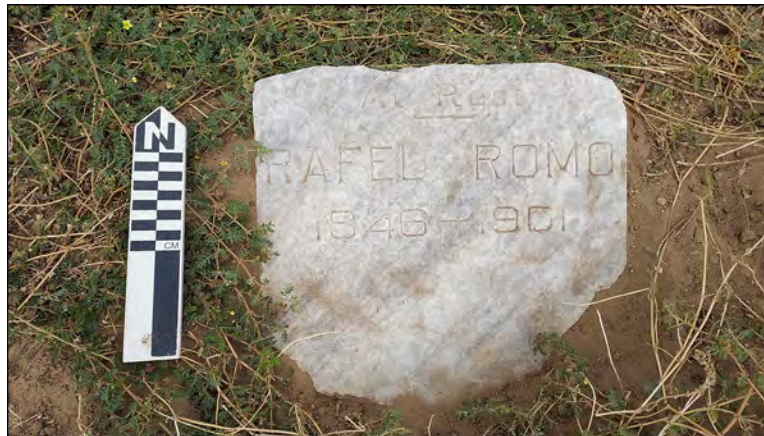
Feature PD: 100

Damage type(s): buried/sunk, fragmentation—loss, tilted/fallen

This grave is marked with a broken marble headstone that has fallen over. The bottom of the headstone is buried. The headstone is undecorated and bears the following inscription:

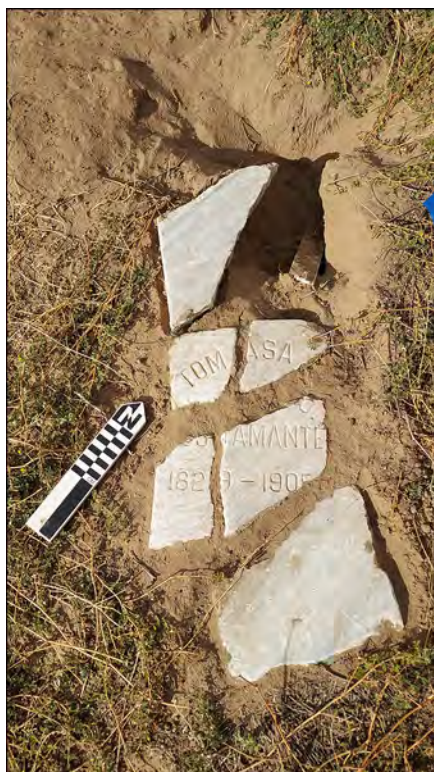
Feature PD: 102

Damage type(s): burrowing-animal disturbance, fragmentation—no loss, fragmentation—loss, tilted/fallen

This grave is marked with a shattered marble headstone. The headstone has fallen over. Additionally, the monument is broken into seven pieces, and additional pieces are missing. An animal burrow is adjacent to the headstone fragments. The monument is undecorated but is inscribed with the following: “TOMASA/[xxx]TAMANTE/1829–1905”.

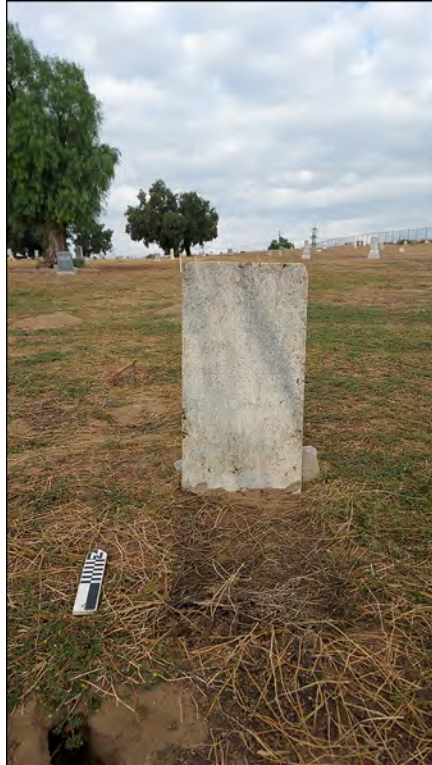
Feature PD: 104

Damage type(s): burrowing-animal disturbance, fragmentation—no loss, tilted/fallen

This grave is marked with a marble die-on-base monument. The headstone component had broken from the base and was lying on the ground, front side down; the base is tilted forward, as well. An animal burrow was observed near the monument. Cement on the surface of the base and the bottom of the headstone indicates that repairs to this monument were attempted. The headstone is decorated with a cross motif and the following inscription:

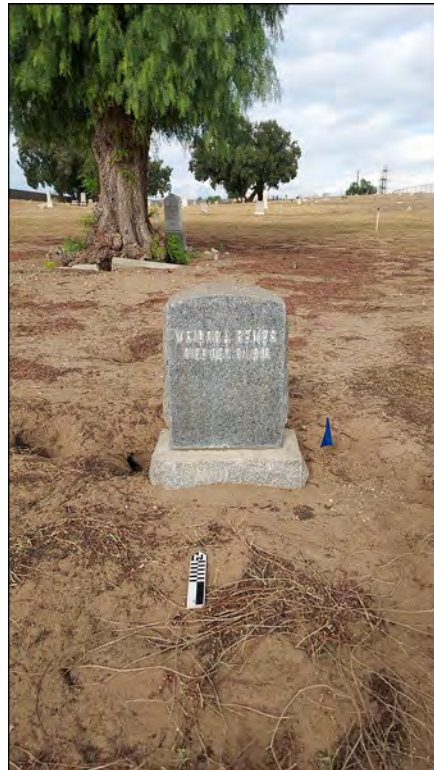
Feature PD: 106

Damage type(s): burrowing-animal disturbance

This grave is marked with a granite die-on-base monument. The sides, top, and back of the headstone component and the sides, front, and back of the base are all rock pitched. The top of the base is chamfered. An animal burrow is adjacent to the monument. The headstone is undecorated but is inscribed with the following: "YSIDORA REYES/DIED DEC 31 1910".

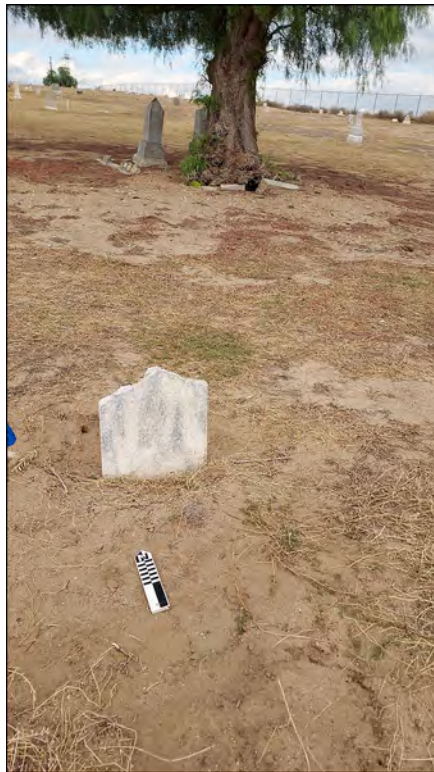
Feature PD: 108

Damage type(s): buried/sunk, erosion, fragmentation—loss

This grave is marked with a partial marble headstone. The top of the headstone is broken and missing, and the headstone has sunk into the ground over the years. The inscription is difficult to read because of erosion, but there appears to be a cross motif. Below the cross, the following is inscribed, “JOSEPH MELENDRES/1844–1908”. A fragment of black granite was found behind the headstone and may be part of a base.

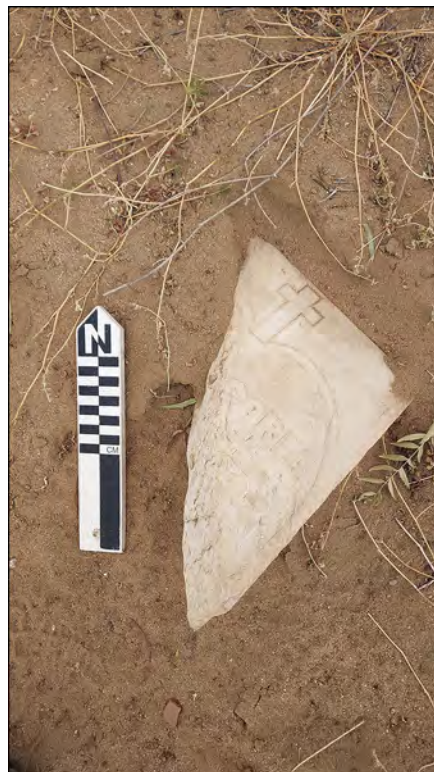
Feature PD: 110

Damage type(s): fragmentation—loss

This grave is marked with a fragment of a marble headstone. Most of the headstone is missing, and only the right upper quadrant is present. The headstone bears a heart-and-cross motif. The only part of the inscription that is present is “[. . .]CORIA/EL./[. . .]92”.

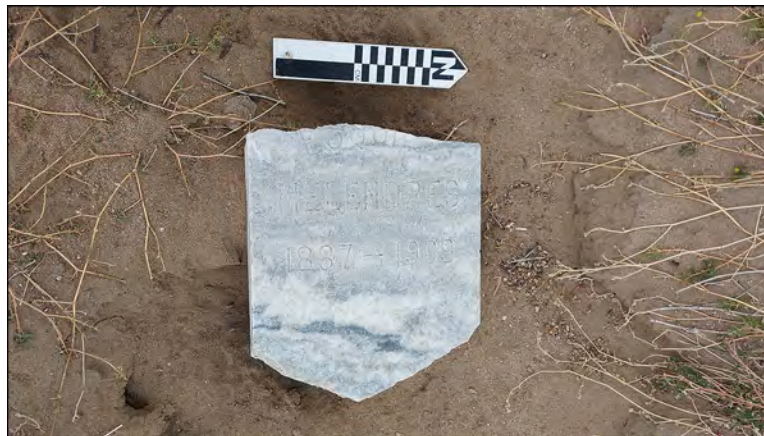
Feature PD: 112

Damage type(s): burrowing-animal disturbance, fragmentation—loss

This grave is marked with a fragment of a marble headstone. Most of the headstone is missing, and only the midsection is present and is on top of an animal burrow. The headstone is undecorated but bears the following inscription: “ESQUILL/MELENDRES/1887–1909”.

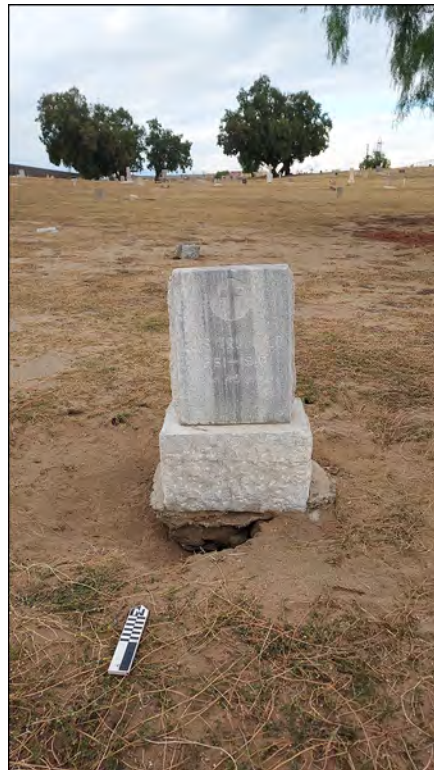
Feature PD: 114

Damage type(s): burrowing-animal disturbance

This grave is marked by a marble die-on-base monument. The sides and back of the headstone component and the sides, front, and back of the base are rock pitched. The top of the base is flat and not chamfered like most of the other bases in the cemetery. The profile of the headstone is wedge shaped. A massive hole from a burrowing animal is present at the base of the monument. The monument appears to have been stabilized by concrete. The headstone is decorated with a cross motif and inscribed with the following: “LUIS TRUJILLO/1861–1910/edad 49 anos [*sic*]”.

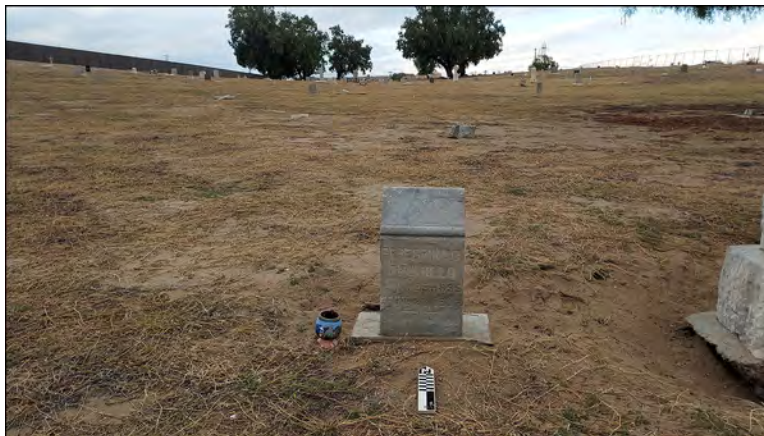
Feature PD: 116

Damage type(s): tilted/fallen

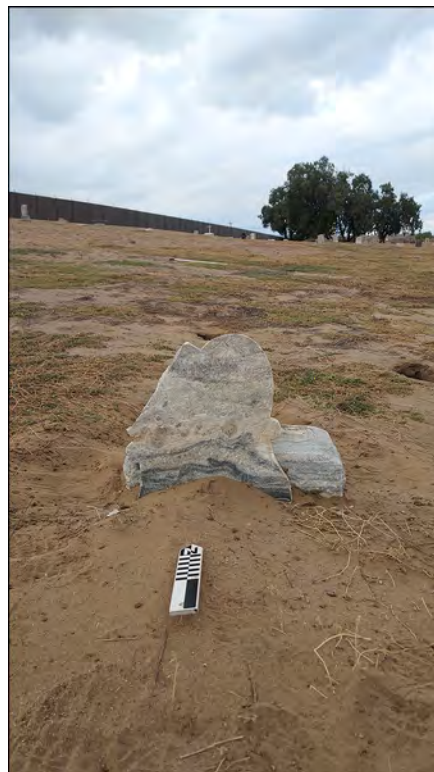
Feature PD: 118

Damage type(s): burrowing-animal disturbance, erosion, fragmentation—loss, fragmentation—no loss

The grave is marked with a marble tab-in-socket monument. The headstone is broken from the base and is also missing a portion of its left side. The base is rock pitched on the sides, front, and back. The inscription is difficult to read because of erosion of the monument surface. Animal burrows were observed near the monument. The monument bears a cross motif and is inscribed with the following:

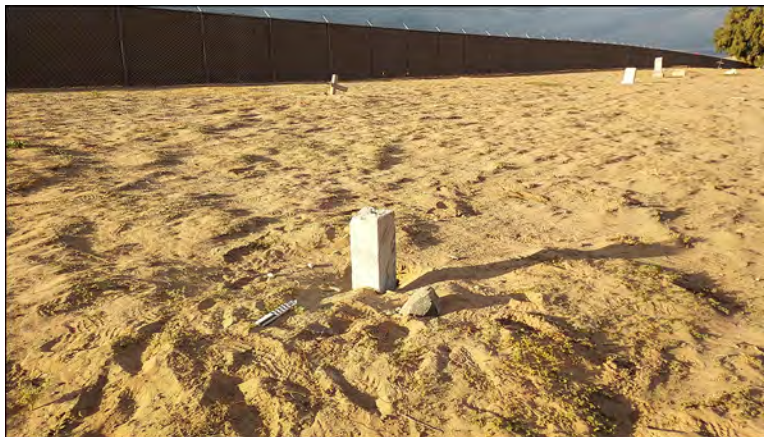
Feature PD: 120

Damage type(s): buried/sinking fragmentation—loss

This grave is marked by a fragmented, upright marble block, possibly an obelisk or row-marker fragment. The monument is broken and is sinking into the ground. It is not decorated, and there is no name or other defining characteristics.

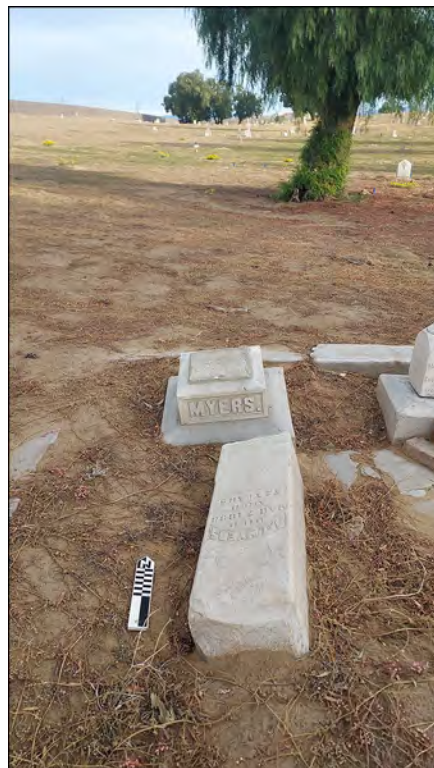
Feature PD: 124/128

Damage type(s): buried/sunk, cracked, disassembled—no loss, fragmentation—loss, tilted/fallen

This grave is marked with an obelisk. The obelisk spire and subbase are composed of marble, and the base is granite. The tops of the base, subbase, and spire are chamfered. The cement used to adhere the spire to the subbase has failed, and the spire is lying on the ground in front of the base. The spire is decorated with a lily and banner on the front and several geometric/linear features around the bottom. The front of the spire is inscribed with the following:

This grave was found in a large area bounded by concrete coping (Feature 128), immediately west of and adjacent to the grave of Dolores Trujillo (Feature 126). Written in the concrete of the coping is a date: May 12, 1931. The ground in front of this grave within the coping is covered in a layer of cracked concrete that was likely poured at the same time as the coping.

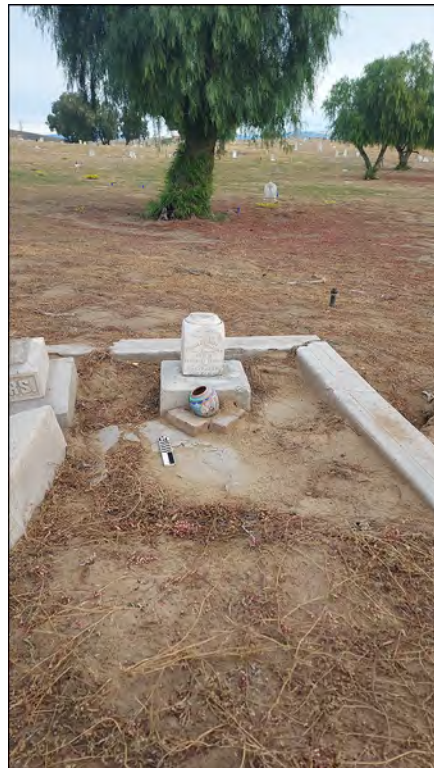
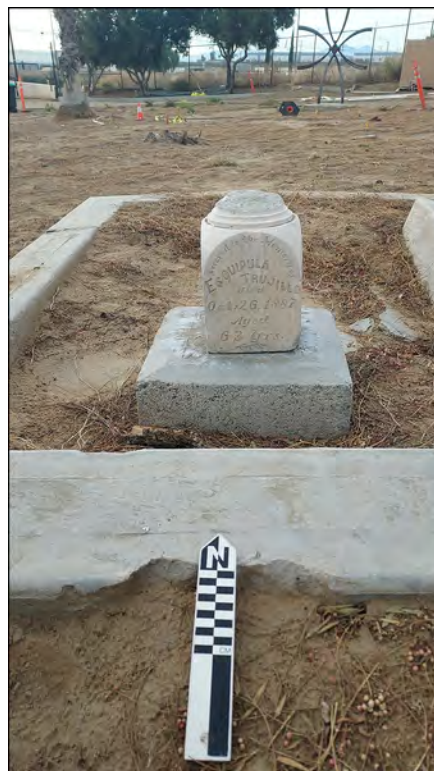
Feature PD: 126/128

Damage type(s): fragmentation—loss

This grave is marked with the remains of a marble column. The monument consists of a granite base upon which a smaller marble base and the surbase of a column sit. The column is broken at the surbase, and the remains of cement suggested that an attempt to repair it had occurred at some point in the past. In front of the marble base are two bricks and a small ceramic paint jar. This grave marker commemorates two individuals: Maria Dolores Trujillo and Esquipula Trujillo. It is east of and adjacent to the grave of A. J. Myers (Feature 124), in an area that has been paved with concrete and bounded by concrete coping (Feature 128). The marble base of the column bears two inscriptions in a flowing, almost cursive, script. One inscription is on the front of the marker, and the other is on the back. The front inscription is as follows:

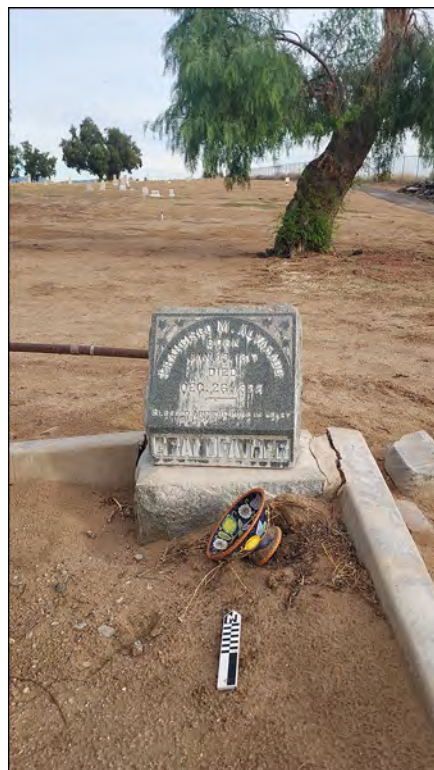
Feature PD: 136

Damage type(s): cracked, open joints

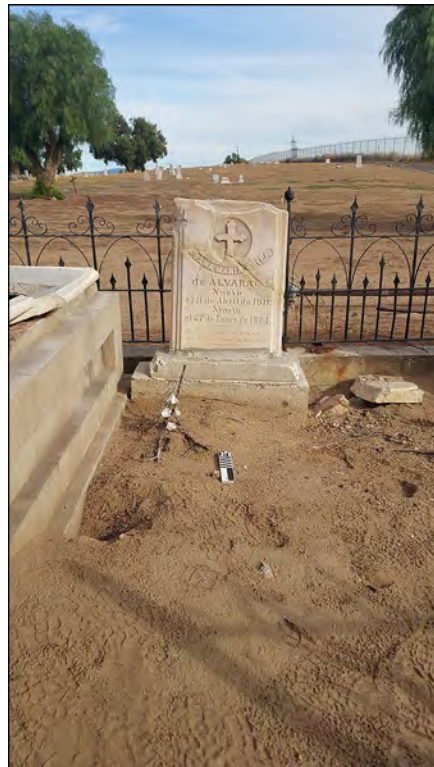
Feature PD: 142**Name:** Juana Maria [. . .]bila de Alvarado**Dates:** April 11, 1811–January 27, 1884**Monument type:** die on base**Enclosure:** concrete (Feature 146)**Damage type(s):** cracked, fragmentation—loss, fragmentation—no loss, spalling**Repair type(s):** basal resetting, repair—hard cement**Description:**

This grave is marked with a die-on-base monument. The headstone component is composed of marble, and the base is made of concrete. Although the headstone appears to be the original marker, the base may be a more-modern addition. The headstone had been shattered into several pieces, but some of the pieces had been reattached with cement. Two other fragments were located on the ground next to the monument. Cracking and spalling were observed on the headstone and base, and the headstone looked like it had been reset onto the base. The headstone is decorated with a cross motif and inscribed with the following:

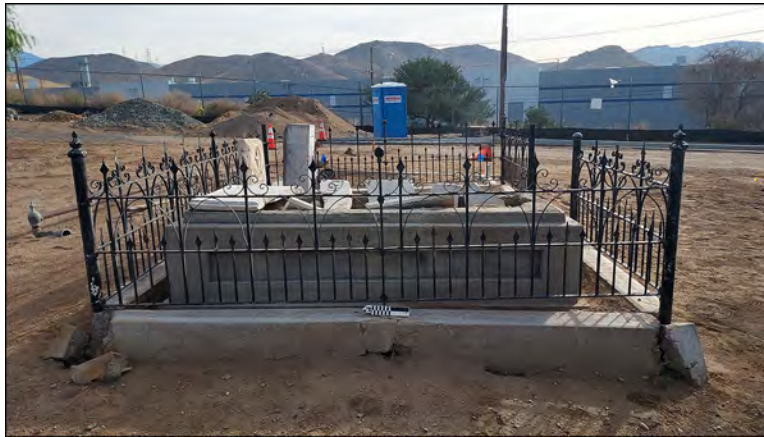
Feature PD: 144

Damage type(s): fragmentation—no loss

This grave is marked by a concrete box tomb with a marble ledger slab over it. The marble slab had been broken into numerous pieces that had all fallen into the box tomb. The concrete component of the box tomb, however, appeared to be undamaged. The marble slab is undecorated but inscribed with the following: “C[. . .] JENSEN./1814–1886”.

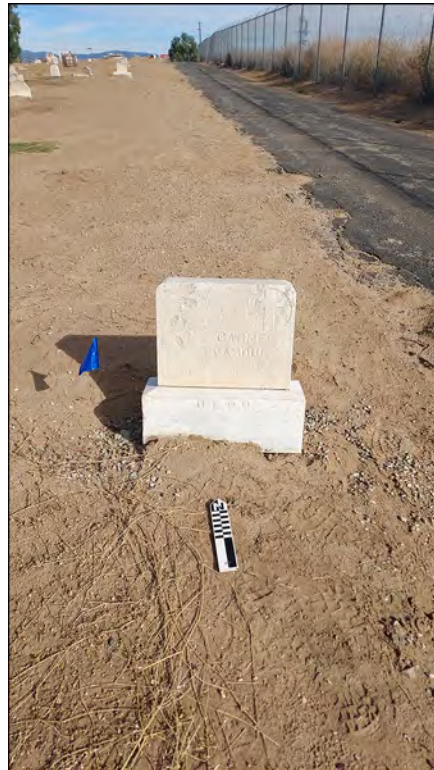
Feature PD: 148

Damage type(s): ground loss

This grave is marked with a marble die-on-base monument. Although the monument is in excellent condition, the ground around the monument is eroding away, potentially posing a stability risk to the monument. The monument appears to be a modern replacement for the original marker. The headstone portion of the monument bears a cross motif offset to the top-right corner of the marker and poppies vertically arranged along the left side of the monument face. The headstone is inscribed with the following:

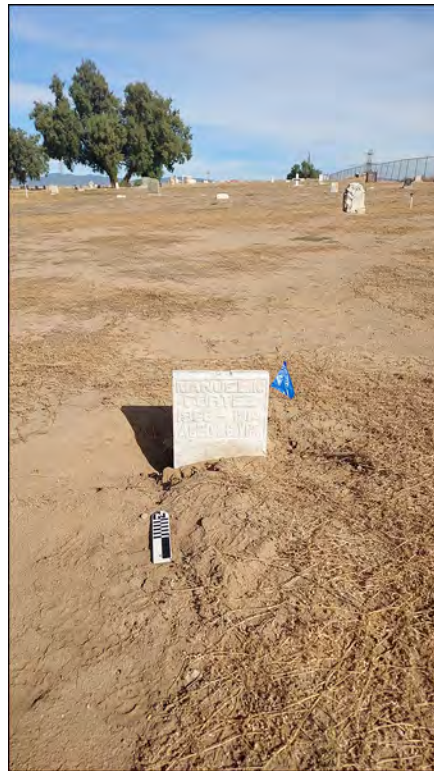
Feature PD: 152

Damage type(s): buried/sunk, ground loss

This grave is marked with a headstone that is sinking into the ground such that if there is any base present, it is current unobservable. Additionally, the ground is eroding away from the marker, potentially posing a stability risk to the monument. A mass of concrete was observed behind the headstone, likely to help prop it up. The monument is decorated with a cross on top of the top margin of the headstone and bears the following inscription:

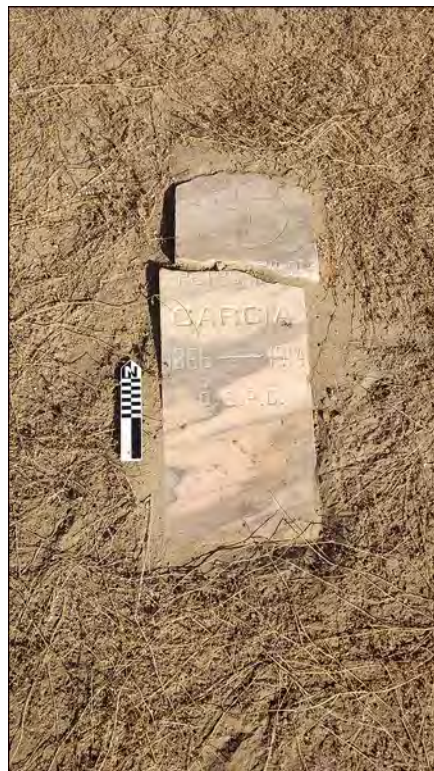
Feature PD: 154

Damage type(s): fragmentation—no loss, tilted/fallen

This grave is marked by a pink marble headstone that has fallen over and broken in half. The fracture has partially obscured the name of the deceased. The headstone is decorated with a cross-and-ivy motif and bears the following inscription:

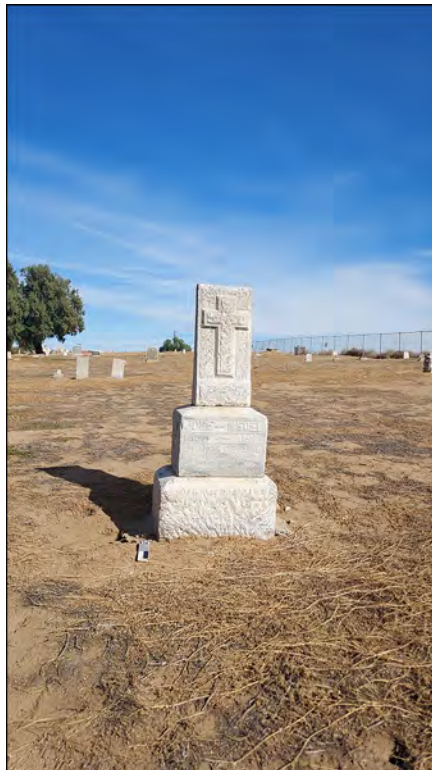
Feature PD: 158

Damage type(s): burrowing-animal disturbance

This grave is marked by an obelisk. The front and back pillars of the obelisk are angled, giving the pillar a trapezoidal cross section. The sides, top, and back of the pillar are rock pitched, and the front has a large cross carved onto it. The surface of the cross is rock pitched, the field behind the cross is decorated with a series of carved squares. The front of the subbase is formed and finished, and the sides and back are rock pitched; the top of the subbase is chamfered. The base also has a chamfered top, but the sides, front, and back are rock pitched. An animal burrow was observed behind the monument; apparently, it had removed a lot of sediment from the base. A mass of concrete was observed beneath the monument and apparently had been placed there to help stabilize it.

Repair type(s): concrete stabilized

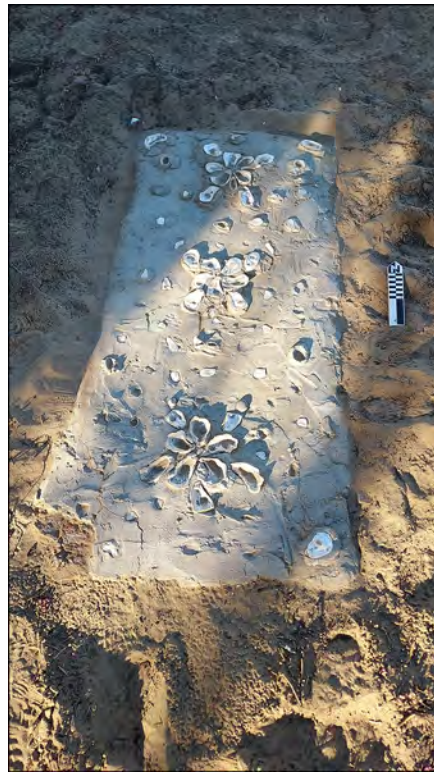
Feature PD: 188

Damage type(s): fragmentation—loss, cracked, buried/sunk

This grave feature consists of a concrete ledger-type monument that contains hand-inlaid shells and a glass bottle base. The monument is rectangular. Fragmented sections of three corners show that the monument was constructed with a thin (0.13–0.50-inch) layer of concrete on top of the brick (possibly indicating an underground vault). The monument is decorated with oyster shells, Venus and Pismo clamshells, and a glass bottle base that were pressed into the concrete while wet. The shells and bottle base are spaced sporadically around the monument in no discernable pattern. Several shells appear to be missing, and the monument has multiple cracks running through it. In addition, the monument had been buried under 6-8 inches of soil prior to recording. There are no inscriptions or dates on the marker.

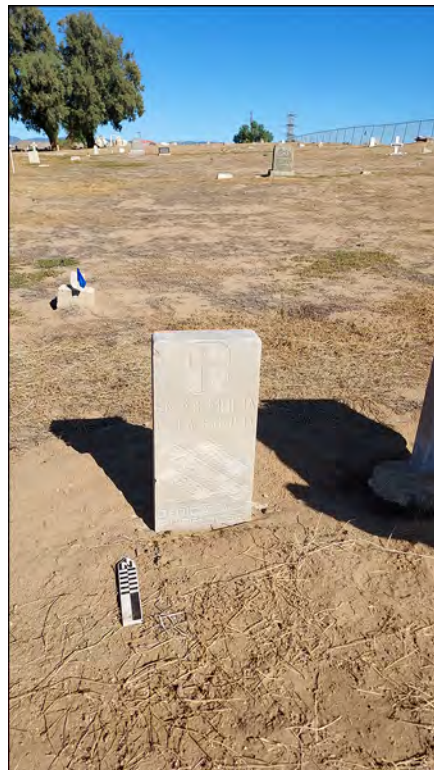
Feature PD: 212

Damage type(s): spalling, ground loss

This grave is marked with a marble headstone. The overall shape of the marker is rectangular, and it has a rectangular arch. The headstone has been inserted into poured-in-place concrete with no discernable shaping and likely represents later basal resetting to keep the headstone standing. The monument contains an incised cross above the inscription. It has some minor spalling along the edges, and the base is partially undercut by ground loss. Inscribed on this monument is the following:

Repair type(s): basal resetting

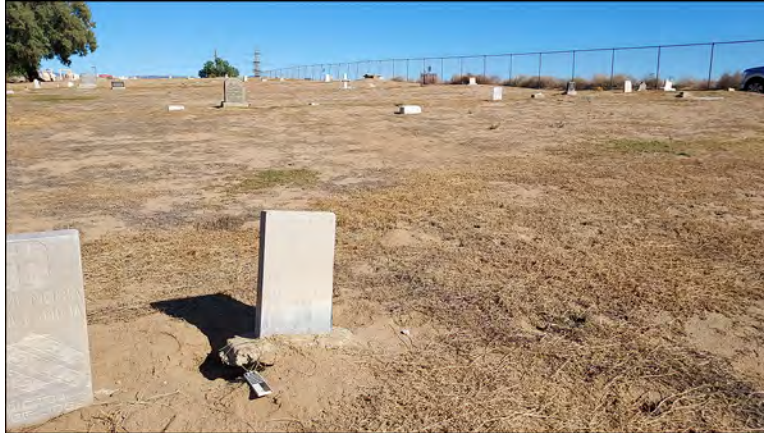
Feature PD: 214

Damage type(s): disassembled—loss, fragmentation—loss, buried/sunk

This feature consists of a green sandstone base for a die-on-base monument. The base is chamfered. The top of the block contains patches of mortar where the headstone component likely sat. The headstone component is missing, and the base contains irregular gouges/grooves on the top surface. One corner has been fragmented (with loss), and the base is partially buried. There are no inscriptions or decorations on the monument base.

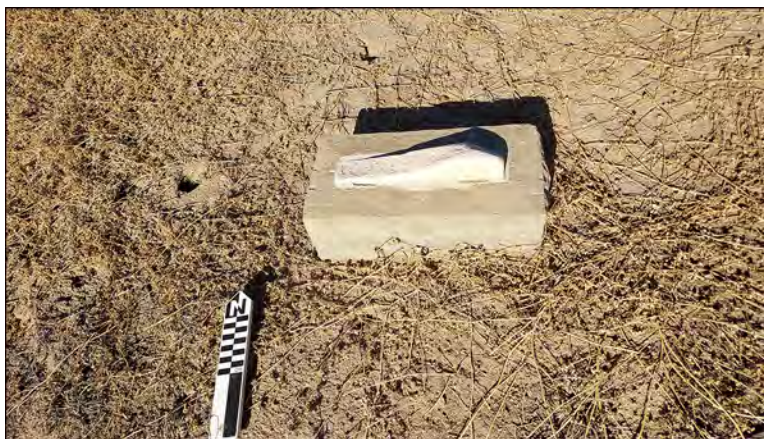
Feature PD: 238

Damage type(s): fragmentation—loss, cracked, burrowing-animal disturbance

This grave is marked with a marble headstone. The headstone is roughly rectangular and has a rectangular arch. A corner of the headstone has fragmented off and is missing. It was replaced with concrete in a later repair. Other repairs included resetting of the headstone, which may have fallen, in a thin base of concrete and the mortar filling of a crack that runs down the back of the stone. The concrete used to reset the headstone is fragmented, and some is missing. There is burrowing-animal disturbance next to the headstone, as well. Inscribed on this monument is the name of the deceased, along with their birth and death dates: “RAPHAEL/CONTRERAS/1878–1920”.

Repair type(s): basal resetting, mortar fills

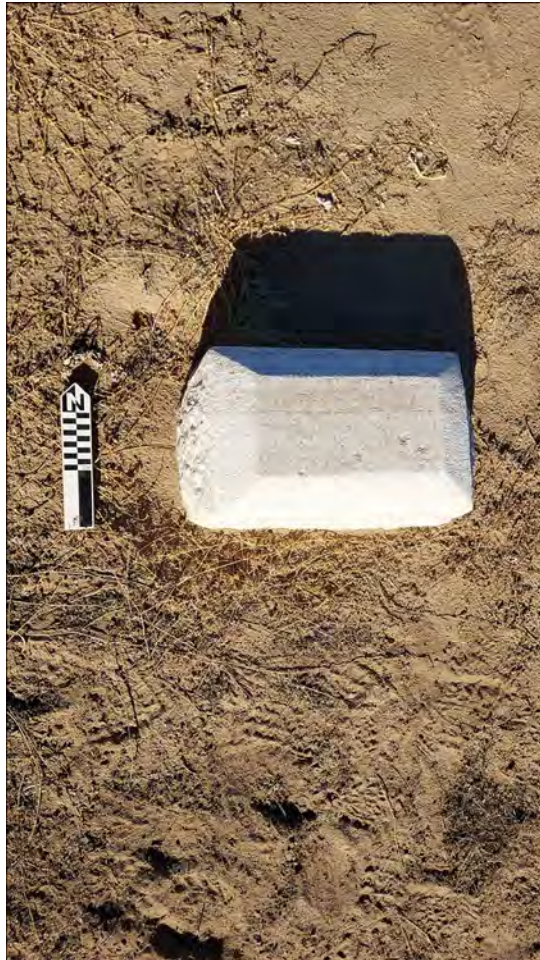
Feature PD: 242

Damage type(s): disassembled—loss, spalling, fragmentation—loss

This feature is a concrete monument base that consists of two stacked concrete blocks. The bottom block is relatively thin, rectangular, and chamfered along the edges. The top block is thicker than the bottom block but is smaller in length and width, forming a stair-step shape with the lower block. The top block is also chamfered, around the top edge. The top of the base contains a rectangular patch of mortar and has a single piece of rebar protruding from it, which likely served as a support for the top of the monument, now missing. There are a minor amount of spalling and some missing fragments along the edges of the base. There are no inscriptions or decorations on the base.

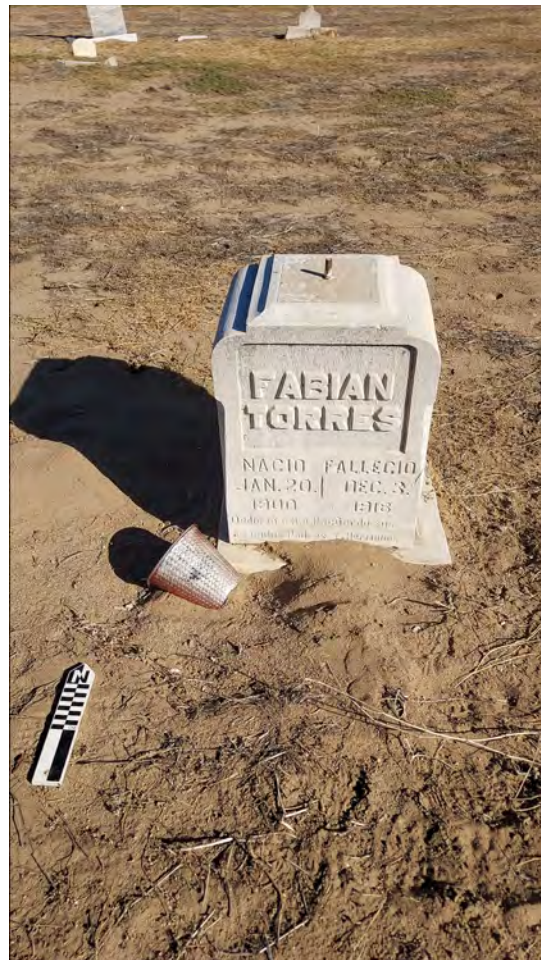
Feature PD: 270

Damage type(s): fragmentation—loss

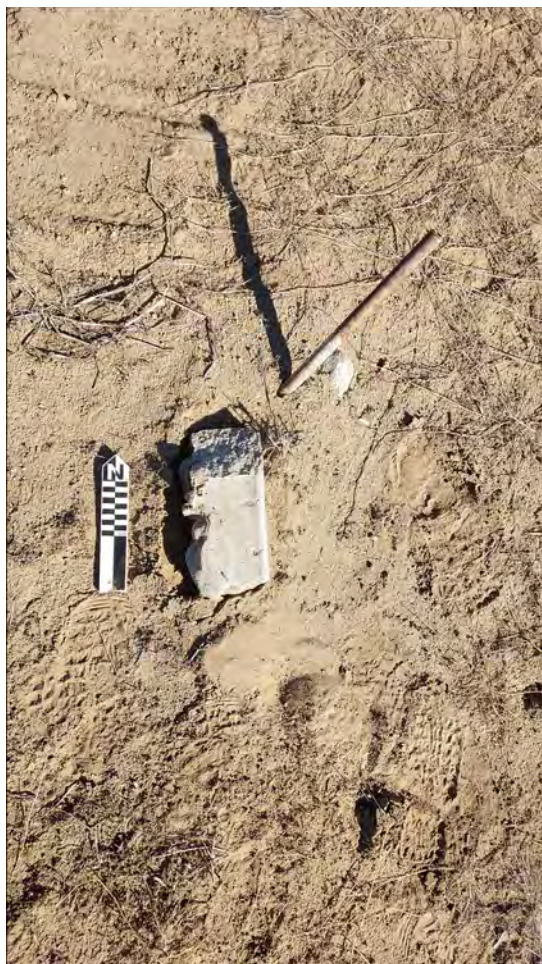
This feature consists of a segment of 1-inch steel pipe that is protruding out of the ground. A small piece of squared concrete coping is lying next to the pipe. This feature may be the remains of a grave monument that has been removed or destroyed.

Repair type(s): none

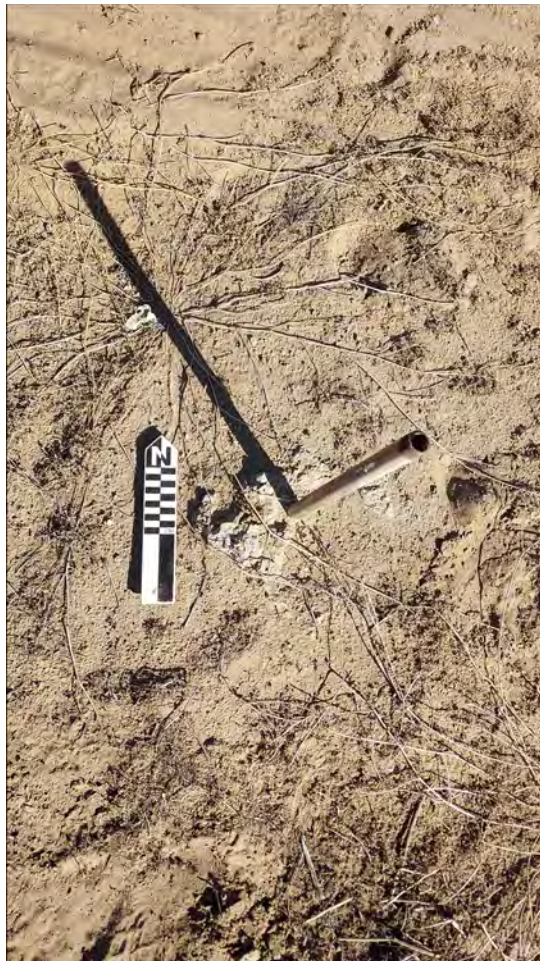
Feature PD: 272

Damage type(s): fragmentation—loss

This feature consists of a segment of 1-inch steel pipe that is protruding out of a poured-in-place concrete base with no shaping or defined form. This feature may be the remains of a grave monument that has been removed or destroyed.

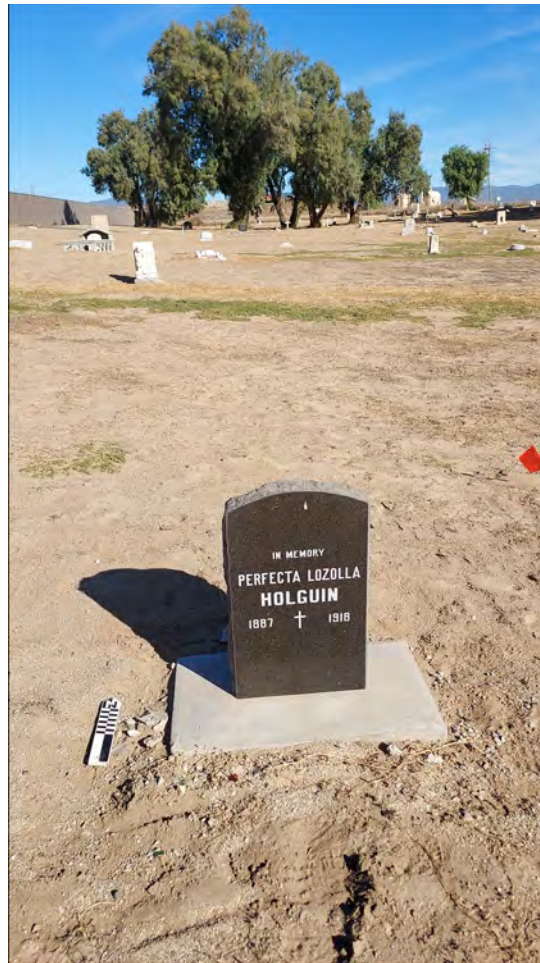
Feature PD: 274

Damage type(s): none

This grave is marked with a black marble die-on-base monument set on a concrete base. The monument is roughly rectangular and has a segmental arch. The surface of the monument is rock pitched, except for the face, which is polished. The base is squared and has smooth surfaces. The monument is in excellent condition and, based on the design and condition, may be a modern replacement. Inscribed on this monument is the name of the deceased, along with their birth and death dates, with a cross between the two years: "IN MEMORY/PERFECTA LOZOLLA HOLGUIN 1887 + 1918".

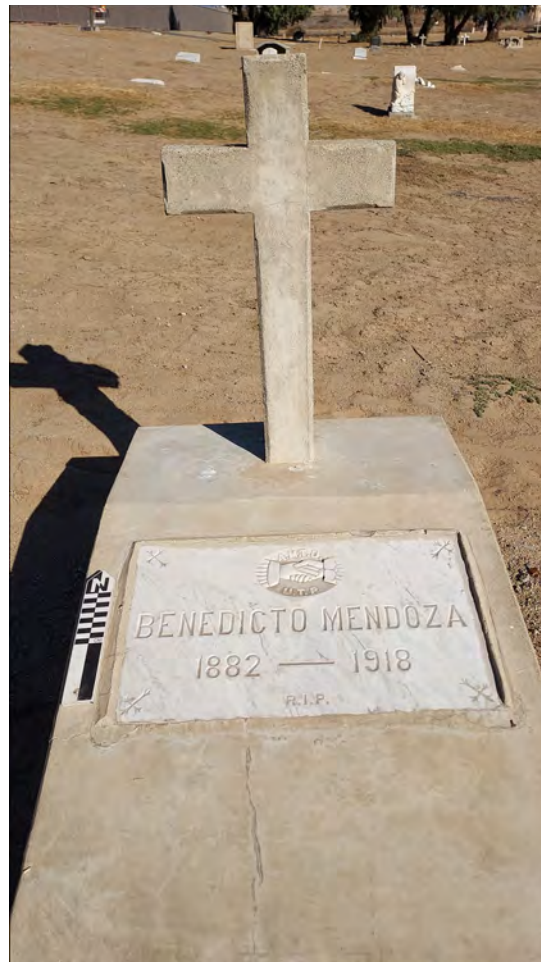
Feature PD: 276

Damage type(s): fragmentation—loss, spalling, cracked, tilted/fallen

This grave is marked with a concrete monument inset with a plaque. The monument is roughly rectangular and sits on a rectangular concrete base. The top block has a smooth surface and squared edges. Approximately 25 percent of the top of this block (in the rear of the monument) is flat and has a concrete cross sitting on top of it. The front 75 percent of the block is sloped forward. The sloped portion contains the plaque and inscription. The plaque is rectangular, made of marble, and inset into the concrete monument. It contains a carved medallion with two clasped hands and is inscribed, “AMTU/UTP”. The medallion sits above the inscription. The monument is tilting and has moderate spalling around the edges, as well as several cracks both in the front and back of it. A small portion of the cross has fragmented off the back of the monument. Inscribed on this monument is the name of the deceased, along with their birth and death dates: “BENEDICTO MENDOZA/1882–1918/R.I.P.”.

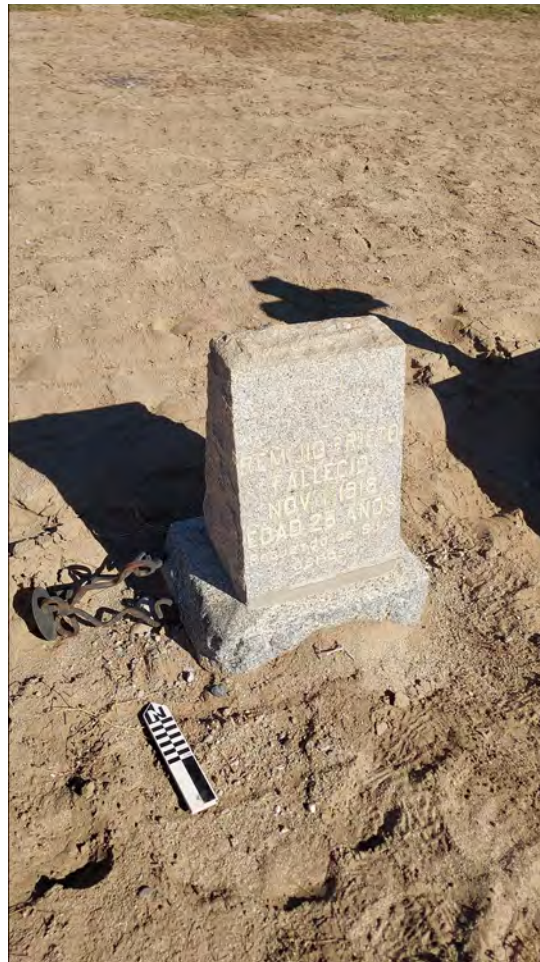
Feature PD: 278

Damage type(s): none

This grave is marked with a granite die-on-base monument set on a granite base. The monument is roughly rectangular and has a rectangular arch. The cross section of the monument is trapezoidal, with the base of the die thicker than the top. The surfaces of both the monument and the base are rock pitched, except for the monument face, which is polished. The face of the monument has an incised cross above the inscription. The base is chamfered. The monument is in excellent condition and, based on its design and condition, may be a modern replacement. Inscribed on this monument is the name of the deceased, along with their birth and death dates: "REMIJIO PRIETO/FALLACIO/NOV 1 1918/EDAD 25 AÑOS/Recuerdo de sus/esposa". A metal tripod-type candle holder is lying on its side next to the monument.

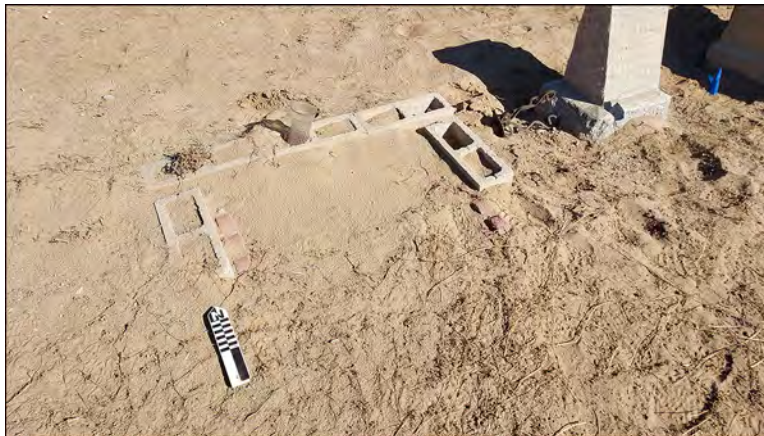
Feature PD: 280

Damage type(s): disassembled—loss, buried/sunk

This grave is marked with five cinder blocks that have been arranged to form the top corners and side of the possible coping; no grave maker, such as a headstone or cross, is present. The cinder blocks are largely buried and are lined, intermittently, on their interiors by red, scalloped landscaping bricks. The bricks are also largely buried; only their rounded tops are above the surface. There is no headstone or other marker present, but a glass vase has been placed on the top-center cinder block, at the head of the feature. There are no inscriptions or decorations on the cinder blocks or bricks present.

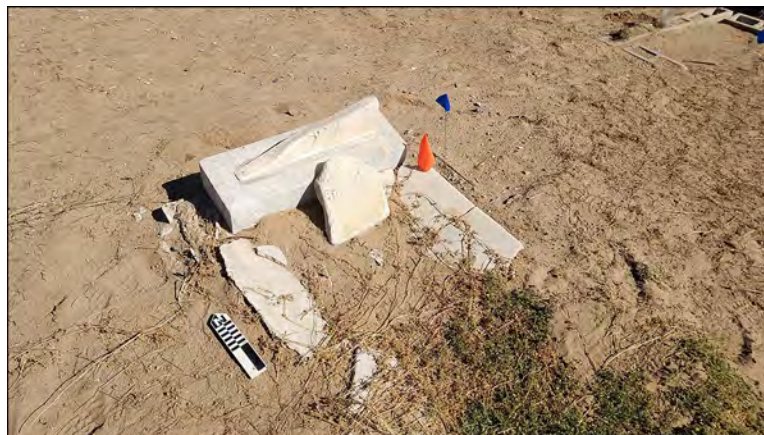
Feature PD: 282

Damage type(s): fragmentation—loss, tilted/fallen, buried/sunk, cracked

This grave is marked with a marble die-on-base monument set on a marble base. The monument is at the head of a ledger-type concrete slab that has largely fragmented and is buried, with the lower half missing. The die-on-base monument contains only the lower portion of the headstone. Most of the headstone has broken off from the base and is largely missing. One piece of the fragmented headstone is leaning against the front of the base. The base is rectangular and has a rough surface and a chamfered top. The portion of the headstone that is still attached to the base contains the bottom portion of a carved relief plant or flower in a circular medallion. The fragment of the headstone leaning against the base contains the inscription, “[missing text] ES/ [missing text] 918”, and a carved relief cross next to it.

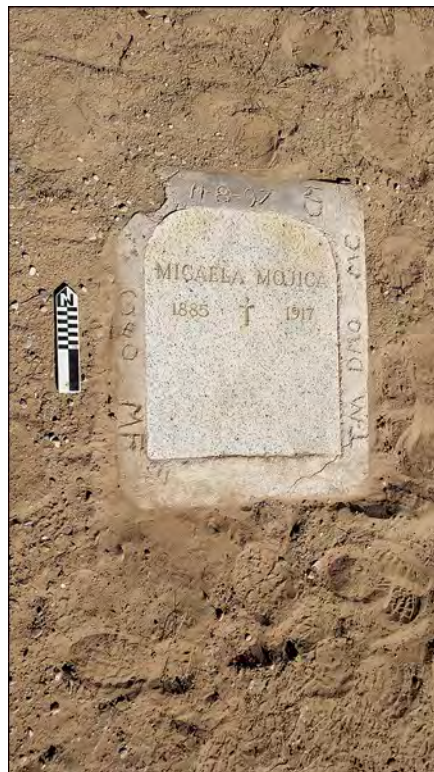
Feature PD: 284

Damage type(s): fragmentation—loss, buried/sunk, cracked, tilted/fallen

This grave is marked with a marble headstone/block lying flat on the ground. The headstone is rectangular and has a basket arch. The face of the headstone has an incised cross in the center, between the birth and death years. Although the headstone appears to be in good condition, it is mounted in a rectangular, thin concrete slab that was installed in 1997. The concrete slab was inscribed by hand with “11-8-97 CM”, “GEO MF”, and “TM DMO MC”, which may represent the initials of the family members who installed the slab. One of the top corners of the slab has fragmented off and is missing. The slab is partially buried in the soil and has a crack running through one of the bottom corners. The inscription on the headstone is “MICHAELA MOJICA/1885 [cross] 1917”.

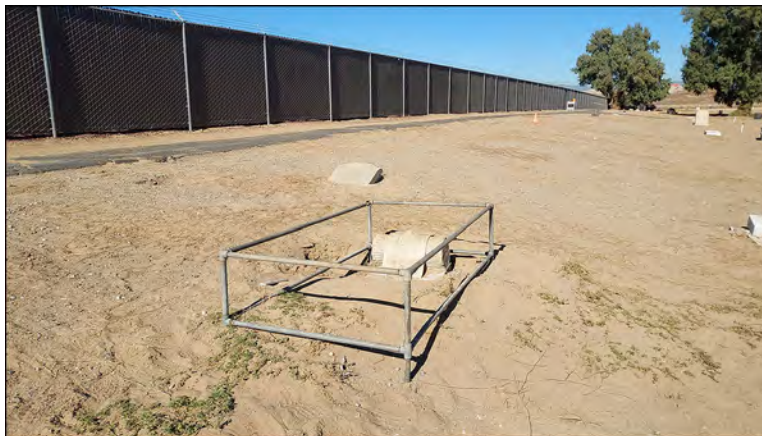
Feature PD: 286

Damage type(s): spalling, buried/sunk, ground loss, burrowing-animal disturbance

This grave feature consists of a cast-stone monument shaped like a wooden log lying on a cast-stone rectangular base. The log has a scroll decoration that covers the top and front of the log, extending onto the base. A cross is incised in the top of the scroll, and the scroll is molded such that it appears that a branch from the log is poking through the top of the scroll, next to the cross. Cast-stone feathers or leaves cross in front of the base and scroll, below the inscription. The monument has some minor spalling along the top edges of the log and the base. A modern steel-pipe enclosure has been erected around the monument and may act to shelter it from mowers or foot traffic. The fence is constructed out of 1-inch steel pipe and pipe joints. It is not rusted, but several of the joints are separating, and the left side of the piping has been partially buried by soil. A small area of ground has collapsed adjacent to the left side of the monument, likely from burrowing-animal disturbances. Inscribed on this monument is the name of the deceased, along with their birth and death dates, age at death, and parents' names: "JOHN DOMINGUES/1912–1918/EDAD 6 ANOS/SON OF FRANCIS & MIKE/DOMINGUES".

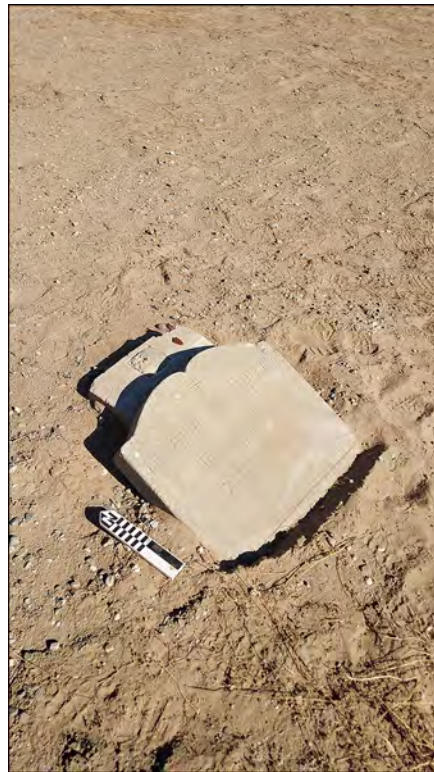
Feature PD: 290

Damage type(s): (a) disassembled—loss, spalling, tilted/fallen; (b) fragmentation—loss, spalling, cracked

This feature consists of two separate monuments that have been stacked together. The first monument is a concrete headstone that has fallen off its base and now leans against the second monument. The base is missing but the headstone has been leaned against a plaque marker (see below). It is unclear whether the headstone is associated with the plaque marker, but they are not the same size and were not likely parts of the same monument. The headstone is roughly rectangular and has a heart-shaped top margin. An incised cross has been carved above the inscription. Inscribed on this monument is the name of the deceased, along with their death date: “IGNACIA CASTOPENA/FALLESIO/7-10-1918”. A minor amount of spalling is present along the edges of the headstone.

The second monument is a square-shaped, broken concrete base that likely once held a cross or other ornament that was missing at the time of recordation. Although most of the face of the monument is covered by the headstone (see below), the top of an inscribed heart with an arrow running through it is visible near the top of the face. The base is in poor condition and has multiple cracks running through it and spalling along the edges; two of the corners have broken off.

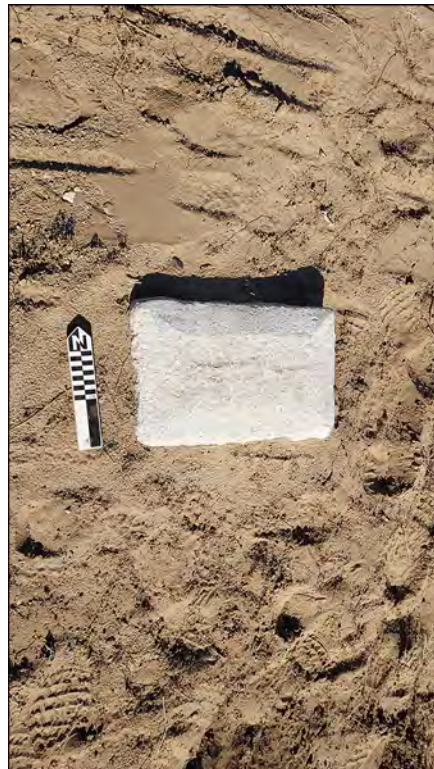
Feature PD: 292

Damage type(s): disassembled—loss

This feature consists of a marble monument base. It is rectangular and has a chamfered top and rock-pitched sides. The rest of the monument has been disassembled and is missing. There are no inscriptions or decorations on the base.
