Archaeological Condition Assessment and Ground-Penetrating Radar (GPR) Surveys for Agua Mansa Cemetery, San Bernardino County, California

Technical Report 24-26
Statistical Research, Inc.
Redlands, California

April 2024

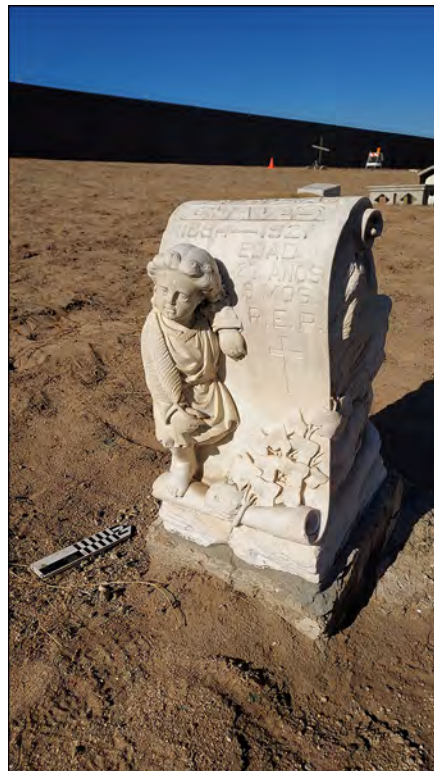
Feature PD: 295

Damage type(s): fragmentation—loss, spalling, ground loss

This grave feature consists of a marble monument shaped like a stack of slate or fieldstone with a scroll draped over the front (which holds the inscription). A carved relief cherub is standing in front of the scroll, in a posture that looks as though it were leaning against the scroll. The cherub is holding a feather or quill in its hand. Carved relief ivy leaves are at the base of the scroll, next to the cherub. A cross has been carved into the scroll, under the inscription. The monument has some minor spalling along the edges but is otherwise in good condition. It is set on a concrete base that is in poor condition and has multiple cracks and fragments falling off it. The monument has been repaired; it appears that it has been reattached to the base with mortar, and the base has been reset in poured-in-place concrete. There is ground loss surrounding the base, exposing the foundation. Inscribed on this monument is the name of the deceased, along with their birth and death dates and their age at death: “EUSOLIA/CHAVES/1894–1921/EDAD/27 AÑOS/6 MOS./R.E.P”.

Repair type(s): basal resetting, repointing

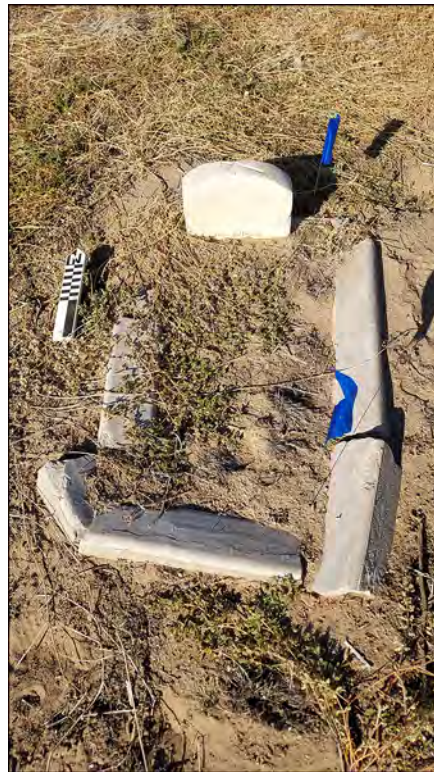
Feature PD: 298

Damage type(s): fragmentation—loss, tilted/fallen, buried/sunk, spalling, burrowing-animal disturbance

This grave is marked with a marble headstone and concrete coping. The headstone is rectangular and has a segmental arch. The top of the headstone has an incised cross in the center that is oriented diagonally to the long axis of the stone. There is some spalling on the edges of the headstone. The coping (Feature 300) around the grave is rounded and in poor condition. It has fragmented into multiple pieces that have all fallen over. The top two corners of the coping appear to be missing but may be buried under soil. There is also animal-burrowing activity within the coping. The inscription on the headstone is “RAUL LARA/NACIO/OCT. 11. 1921/EDAD 10 MESOS/18 DIAS”.

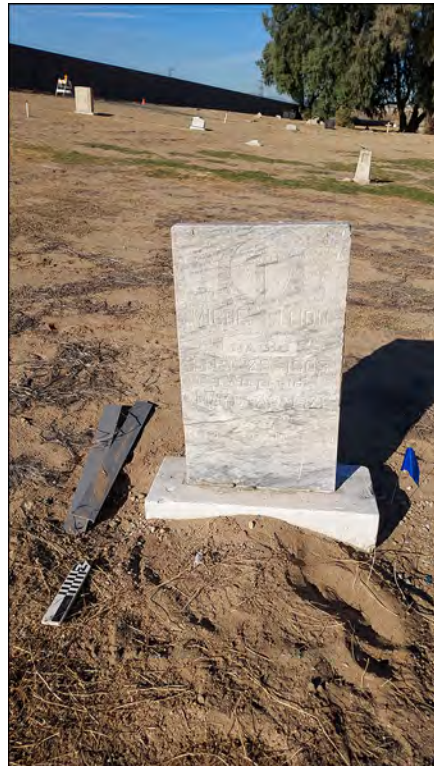
Feature PD: 302

Damage type(s): fragmentation—no loss, spalling, buried/sunk, failed repair

This grave is marked with a marble tab-in-socket monument with a marble base. The monument is roughly rectangular and has a rectangular arch. The headstone is decorated with a low carved relief cross in a circle flanked by carved relief flower vases in rectangles above the inscription. The base is squared and has a smooth surface. Minor spalling is present around the edges of the base, and the bottom has been partially buried by soil. The headstone has previously broken into two pieces that have been repaired and are currently cemented together. In addition, aluminum was used to try and stabilize the monument. Two aluminum sheets appear to have once been glued onto the sides of the headstone. They have since fallen off the headstone and are stacked next to it. However, a layer of glue from that repair remains on both edges of the headstone. Inscribed on this monument is the following:

Repair type(s): pinning, repair—hard cement

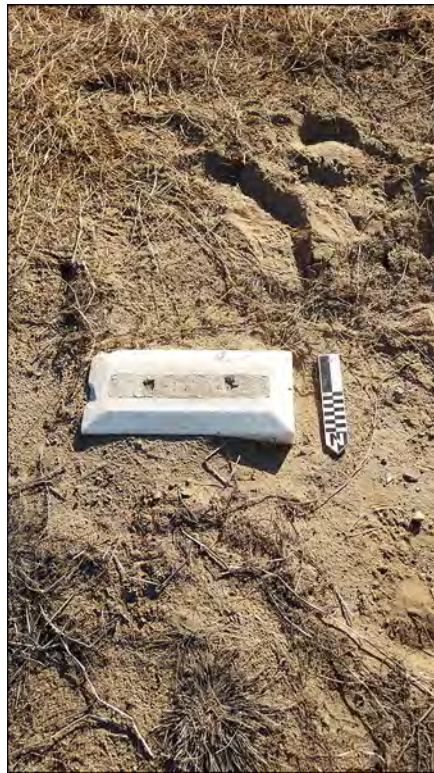
Feature PD: 304

Damage type(s): disassembled—loss, fragmentation—loss

This feature consists of a marble monument base for a die-on-base-type monument. The base is rectangular and has a chamfered top and polished sides. The center of the base has an insert of what appears to be concrete. The rest of the monument has been disassembled and is missing, but there are two holes in the top of the base that contain broken metal bolts that were likely used to anchor the headstone to the base. There is a minor amount of chipping on the edges of the base but no inscriptions or decorations.

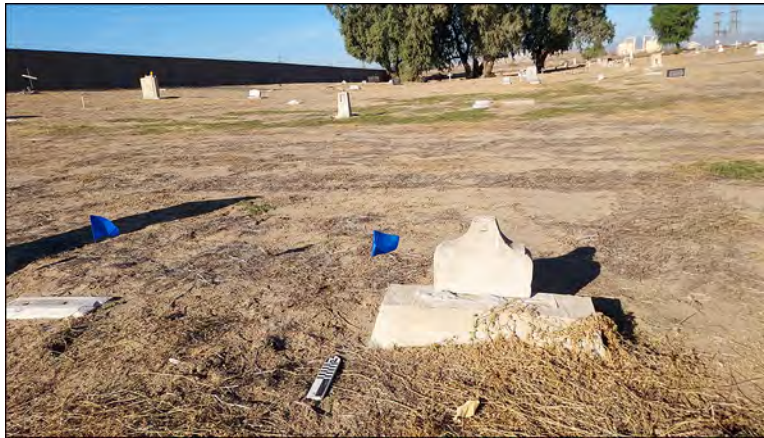
Feature PD: 306

Damage type(s): fragmentation—loss, spalling, tilted/fallen

This feature consists of two separate monuments that have been stacked together. The first is a fragment of a marble headstone on a concrete base. Most of the headstone has fractured off from the base and is missing. The base is chamfered and has smooth sides. There is some minor spalling along the edges of the base, and the base is slightly tilted. There are no inscriptions or decorations on the base.

The second monument is a marble headstone that has fallen off its base. Based on the size of this headstone, it does not appear to match the headstone that was broken off the monument. Both the base and the top half of the headstone are missing. The bottom of the headstone has been placed standing on top of the other monument. The headstone contains rounded shoulders or caps, and it appears that a decoration or cross likely originally formed the top half of the headstone. There are no inscriptions on the headstone, but the bottom portion of a carved relief cross is visible below the break in the top of the monument. A minor amount of spalling is present along the edges of the headstone.

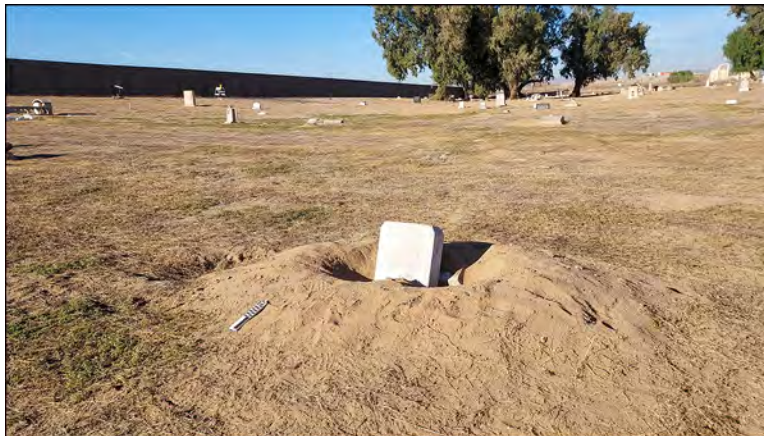
Feature PD: 308

Damage type(s): disassembled—no loss, spalling, buried/sunk, burrowing-animal disturbance

This grave is marked with a marble headstone and a concrete base. The headstone and base are in a hollow area in the middle of a large pile of soil. It is unclear whether the soil was built up around the monument intentionally or is the result of a large amount of animal burrowing. The base is almost entirely buried in soil, with only one corner visible. The visible portion indicates that the base is made of concrete with squared sides and a smooth surface. The headstone is roughly rectangular and has an angular basket arch. A low carved relief cross in a circle is set above the inscription. The headstone has fallen off the base and is leaning against it. The bottom of the headstone is partially buried, and there is a minor amount of spalling along the edges of the headstone. Inscribed on this monument is the name of the deceased, along with their birth and death dates: “VICTOR DELLA ROSA/1914–1922”.

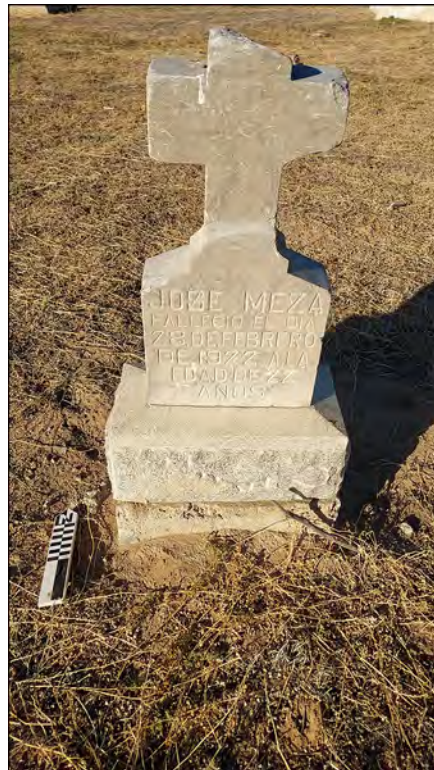
Feature PD: 310

Damage type(s): fragmentation—loss, spalling, open joints, buried/sunk

This grave feature consists of a marble cross-shaped monument on a marble block and a concrete base. The headstone portion of the monument is shaped like a cross and has a rectangular area beneath the cross that contains the inscription. The top of the cross has broken off and is missing, and the neck of the cross has been repaired/reattached to the monument with cement. The cross-shaped headstone is sitting on top of a rectangular marble block that is chamfered and has rock-pitched sides. This marble block is sitting on a rectangular concrete base that is mostly buried. The visible portions of the base are squared and have smooth sides. The back side of the base appears to have a layer of mortar or plaster over it that is heavily cracked and flaking off. The monument has spalling around the edges, and the joints between elements are open. Inscribed on this monument is the name of the deceased, along with their death date and their age at death: “JOSE [the “S” is inscribed over a “Z” and is likely repairing a misspelling] MEZA/FALLECIO EL DIA/28 DE FEBRERO/DE 1922 A LA/EDAD DE 22/AÑOS”.

Repair type(s): repair—hard cement

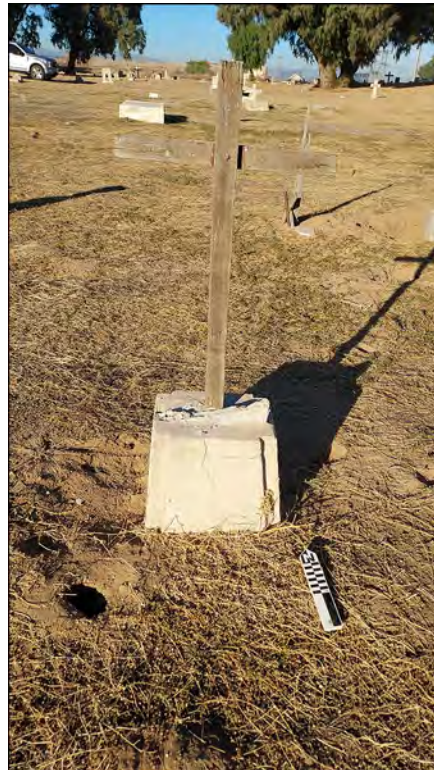
Feature PD: 312

Damage type(s): fragmentation—loss, spalling, cracked, burrowing-animal disturbance

This grave feature consists of a wooden cross attached to the top of a chamfered concrete base. The base has angular notches in each corner such that the plan view has a cross or plus-sign shape. The base also contains the bottom of a marble headstone, most of which has broken off and is missing. The wooden cross is made with 0.75-inch milled lumber and has a metal nail or fastener in the center. The concrete base is cracked and has minor spalling on its edges. There is animal-burrowing activity adjacent to the base. There are no inscriptions or decorations on any of the remaining elements of the monument.

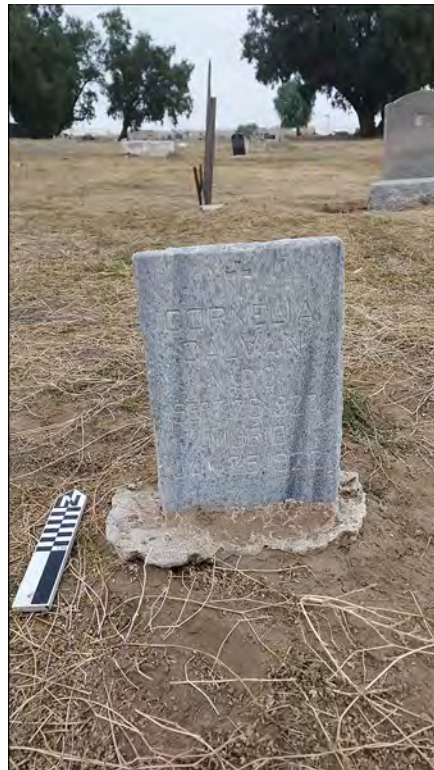
Feature PD: 314

Damage type(s): spalling

This grave feature is marked with a marble headstone. The headstone is rectangular and has a rectangular arch with rock-pitched sides and polished faces. The headstone has an inscribed cross above the inscription. The headstone has been inserted into poured-in-place concrete that has an irregular shape and is sitting on the ground surface. This is likely a later basal resetting to keep the headstone standing. There is minor spalling along the edges of the headstone. Inscribed on this monument is the name of the deceased, along with their birth and death dates: “CORNELIA/CALVAN/NACIO/SEPT 26 1920/MURIO/JAN 25 1922”.

Repair type(s): basal resetting

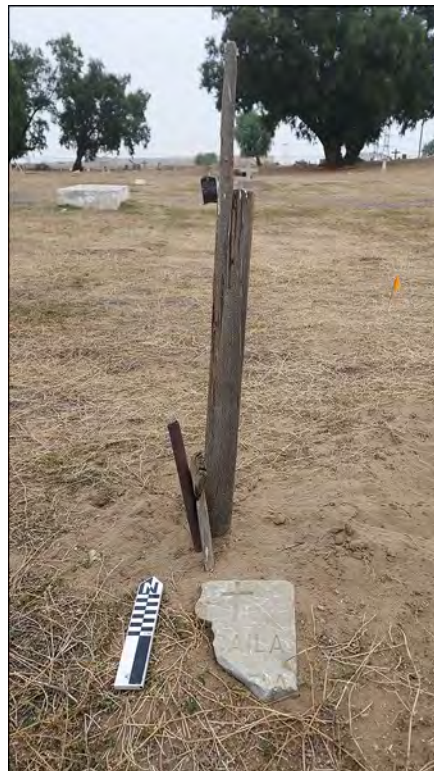
Feature PD: 316

Damage type(s): fragmentation—loss, tilted/fallen

This grave feature consists of a fragment of a marble headstone lying next to a metal 1-inch pipe and a broken milled-lumber post (likely the base of a cross) that are protruding from the ground. One of the cross bars and a portion of the top of the wooden cross are still attached to each other and have fallen between the metal pipe and the wooden base. The marble headstone fragment consists of the top-left corner of the headstone and a portion of the left side of the headstone. The rest of the headstone is missing, and it is unclear whether that fragment was moved after it was broken. The portion of the headstone present has an incised cross at the top and a partial inscription: “[. . .]CAILA”.

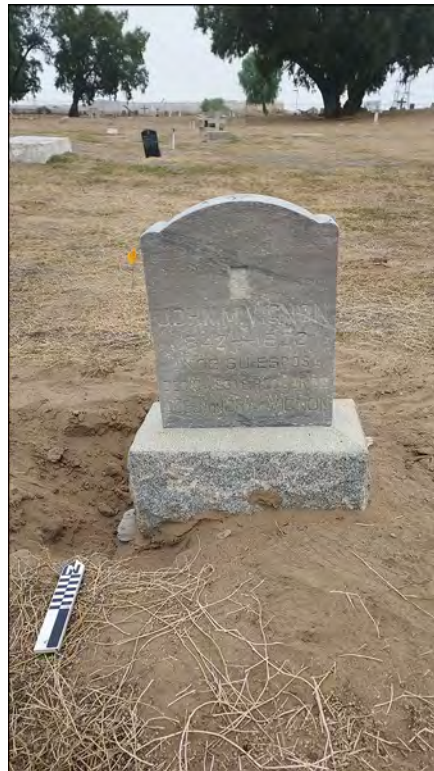
Feature PD: 318

Damage type(s): burrowing-animal disturbance, disassembled—loss

This grave feature consists of a marble die-on-base monument with a granite base. The headstone is rectangular and has a segmental arch and rounded caps. The top of the headstone has a carved relief cross decoration. The face of the monument has an inscribed ribbon motif at the top and a carved, inset square in the center of it that likely held an inset decoration that is now missing. Faintly incised in this square is “2/3”. The headstone is sitting on top of a rectangular granite base with a chamfered top and rock-pitched sides. The base and the headstone are in excellent condition. Animal burrowing has undercut the left side of the monument, although it is not leaning at this point. Inscribed on this monument is the name of the deceased, along with their birth and death dates and a dedication: “JOHN M. VIGNON/1842–1922/ AÑOS SU ESPOSA/DEDICA ESTE RECUERDO/ALEJANDRA VIGNON”.

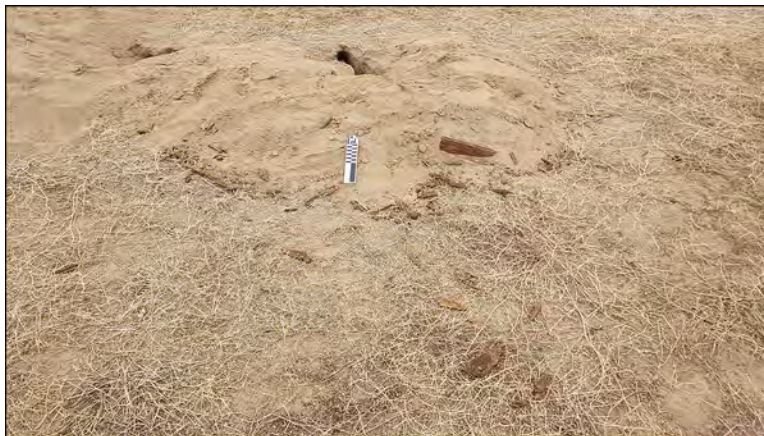
Feature PD: 320

Damage type(s): fragmentation—loss, burrowing-animal disturbance

This grave feature consists of a collection of wooden coffin fragments that have been brought to the surface by burrowing animals. The collection contains over 100 fragments of wood lying on and around a mound of recently upturned soil that surrounds several animal burrows. One larger wooden fragment shows that the coffin construction was done using tongue-and-groove joints. No coffin hardware, human remains, or decorative items were noted in the feature.

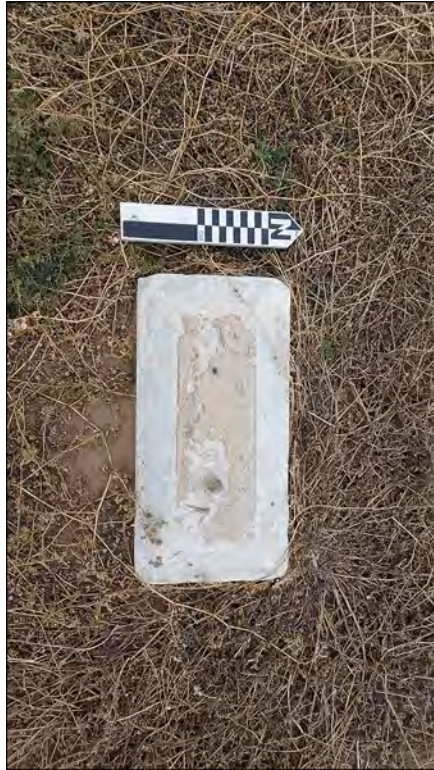
Feature PD: 322

Damage type(s): disassembled—loss, spalling

This feature consists of a marble base for a die-on-base-type monument. The base is rectangular and has a chamfered top and polished sides. The center of the base has a rectangular patch of mortar on top where the original monument once sat. There are two holes in the top of the base, for bolts, likely to anchor the monument to the base. There is a minor amount of spalling on the edges of the base. There are no inscriptions or decorations on the base.

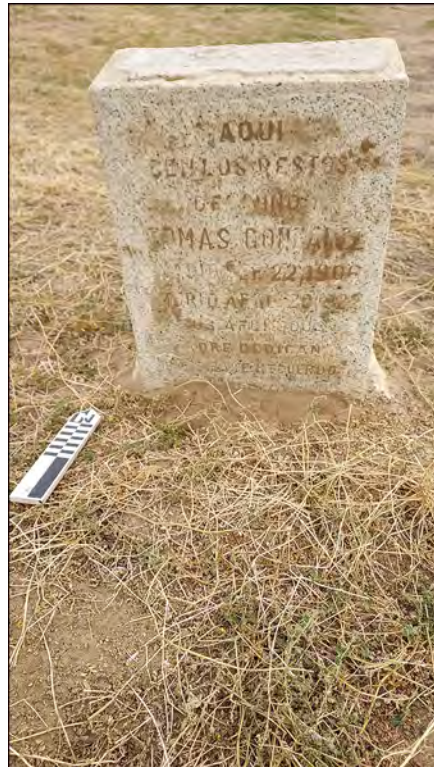
Feature PD: 324

Damage type(s): disassembled—loss, tilted/fallen, buried/sunk, erosion

This grave feature consists of a granite die-on-base monument with a granite base. The headstone is rectangular and has a rectangular arch. The top of the headstone has a rectangular patch of mortar on it where a decoration or top block once sat. That decoration or top block is missing. The base is largely buried. The visible portion appears to be a rectangular base with squared corners and smooth sides. The monument is slightly tilted, and the headstone sits at an angle on the base and was likely moved or reset at some point. Inscribed on this monument is the name of the deceased, along with their birth and death dates and a dedication: “AQUI/CEMLOS RESTOS/DEL MINO/TOMAS GONZALEZ/NACIO SEP. 22. 1906/MURIO APRIL 20 1922/SUS AFLIGADOS/PADRE DEDICAN/ESTE RECUERDO”. The inscription is faint, and the headstone has been subjected to erosion.

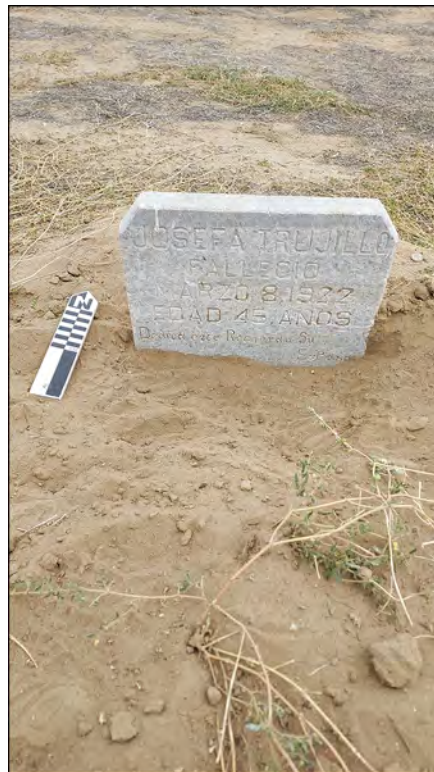
Feature PD: 326

Damage type(s): buried/sunk, spalling

This grave feature consists of a marble headstone partially buried by soil. Although the headstone is standing, the bottom half is buried, and it is unknown whether it has an associated base. The headstone is rectangular and has a modified rectangular arch where the corners are cut at a 45° angle. There is some minor spalling on the edges of the headstone. Inscribed on this monument is the name of the deceased, along with their death date and age and a dedication: “JOSEPHA TRUJILLO/FALLECIO/MARZO 8, 1922/EDAD 45, ANOS [*sic*]/[in script] Dedicó este Reduerdo Su/Esposa”.

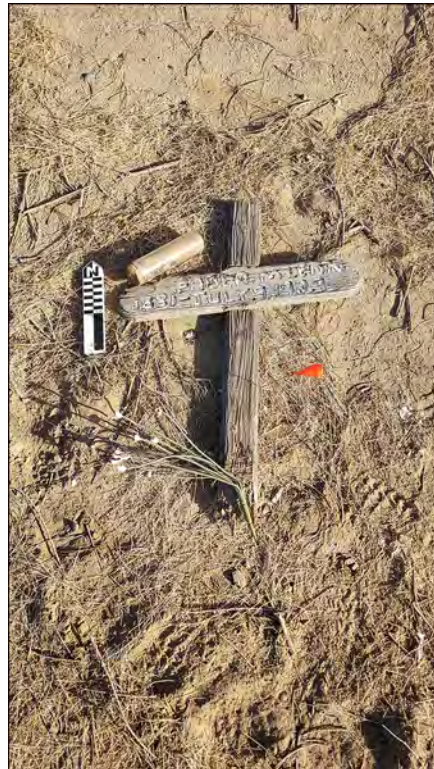
Feature PD: 380

Damage type(s): tilted/fallen, open joints

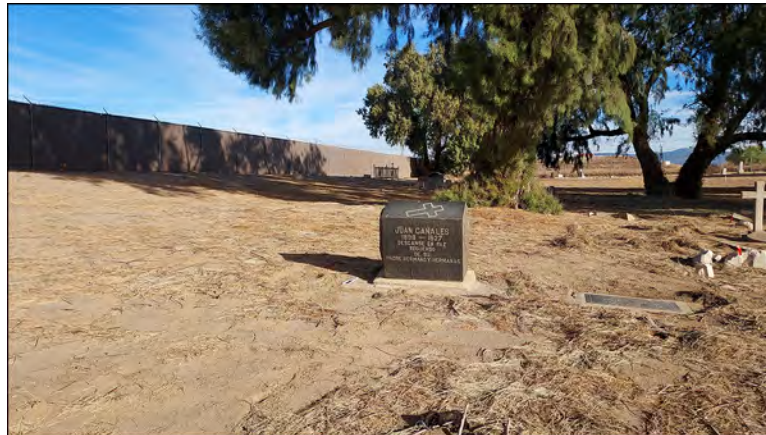
This grave is marked with a die-on-base monument that has a black marble headstone and white granite base. The top of the headstone is beveled on the northern and southern sides. The eastern and western sides of the headstone are rock pitched, and the top and face are polished. A cross has been carved on top of the headstone, at an angle to the long axis of the stone. The base is made of white granite and has a chamfered top and rock-pitched sides. The headstone is tilting forward, and the joint between the base and the headstone is open. Inscribed on this monument is the name of the deceased, along with their birth and death dates and a dedication: “JUAN CANALES/1898–1927/DESCANSE EN PAZ/RECUERDO/DE SU/PADRE HERMANO Y HERMANAS”.

Repair type(s): none

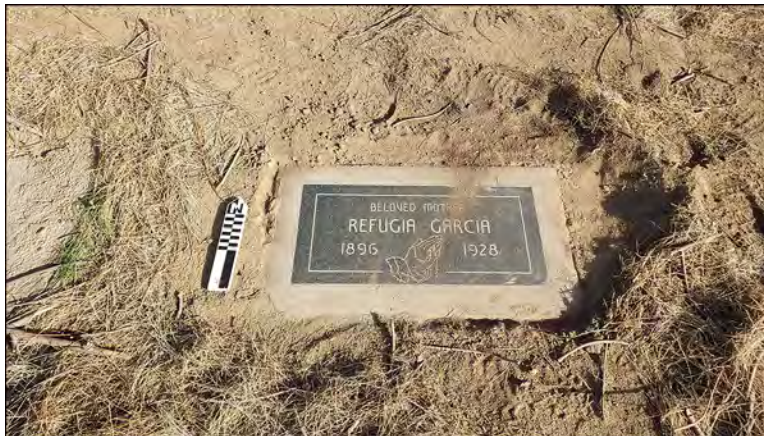
Feature PD: 382

Damage type(s): buried/sunk

This grave is marked with a modern replacement lawn-style monument that is flush with the ground surface and contains a polished black granite plaque in a concrete casing. The plaque has incised praying hands and a rosary in the center of the inscription. The monument is partially buried by soil. The inscription reads, “BELOVED MOTHER/REFUGIA GARCIA/1896 [praying hands] 1928”.

Repair type(s): none

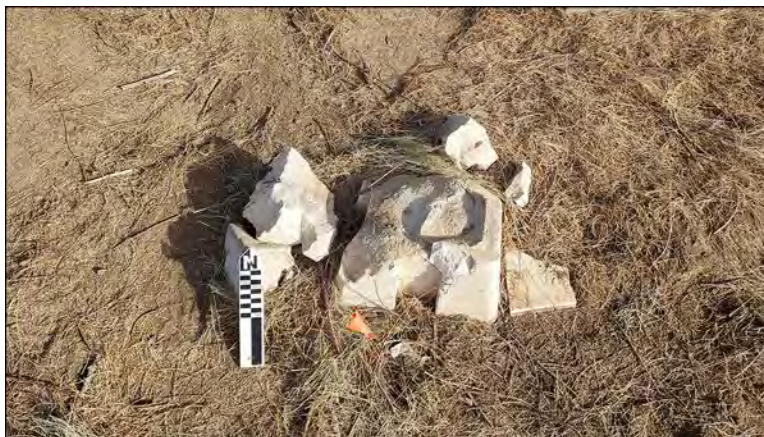
Feature PD: 384

Damage type(s): fragmentation—loss

This grave feature consists of a concrete base that has been broken into at least six fragments and one fragment of a marble headstone. Much of the monument is missing, and the remaining fragments are too small and irregular to discern a shape or monument type. There are no inscriptions or decorations on the base or the headstone fragment.

Repair type(s): none

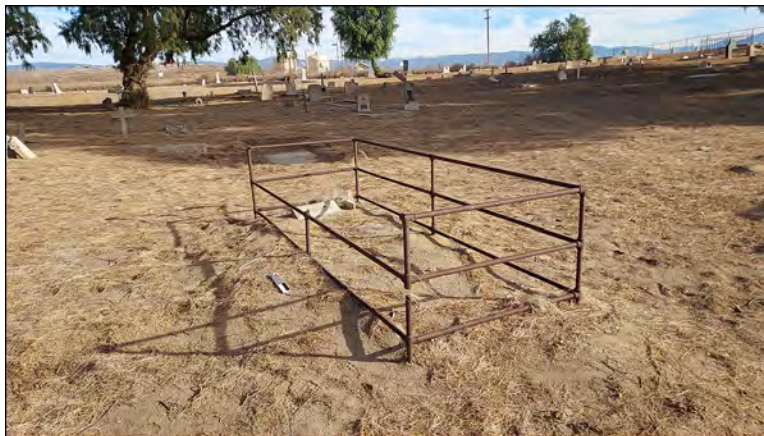
Feature PD: 386/388

Damage type(s): disassembled—loss, tilted/fallen

This feature consists of a granite base for a die-on-base-type monument. The base is rectangular and has a chamfered top and rock-pitched sides. The top of the base has two metal sleeves, likely for bolts used to anchor the monument to the base. The base is tilting slightly. There are no inscriptions or decorations on the base. A potentially later iron fence has been erected around the monument and may act to shelter it from mowers or foot traffic (Feature 386). The fence is constructed of 1-inch iron pipe and pipe joints. It is rusted, and one of the rails is missing.

Repair type(s): none

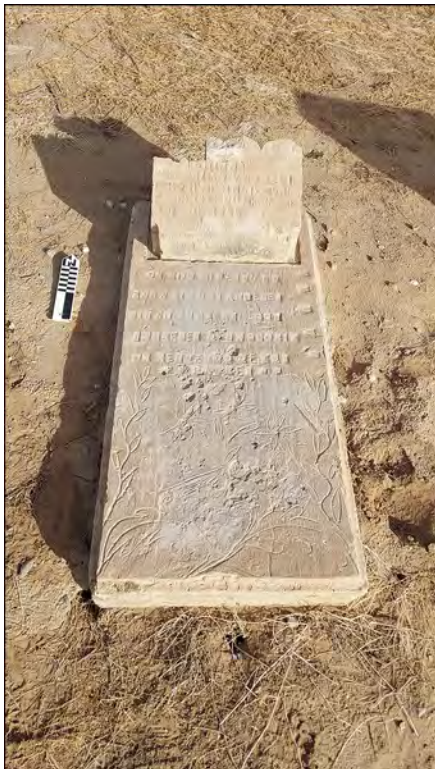
Feature PD: 390

Damage type(s): fragmentation—loss, cracked, erosion, burrowing-animal disturbance

This is a multicomponent monument with concrete slant marker inset into the head of a concrete ledger monument. The plaque marker has a slanted front face that contains the inscription. A rectangular column of concrete is inset into the rear of the marker. The column is broken and once may have been the base of a cross. The letters in the inscription were created using stamps in wet concrete. The plaque marker is in poor condition and has cracks running through it, fragments missing from the top, and eroded surfaces. Inscribed on the plaque marker is the following:

The ledger monument consists of a rectangular concrete slab with scotia-haunch edges that rim the top of the ledger. The ledger contains an inscription that was created using stamps in wet concrete. The inscription is above an inscribed floral-and-leaf motif that decorates the bottom half of the monument. The ledger is in moderate condition and has pits and gouges on the top, as well as eroded surfaces. Multiple animal burrows were noted running beneath and around the monument. Inscribed on the ledger monument is the following:

Repair type(s): none

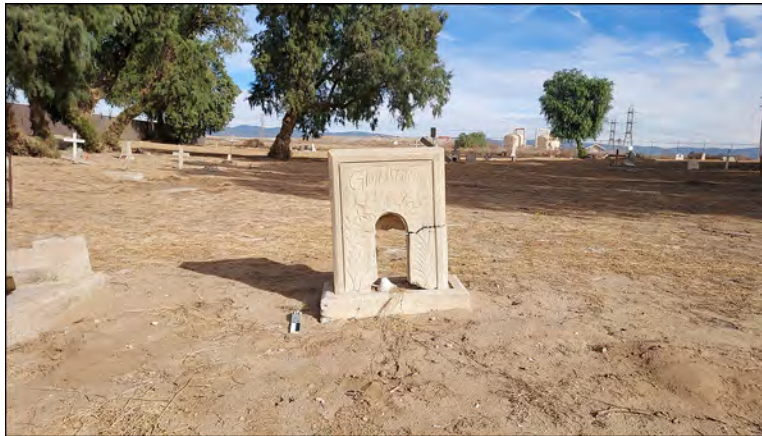
Feature PD: 392

Damage type(s): cracked, spalling, disassembled—loss

This grave is marked with a tab-in-socket monument that contains an alcove for a small shrine or decoration. Both the headstone and the base are made of concrete. The headstone is rectangular and has a rectangular arch and chamfered edges. The headstone has a large archway-shaped alcove in the center that likely served as a space for a small shrine or decoration that is now missing. A floral motif has been carved into each side of the alcove, and the inscription is set above it. A white rock has been placed in the alcove, but it is unclear whether it is associated with the monument. The base is rectangular and has a chamfered top and squared sides. Both the base and the headstone are cracked and have minor spalling along the edges. Inscribed on the ledger monument is the following:

Repair type(s): none

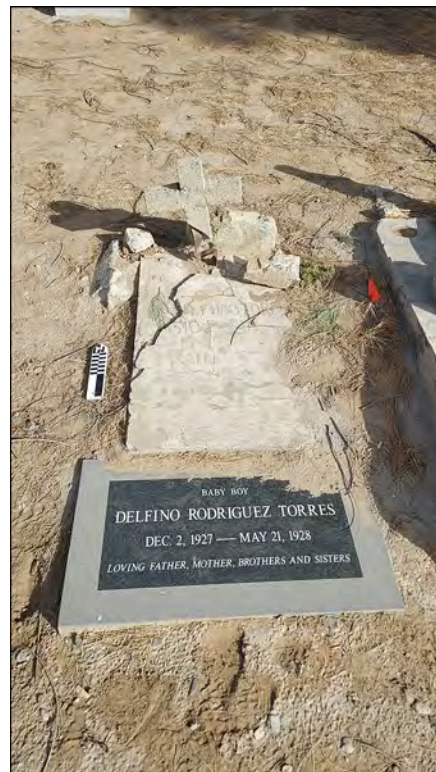
Feature PD: 394

Damage type(s): buried/sunk, cracked, erosion, fragmentation—loss, tilted/fallen

This grave feature consists of two monuments. The first is a fragmented and fallen concrete headstone with a broken concrete base. The base is too broken to determine the monument type. The headstone is rectangular and has a rectangular arch. It is cracked and fallen and is lying in front of the base. The surface of the headstone is flaking off. A broken concrete cross appears to be attached to the top of the headstone. A portion of the vertical bar of the cross is missing, and the cross is attached with a metal strap. The base has been broken into at least four fragments, and some of it appears to be missing. Its shape is indecipherable. Inscribed on the headstone is “[. . .] ELFINO TORES/[. . .] SIO EL DIA/[. . .] de 12 1927/FELLESIO [*sic*]/5-2-1928”.

The second monument is a modern replacement lawn-style monument. The monument is flush with the ground surface and contains a polished black granite plaque in a concrete casing. The northeastern corner of the monument is buried by soil. The inscription reads, “BABY BOY/DELFINO RODRIGUEZ TORRES/DEC. 2, 1927 — MAY 21, 1928/LOVING FATHER, MOTHER, BROTHERS AND SISTERS”.

Repair type(s): none

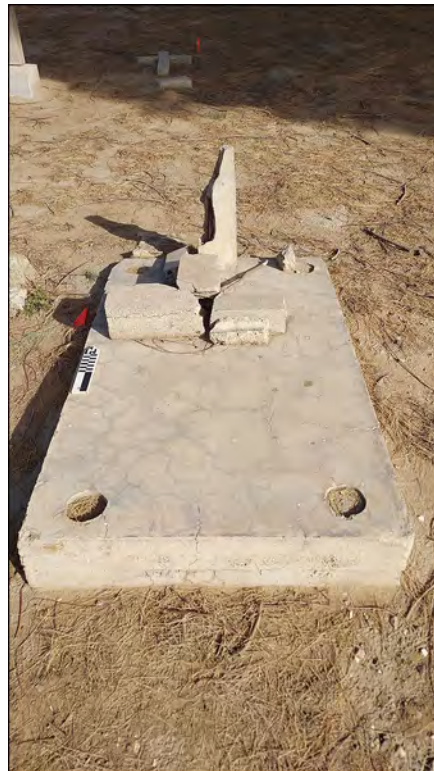
Feature PD: 396

Damage type(s): cracked, fragmentation—loss, spalling

This grave is marked with a concrete ledger monument that has a broken concrete cross mounted at its head. The ledger is rectangular with squared sides. The top has four circular holes for candles or flower vases, one at each corner. The ledger has multiple small cracks and a minor spalling along the edges. The broken vertical bar of a large concrete cross is mounted to the head of the ledger. The cross has fragmented with several pieces missing. Three fragments, consisting of the top of the vertical bar and two portions of the cross bar, have been laid face up on the monument and have been arranged into their respective locations within the cross. Two of these cross fragments contain some of the inscription for the monument. The inscription has been hand drawn into the wet concrete. Much of the inscription is missing. Inscribed on the fragments present is “INRI/EL NINIO/SAMUEL/AREDOND NAS [. . .]/EL DIA 9 DE AVI [. . .]/SELSA AGUILERA [. . .]”.

Repair type(s): none

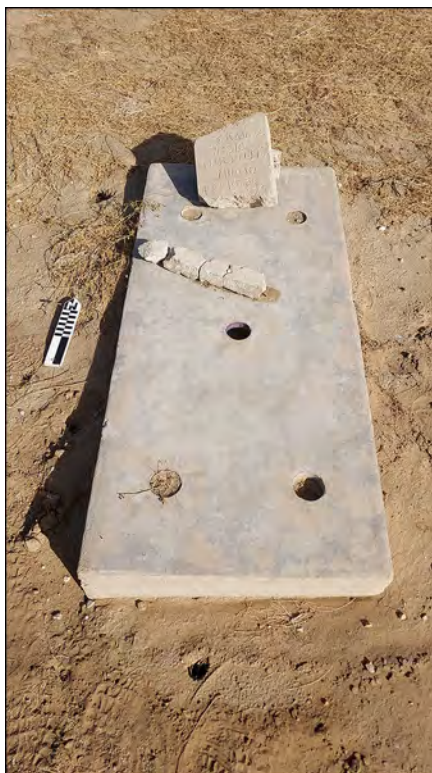
Feature PD: 398

Damage type(s): fragmentation—loss, spalling

This grave is marked with a concrete ledger monument that has a broken headstone mounted at its head. The ledger is rectangular and has squared sides. The top has five circular holes for candles or flower vases, one at each corner and one in the center. The ledger is in good condition and may be a later addition to the monument. The base of a concrete headstone is mounted to the head of the ledger. The headstone has been fragmented, and some of the pieces are missing. Several headstone fragments have been laid on top of the monument; one is leaning against the base, and several are laid in the center of the ledger. The inscription has been hand drawn into the wet concrete, and some of it is missing. Inscribed on the headstone fragments is “[. . .]/CHAVEZ/NACIO/MARZO 30 1925/MURIO/FEBRERO/2 1929”.

Repair type(s): possible basal resetting

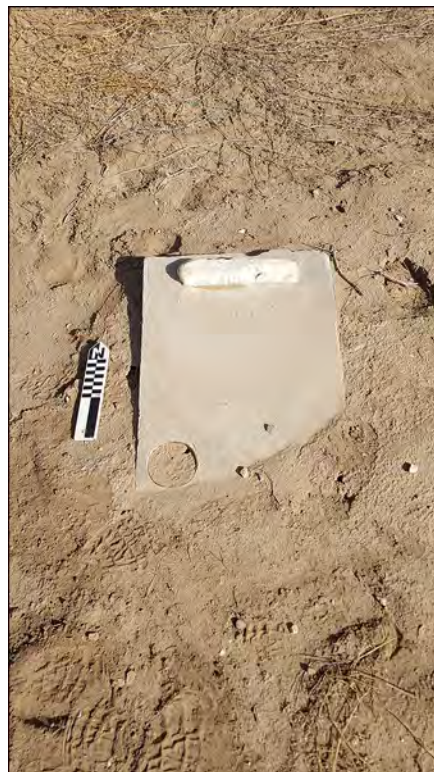
Feature PD: 400

Damage type(s): fragmentation—loss, spalling, buried/sunk

This grave is marked with a marble die-on-base monument with a concrete base. The headstone sits near the rear of the base to allow room for two holes in the front of the base, which likely served as candle or flower-vase holders. The headstone is broken, and only a small fragment of it remains attached to the base. The remainder of the headstone is missing. The base is rectangular concrete with squared edges. There is some spalling along the edges of the base, and the southeastern corner is buried. However, the base is in good condition and may be a later addition to the monument. Much of the inscription on the headstone is missing. Inscribed on the remaining headstone fragment is “de AUG 1912”.

Repair type(s): possible basal resetting

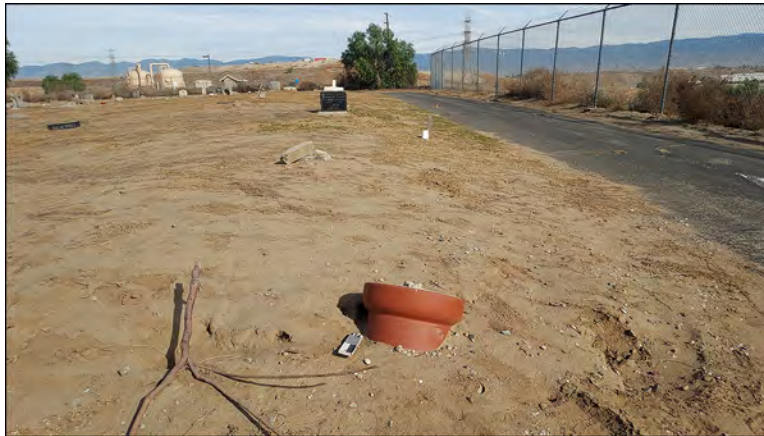
Feature PD: 402

Damage type(s): buried/sunk, fragmentation—loss, tilted/fallen

This feature is a marker of unknown type. The feature consists of the bell-end portion of a ceramic sewer pipe that has been set vertically into the ground and filled with concrete. The center of the feature contains a broken square-shaped base for a cross or decoration that is now missing. The pipe is leaning over and is partially buried.

Repair type(s): none

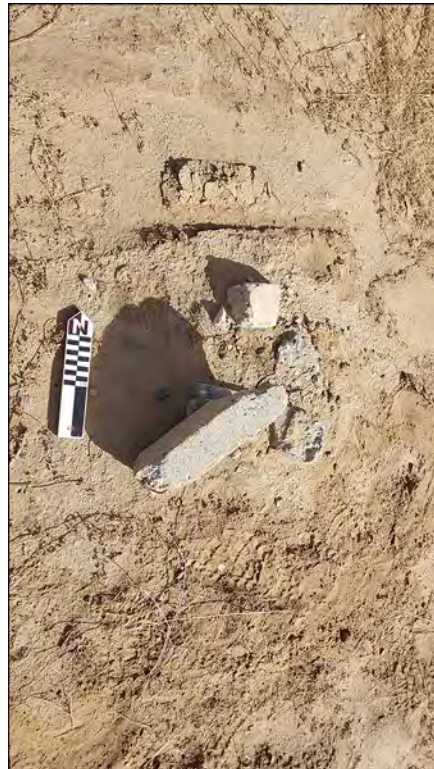
Feature PD: 404

Damage type(s): fragmentation—loss, tilted/fallen

This feature consists of three fragments of a concrete cross clustered together. Most of the monument is missing. There are no inscriptions or decorations on the fragments present.

Repair type(s): none

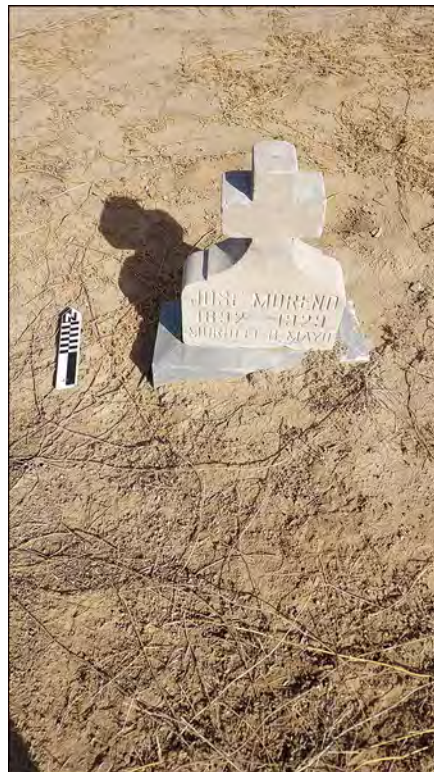
Feature PD: 406

Damage type(s): spalling, tilted/fallen, open joints, buried/sunk

This grave is marked with a marble die-on-base-type monument with a marble base. The headstone contains rounded shoulders or caps topped by a cross. The base is rectangular and has a chamfered top and smooth sides. The cross had fragmented at some point and mortared back into place during a later repair. The monument is tilting but has not fallen over. There is minor spalling on the base, and the joint between the headstone and the base is open. Inscribed on this monument is the name of the deceased, along with their birth and death dates: “JOSE MORENO/1892–1929/MURIO EL 8, MAYO”.

Repair type(s): repair—hard cement

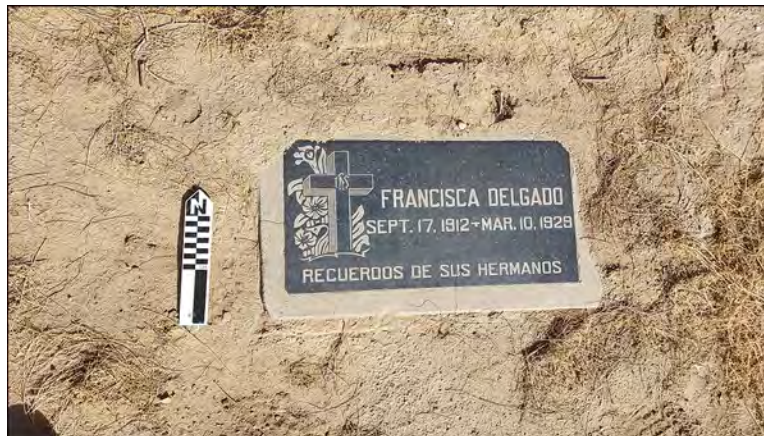
Feature PD: 408

Damage type(s): buried/sunk

This grave is marked with a modern replacement lawn-style monument. The monument is flush with the ground surface and contains a polished black marble plaque in a concrete casing. The plaque has an incised cross-and-floral motif next to the inscription. Three corners of the monument are partially buried by soil. The inscription reads, “FRANCISCA DELGADO/SEPT. 17. 1912–MAR. 10. 1929/RECUERDOS DE SUS HERMANOS”.

Repair type(s): none

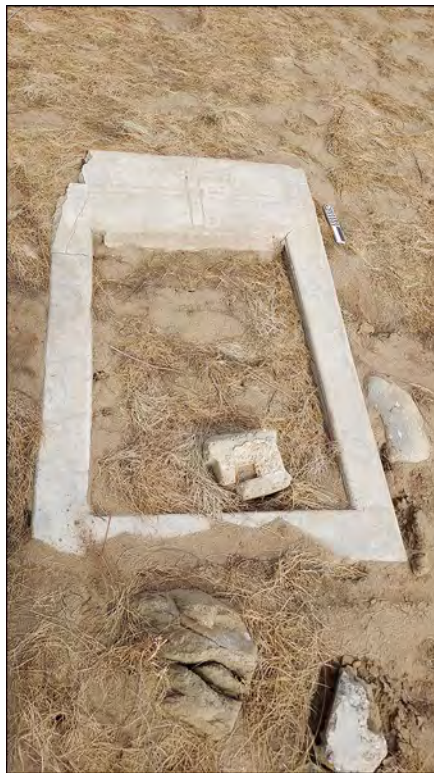
Feature PD: 410

Damage type(s): fragmentation—loss, cracked, buried/sunk

This feature consists of a block that has been incorporated into concrete coping. The block portion is wider at the head of the monument, which contains an incised cross design with two horizontal lines going through it. There is no headstone or inscription associated with this monument, although there are two fragments of concrete near the monument, one inside the coping and one to the south of the coping. It is unclear whether these fragments originated at this monument. Several cracks run through the coping, and the northwestern corner is missing. The southern side of the coping is partially buried.

Repair type(s): none

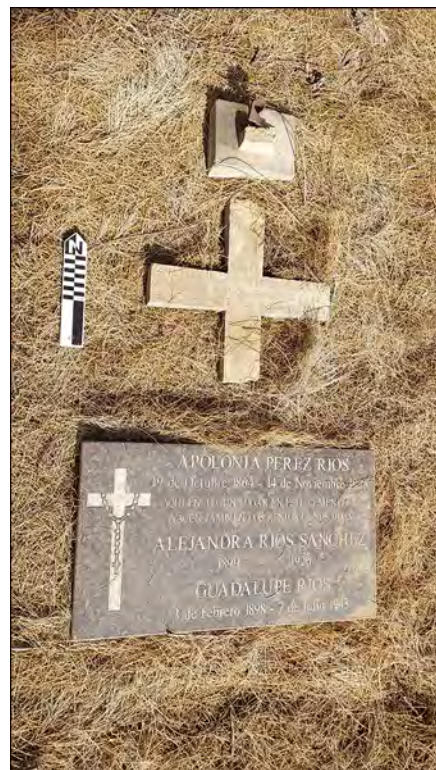
Feature PD: 412

Damage type(s): fragmentation—loss, tilted/fallen

This is a multicomponent monument with a cross-on-base monument and a modern lawn-style replacement plaque. The modern plaque contains the names of three people, and this grave may contain several burials. The cross-on-base monument is made of concrete. The cross has broken off the base and is lying on the ground in front of it. It has squared sides and smooth surfaces and contains a hand-incised inscription on the front of the cross bar. The base is square and has squared edges and a smooth surface. A metal strap protrudes from the top of the base and likely provides support for the cross. Inscribed on the cross is “AqUI [sic] YASEN LOS RESTOS de LA SRA/APOLONIA P RIOS FALLECIO EL 14/de NOV. de 1928 ALA Edad de 69 ANOS”.

Repair type(s): none

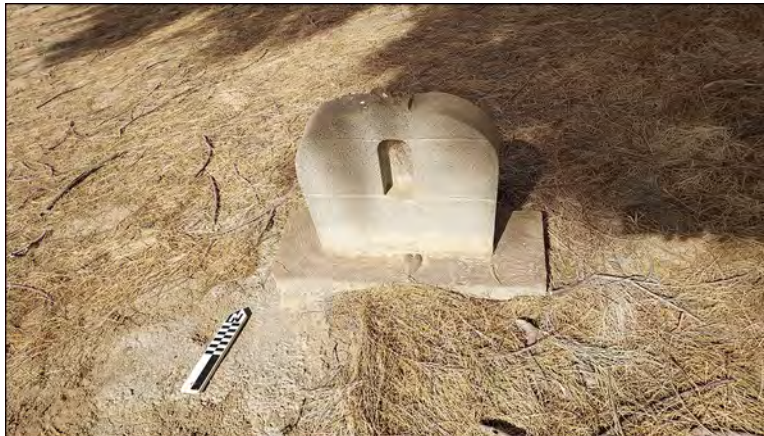
Feature PD: 414

Damage type(s): fragmentation—loss, cracked

This grave is marked by a die-in-socket concrete headstone. The base is concrete and is cracked at the corners. There is a heart protruding from the front center of the base. The headstone has two lines running horizontally on the face of the headstone, in line with the top and bottom of a small alcove feature, likely for a candle insert. The edges are rounded in shape but smooth. There is a breakage point at the top, likely where a concrete cross was once attached but has since been broken off and lost. There is no inscription present on the grave marker.

Repair type(s): none

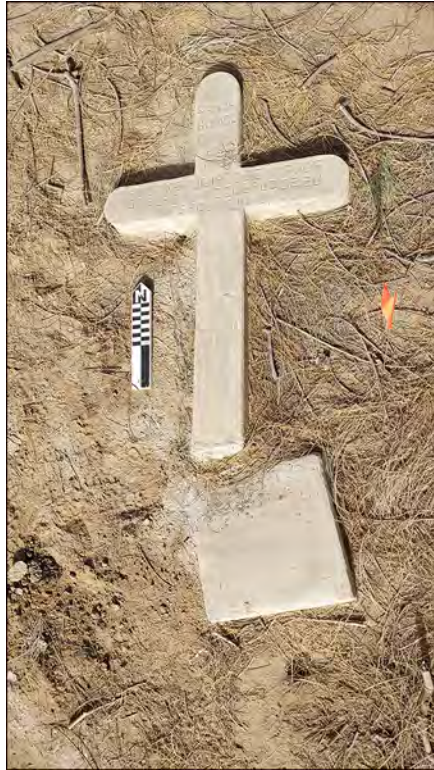
Feature PD: 416

Damage type(s): burrowing-animal disturbance, fragmentation—loss, tilted/fallen

This grave is marked by a smooth, round-edged concrete cross and a square concrete block. The cross has fallen onto the ground and does not appear to have been attached to the block but must have stood behind the block or base. There is rodent-burrowing activity near the base that possibly contributed to the fallen cross. The cross is hand inscribed with “RAMON/GOMEZ/MURIO/EL/DIA/30 DE NOV DE 1928 DE 49 AÑOS/DE EDAD UN RECUERDO DE 2U/ESPOSA E HIJO”.

Repair type(s): none

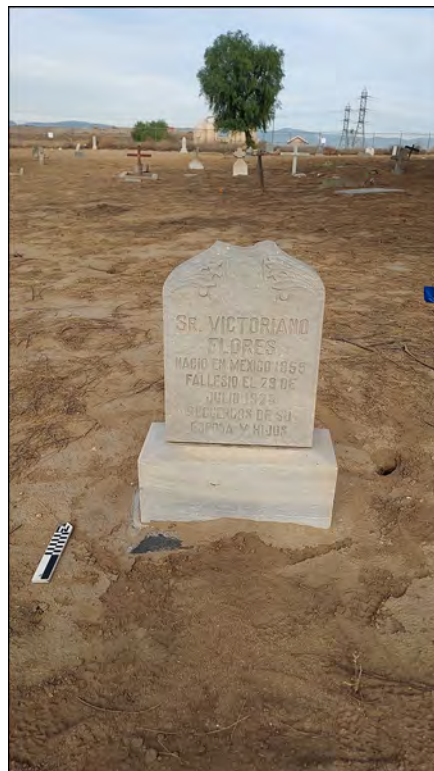
Feature PD: 418

Damage type(s): buried/sunk, burrowing-animal disturbance, fragmentation—loss, ground loss, open joints

This grave is marked by a gray marble die-on-base-style headstone. The very bottom base or foundation is exposed and is a darker gray or black marble. The base or block is a light-gray marble and is smooth on each side. There is rodent-burrowing activity near the base of the grave marker. The top edges are chamfered, and there is an open joint where it meets the headstone. The headstone has something that has been broken off the top. There is an ornate design on the top-left and -right corners of the headstone. The headstone is inscribed with the following:

Repair type(s): none

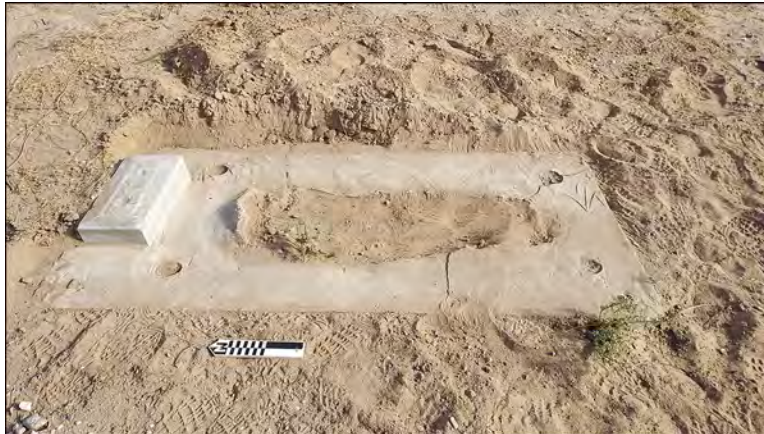
Feature PD: 420

Damage type(s): fragmentation—loss, cracked

This feature consists of a ledger-type monument with a die-on-base headstone that is missing the headstone. The ledger is made of concrete and has a triangular plastered design throughout the surface that resembles leaves. The ledger is rectangular and has four holes for candles or flower vases, one in each corner. The center of the ledger has a large, irregular hole, one side of which has what appears to be part of a concrete structure that has broken off. The hole may have been the location of a marker, tomb, or decoration that is now gone. The headstone base is rectangular and made of marble. It has a chamfered top and polished sides. Two holes are present on the top of the base, for anchor bolts. There are no inscriptions on the ledger or the base. The ledger has several cracks running through it.

Repair type(s): none

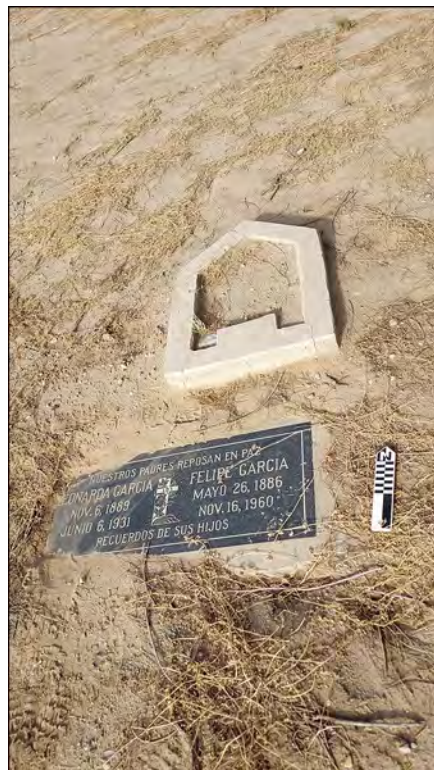
Feature PD: 422

Damage type(s): fragmentation—loss, cracked, buried/sunk

This is a multicomponent monument with a disassembled component and a modern lawn-style replacement plaque. The modern plaque contains the names of two people, and this grave may contain several burials. The disassembled component consists of a shield-shaped concrete border with flat tops and squared edges. This likely served as a base for a monument of some type that is now missing. A plastic snowman platter has been placed on the dirt inside the base, and the base has several cracks running through it. There are no inscriptions on the base.

A modern replacement lawn-style monument has been placed in front of the disassembled component. The monument is flush with the ground surface and contains a polished black granite plaque in a concrete casing. The plaque has a cross-and-floral motif in the center of the inscription. The lawn-style monument is partially buried by soil. The inscription reads as follows:

Repair type(s): none

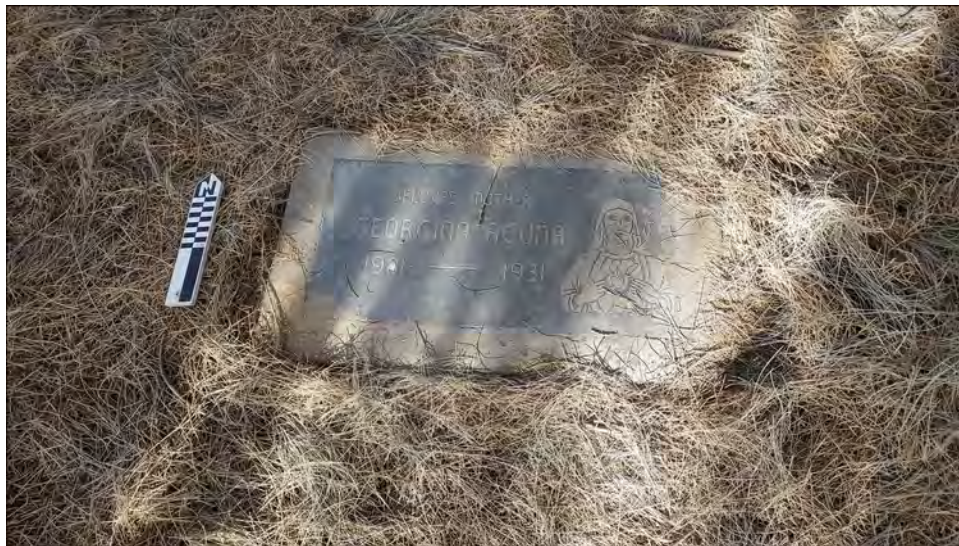
Feature PD: 424

Damage type(s): buried/sunk, erosion

This grave is marked with a lawn-style monument that is flush with the ground surface and contains a black marble plaque in a concrete casing. The plaque has an incised picture of Mary with a knife running through her heart, next to the inscription. The monument is partially buried by fallen tree duff, and the marble surface of the plaque has eroded away in a couple of places. The inscription reads, “BELOVED MOTHER/GEORGINA ACUNA/1901–1931”.

Repair type(s): none

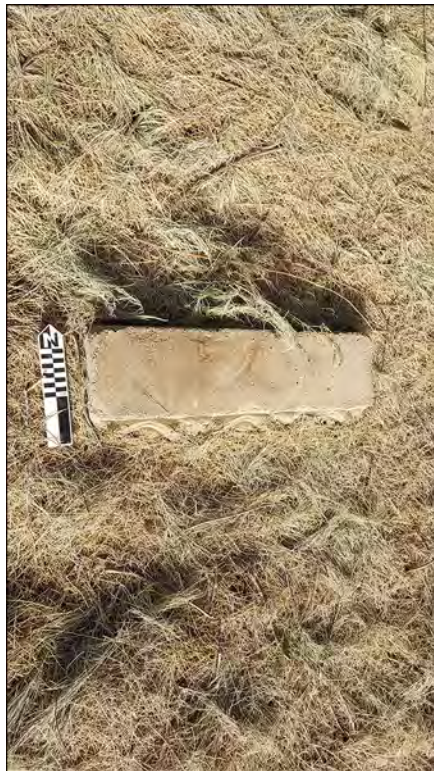
Feature PD: 426

Damage type(s): disassembled—loss

This feature consists of a concrete block that may be a base or decorative piece from a monument. The concrete block is rectangular and has squared sides. The front of the block has a molded scallop (or maybe rainbow) and sunray design. There are no inscriptions on the block, and there are no obvious bolts or anchor points for other monument components.

Repair type(s): none

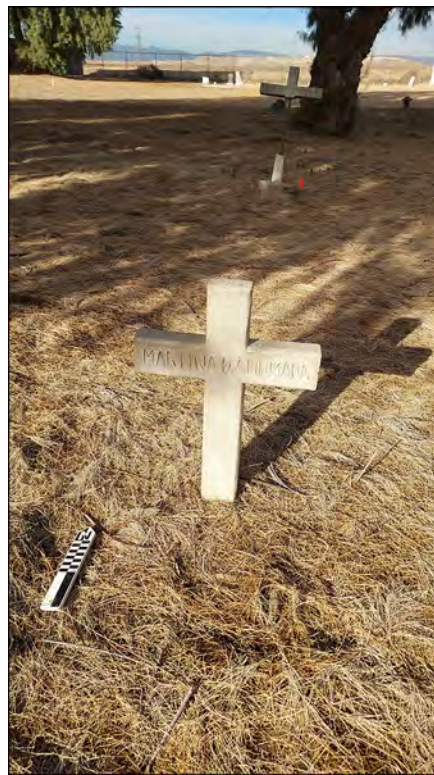
Feature PD: 430

Damage type(s): tilted/fallen

This grave is marked by a concrete cross with the inscription, "MARTINA D. AGUMADA". The cross is smooth but squared along the edges. It is leaning slightly to the east.

Repair type(s): none

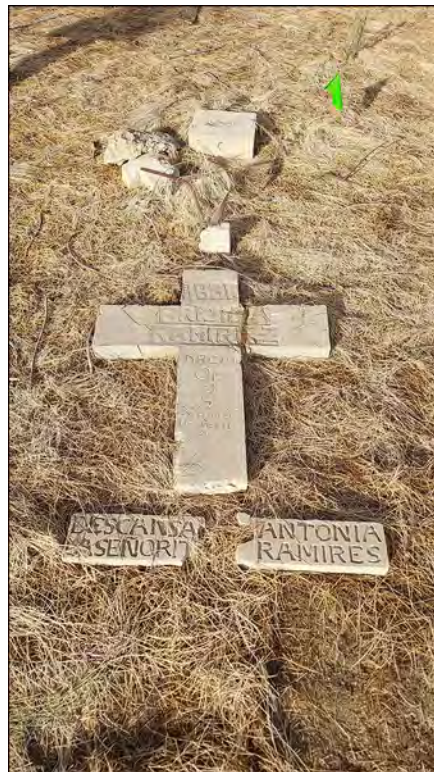
Feature PD: 432

Damage type(s): cracked, fragmentation—loss, tilted/fallen

This grave is marked by a concrete cross that has broken and fallen onto the ground. The cross is cracked and missing a few pieces. The year and name were stamped into the cross, and the remainder of the inscription was written by hand at the base of the cross, in an additional block with a small circle in the middle, in a neatly inscribed font. The cross and block, respectively, are inscribed with “1931/BRIJIDA/RAMIREZ/NACIO/OCT/8/MURIO/11 - ABRIL/‘31” and “DESCANSA ANTONIA/LASEÑORI[. . .] RAMIRES”.

Repair type(s): none
