Archaeological Condition Assessment and Ground-Penetrating Radar (GPR) Surveys for Agua Mansa Cemetery, San Bernardino County, California

Technical Report 24-26
Statistical Research, Inc.
Redlands, California

April 2024

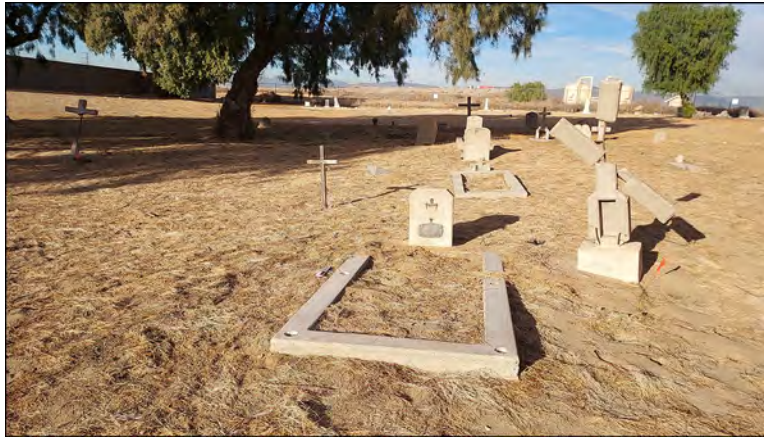
Feature PD: 434/436

Damage type(s): buried/sunk, erosion, fragmentation—loss

This grave is marked by a concrete headstone at the head of a squared concrete coping (Feature 436). The coping has six lined holes spaced along it, for candles or flowers. The northern end of the coping has started to become buried. On the face of the headstone is a metal cross and an ornate plaque. The plaque is inscribed with “*Father*” (in cursive writing). Erosion has affected the face of the headstone, making the inscription at the top difficult to read. The headstone is inscribed “Q. E. P. D./1872 [metal cross attachment] 1932/[ornate metal “*Father*” plaque]/LUIS LEYVA”.

Repair type(s): none

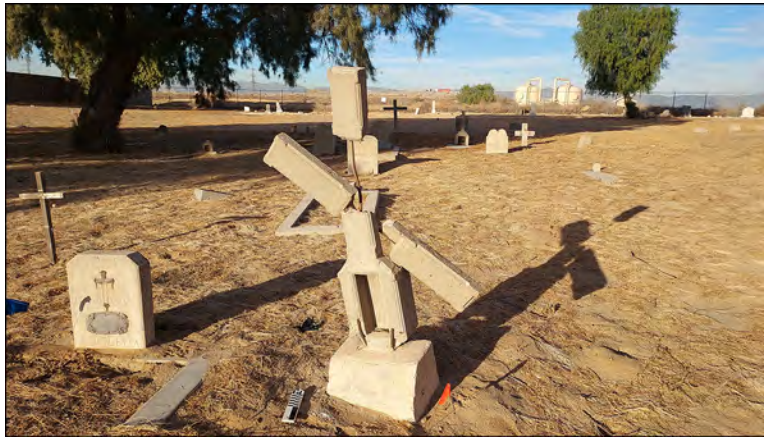
Damage type(s): cracked, fragmentation—loss, tilted/fallen

This grave is marked by a concrete cross that is fragmented and has exposed rebar in the center. Each piece of the cross has a slight chamfered design on the edges. Below the cross is a small concrete grotto that holds a space for a candle or other ornament. The monument is tilting to the west, and there is exposed rebar at the base. The rebar holds the cross and grotto onto the pedestal. The pedestal is cracked, slanted, and sinking to the southwest. There is no inscription present on this grave marker/feature.

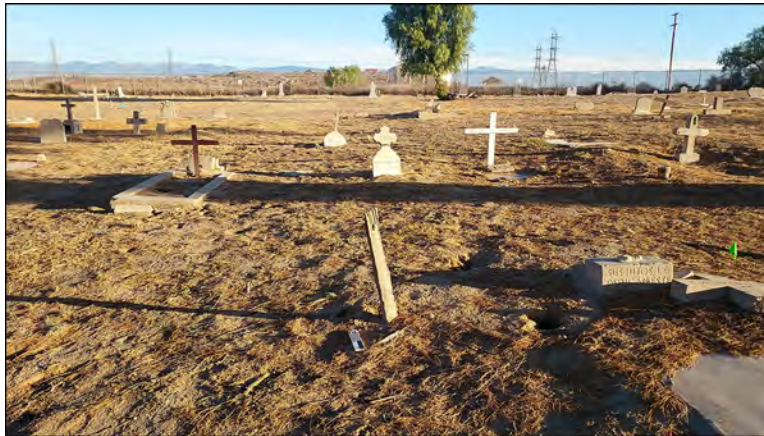
Feature PD: 440

Damage type(s): burrowing-animal disturbance, fragmentation—loss, tilted/fallen

This grave is marked by a wooden cross that has lost its horizontal segment. The remaining piece is tilting to the west and has rodent-burrowing activity near it. The hardware is still attached to the remaining piece of the cross. There is no inscription on this piece of wood.

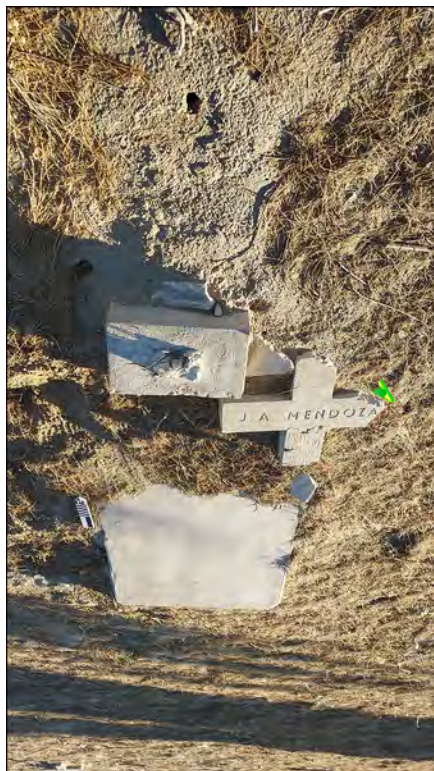
Feature PD: 442

Damage type(s): buried/sunk, fragmentation—loss, ground loss, spalling

This grave is marked with a concrete cross and ledger. The cross has been broken off the base and is missing a few pieces, mostly toward the bottom. The base has an exposed foundation on the northern and eastern sides, and the southern side is covered with soil. The ledger has a squared edge and minor spalling along the sides. The cross is inscribed with “J. A. MENDOZA/FALLECIO/[. . .] 19 DE OCT./DE 1931”. The base is inscribed “SU HIJOS LE/DEDICANESTE/RECUERDO”.

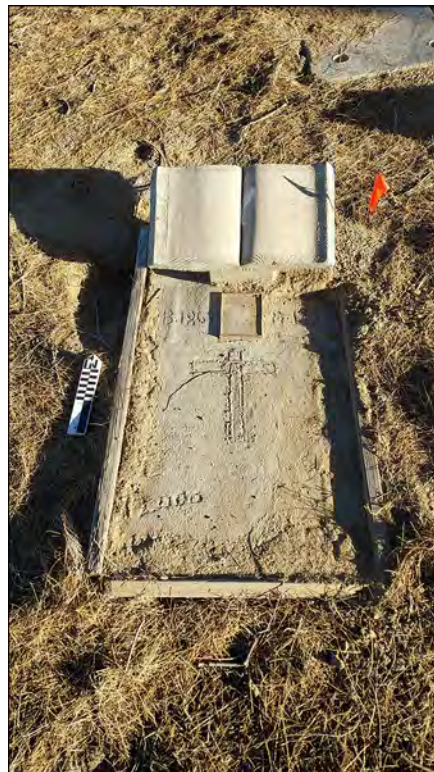
Feature PD: 444

Damage type(s): buried/sunk, burrowing-animal disturbance, erosion

This grave is marked by a concrete stylized headstone in the shape of an open book on a concrete ledger. The concrete book has a tree design on the cover and edges. There may have been an inscription on the pages of the open book, but because of erosion, it is no longer legible. There is also a concrete ledger that was a later edition; it is inscribed with the year 2000. The ledger has a square metal frame under the book, with the inscription “B. 1867” on the left and “D. 1932” on the right. There is a cross drawn in the concrete beneath the metal frame. The ledger has a wooden frame that shows signs of weathering. There is rodent burrowing next to the headstone. There is soil on the edges of the ledger, likely overflowing from the eastern side, where the ground is higher than on the western side.

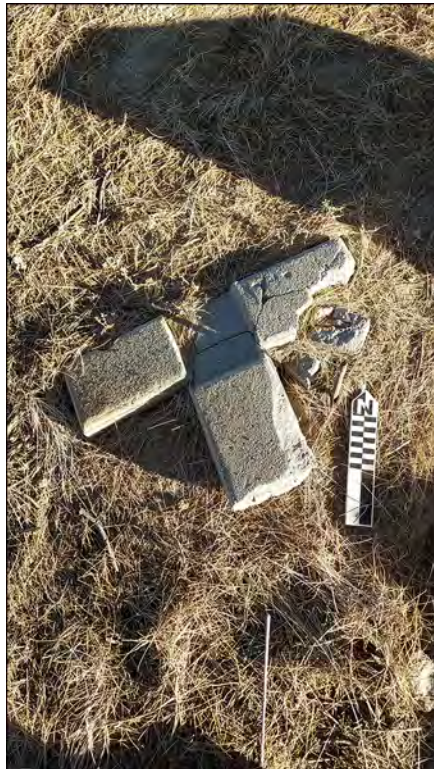
Feature PD: 446

Damage type(s): fragmentation—loss, tilted/fallen

This grave is marked by a concrete cross that has fallen over. Three of its four stems remain, and there is a fragment nearby. Wire and rebar are visible on the eastern side of the cross. The larger piece of the cross is broken into additional fragments. The cross is smooth on the sides and squared along the edges. There is no inscription present on the monument.

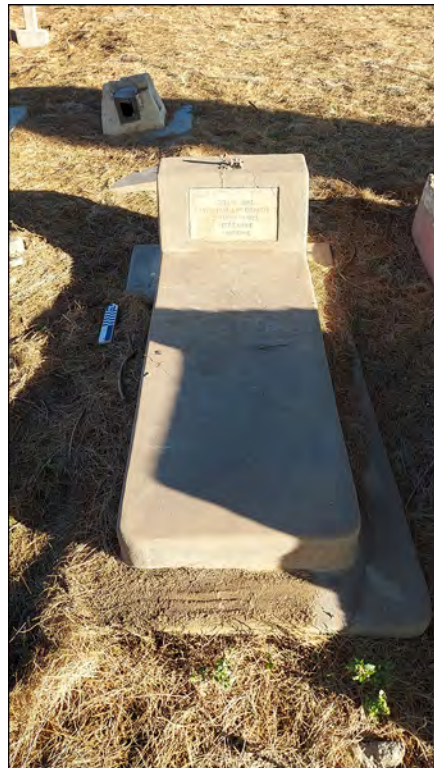
Feature PD: 448

Damage type(s): buried/sunk, cracked

This grave is marked with a two-tier concrete tomb with a plaque marker on top, at its head. The head of the grave marker is cracked, as is the inset plaque. The platform tomb is partially buried on the western and southern sides. The plaque marker is inscribed as follows:

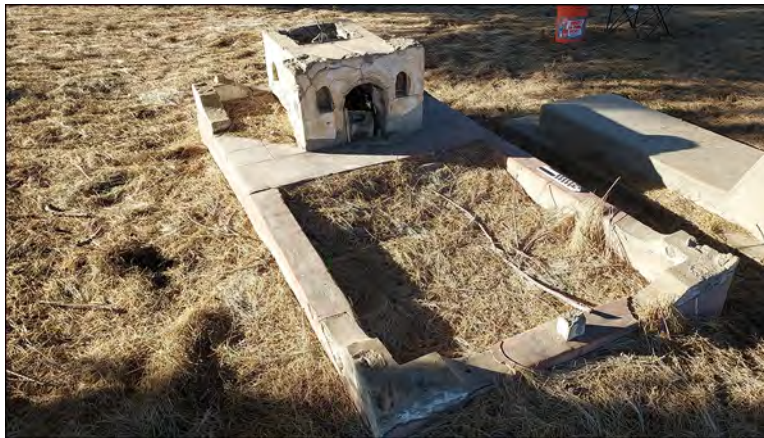
Feature PD: 450/452

Damage type(s): fragmentation—loss, cracked

This grave feature is marked with a concrete monument consisting of a concrete slab that has a miniature concrete church mounted on the top and attached coping (Feature 452). The coping is squared and has raised portions at each corner that contain three broken squares of concrete—likely the bases for a decoration of some sort that is now missing. The center of the foot of the coping has a square base for a concrete cross that has broken and is missing. The head of the monument has a concrete slab that has been sectioned by incised lines running across the surface. The coping and slab contain a layer of red plaster, much of which is chipped off. In the center of this slab, a miniature version of a mission-style church has been built. The church has an arched doorway, two arched windows in front, the bases for two towers on the front facade, and two arched windows on either side. The roof of the church is flat, but the back half of the roof is open and has no covering. It has a thin layer of plaster over the surface, most of which has flaked off, and the church has multiple cracks running through it. A modern-looking metal candle holder has been placed next to the church structure. There are no inscriptions on the monument.

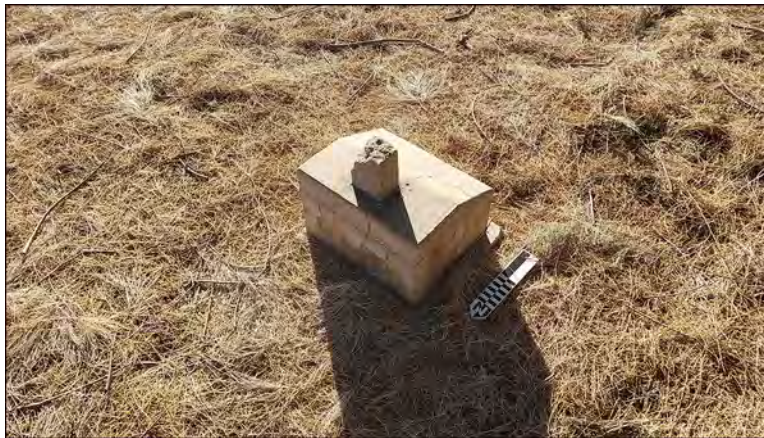
Feature PD: 454

Damage type(s): fragmentation—loss, cracked, buried/sunk

This feature consists of a concrete base for a cross-on-base monument. The subbase has squared sides, a peaked top, and a smooth surface. The surbase has several cracks running through it and the remains of a concrete cross protruding from the top. Only the bottom few inches of the cross remain; the rest has broken off and is missing. The surbase is sitting on a slightly wider, thin concrete base with squared sides and a smooth surface. The base is largely covered in tree duff. There are no inscriptions on the remaining portions of the monument.

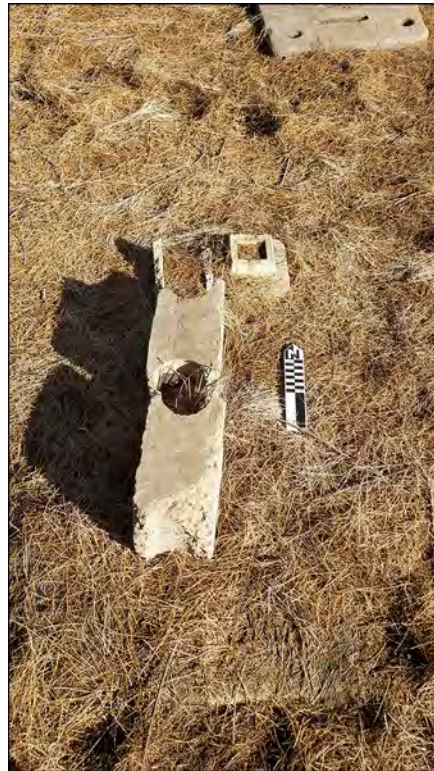
Feature PD: 456

Damage type(s): fragmentation—loss, cracked, buried/sunk

This feature consists of a concrete base for a monument of unknown type. The base contains several components, including a squared concrete post lying on its side. The post has been broken into three pieces, and there is a circular hole in the center, likely for a candle or flower vase. It is unclear whether the post has fallen or was always lying on its side. Next to the post is a square base with a square hole in it that held some sort of cross or decoration. The feature is largely covered in tree duff. There are no inscriptions on the remaining portions of the monument.

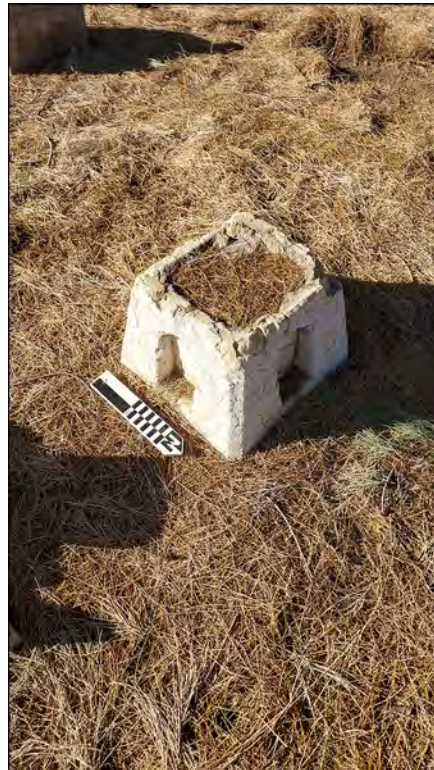
Feature PD: 458

Damage type(s): fragmentation—loss, cracked, buried/sunk

This feature consists of a concrete base for a monument of unknown type. The base is roughly square and has beveled sides and a smooth surface. Each side of the base has an arched doorway shape cut out of it. The top of the base has broken concrete edges where the top of the monument likely once sat. The base is cracked and is largely covered in tree duff. There are no inscriptions on the remaining portions of the monument.

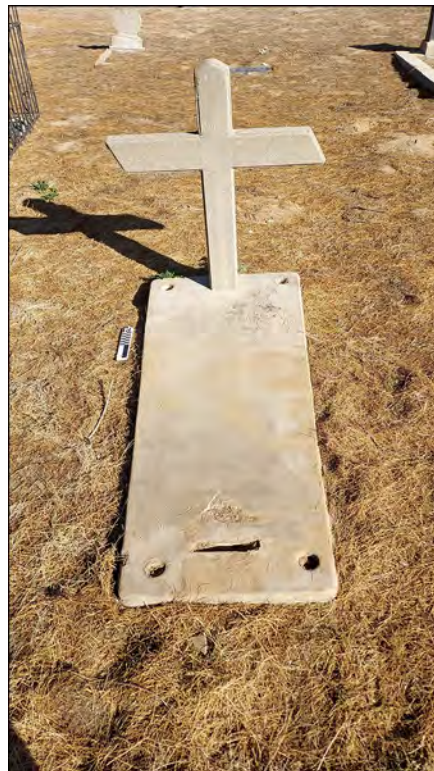
Feature PD: 460

Damage type(s): spalling, disassembled—loss, fragmentation—loss,

This is a grave marked with a ledger monument and a concrete cross installed at the head of the slab. The monument is a ledger-style concrete rectangular slab with rounded edges and a smooth surface. The slab contains four holes for candles or flower vases, one at each corner, and a rectangular slot at the foot that may have contained a footstone. A concrete cross has been mounted at the head of the ledger slab. The cross has a peaked top and angled ends to the cross bar. There is a slot or socket at the foot of the ledger, possibly for a tab-in-socket-style headstone. The monument is in good condition and has only some minor spalling near the foot of the slab. Neither the cross nor the slab contains an inscription.

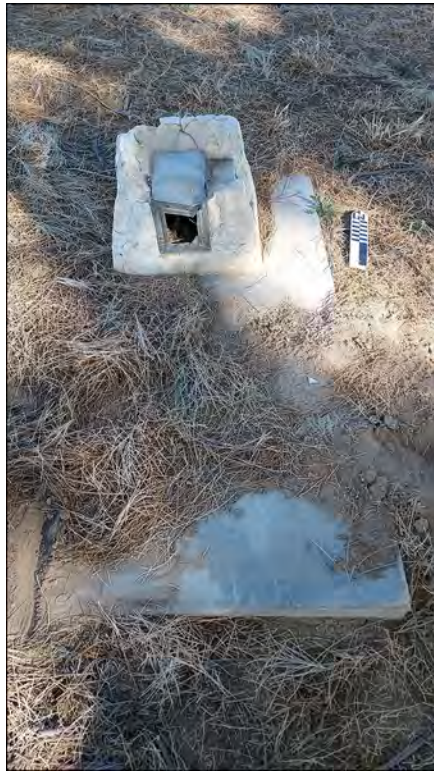
Feature PD: 462

Damage type(s): buried/sunk, cracked, fragmentation—loss

This grave is marked by a concrete ledger that is half buried beneath the soil, specifically on the western side. On top of the ledger is a concrete block that is fragmented and cracked and has an inset metal box. The box appears to have had a glass window in it, but it is uncertain what was originally inside it.

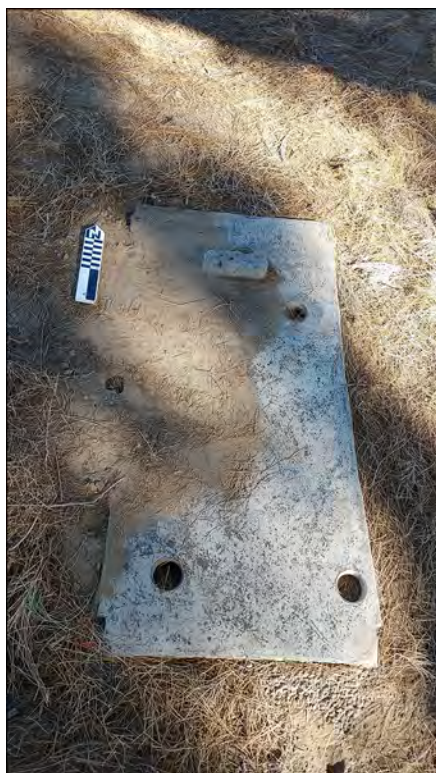
Feature PD: 464

Damage type(s): buried/sunk, burrowing-animal disturbance, fragmentation—loss

This grave is marked by a concrete die on base and a ledger. The ledger has four holes for candles or flowers. Each corner has had a piece removed on purpose, likely for design purposes. The western side of the ledger is partially buried, and there is evidence of rodent-burrowing activity, as well.

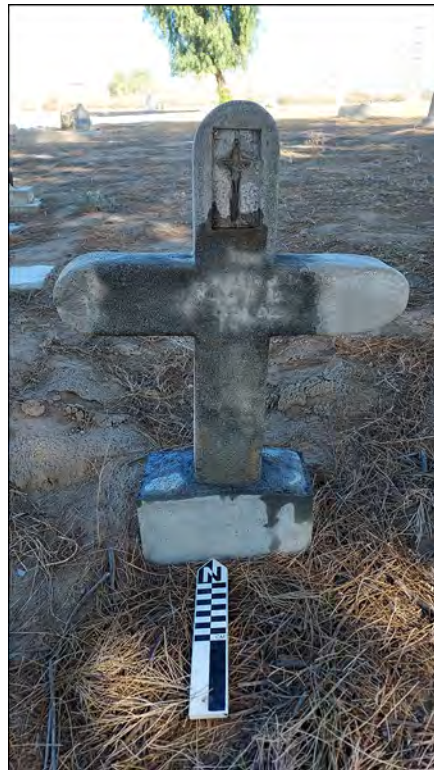
Feature PD: 466

Damage type(s): erosion

This grave is marked by a concrete cross and base. The cross has a Christ motif or ornament attached at the top and an inscription across the center. The inscription is difficult to read and has begun to erode away. The eastern portion of the cross has had repairs done to it, during which hard cement was used to rebuild the segment. The base is smooth along the sides and has a rough finish on top, where the cross was inset. The cross is inscribed “JOSE/[. . .]ria/[. . .] [. . .]urio A. L. /NERO[. . .] 1934/DIED/SU[. . .]”.

Repair type(s): — hard cement

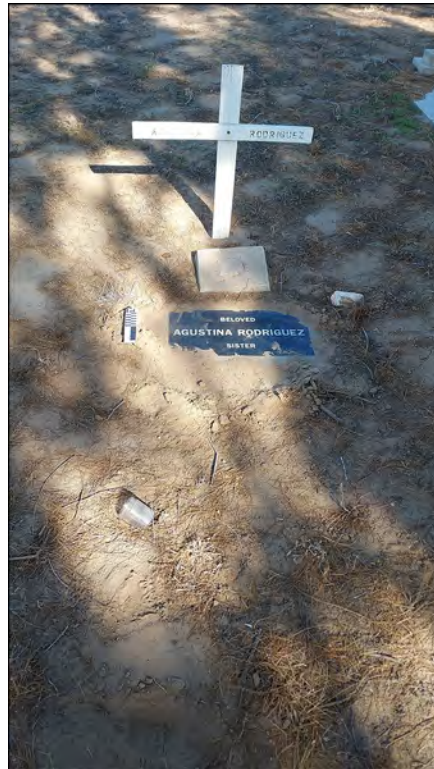
Feature PD: 468

Damage type(s): disassembled—loss, tilted/fallen

This is a grave marked with a multicomponent monument twith a concrete base for a monument, a wooden cross, and a modern lawn-style monument. The base is made of concrete and is roughly square and has chamfered sides and a smooth surface. The base contains a rectangular patch of mortar and a square-shaped rough area in the center, where a cross or other monument likely once sat. The base is slightly tilted. A wooden cross has been erected behind the base. The cross has been painted white and has a metal screw fastener. The cross bar of the cross has had “AUGUSTINA RODRIGUEZ” painted on it in black paint, with stenciled letters. In front of the concrete base, someone has installed a modern replacement marker. The marker is a laser-cut lawn-style marker made of black stone. The marker is inscribed with “BELOVED/AUGUSTINA RODRIGUEZ/SISTER”.

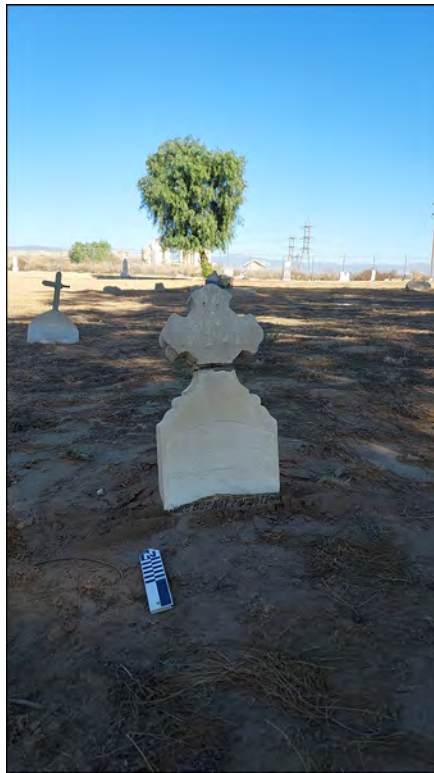
Feature PD: 470

Damage type(s): fragmentation—no loss, buried/sunk

This grave is marked with a marble headstone that contains cyma-recta shoulders and is topped by a decorative cross. The cross is fragmenting off the main headstone but has not yet fully broken off. The bottom of the headstone has significant soil staining from its being partially buried; this staining has colored the bottom line of the inscription black. Inscribed on this monument is the name of the deceased, along with their birth and death dates: “JUANA HIMES/1846–1933/*Gone But Not Forgotten*”.

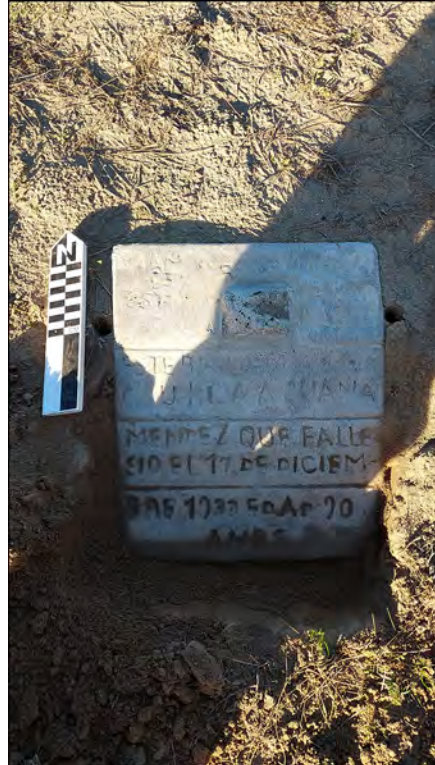
Feature PD: 472

Damage type(s): fragmentation—loss, buried/sunk, erosion

This grave is marked by a rounded concrete block. Something once protruded from the top but has since broken off. Half the block is buried beneath the soil. The inscription is handwritten. Across the top, the inscription has eroded away and is illegible. The remaining inscription reads.

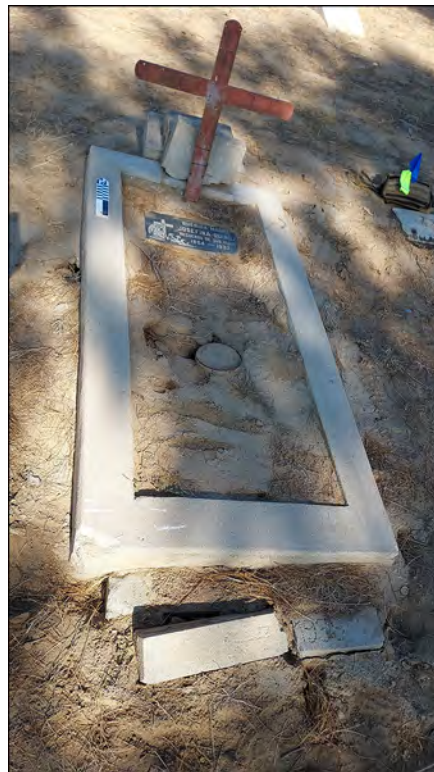
Feature PD: 474

Damage type(s): burrowing-animal disturbance, cracked, fragmentation—loss

This grave is marked by a concrete square shaped die-on-base marker, a metal cross, a black marble lawn-type marker, and squared concrete coping (Feature 476). There is a large flower vase or pot in the center of the coping. The die-on-base marker is cracked and fragmented. Possible evidence of repair with hard-cement gluing was observed on the die-on-base marker. The cross is metal and has wire ties, possibly for holding a flower arrangement. There is animal-burrowing disturbance both inside and outside the squared coping. The black marble lawn marker is modern and has a motif of an angel, a cross with “ihs,” and flowers. The marker is inscribed as follows:

Repair type(s): repair—hard cement

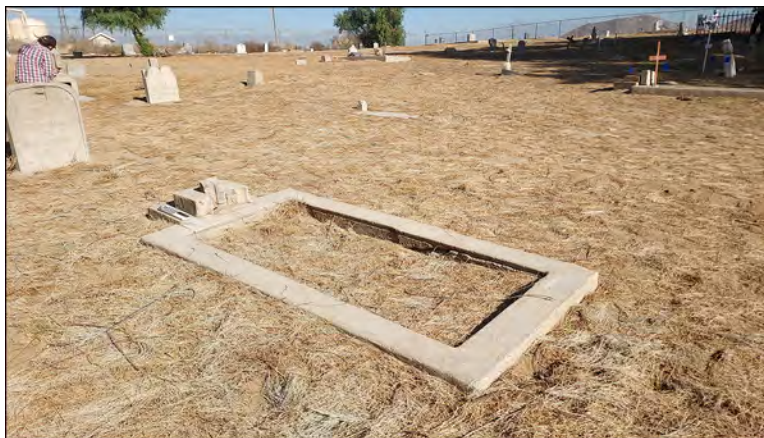
Feature PD: 478

Damage type(s): fragmentation—loss, cracked

This grave is marked by squared concrete coping and a concrete-block base of an unknown monument type. Shells and metal rebar are embedded in the uppermost layer of the base. The base is chipped along the edges.

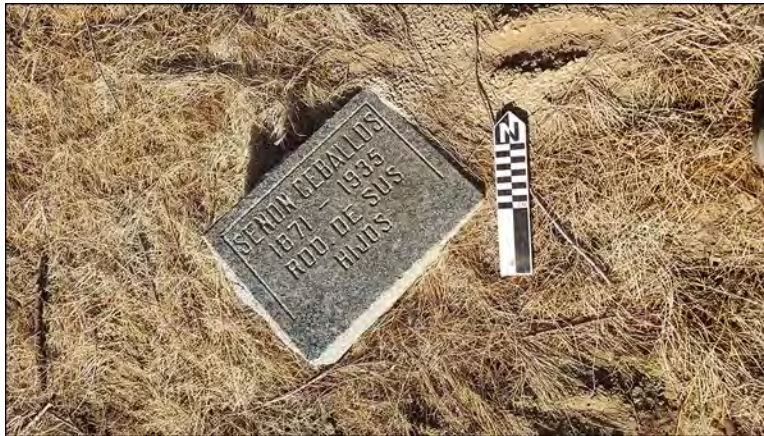
Feature PD: 484

Damage type(s): buried/sunk, tilted/fallen

This grave is marked by a granite block marker. The marker is partially buried on the northeastern corner. The stone appears to have been knocked over; the bottom sides appear smooth, and the other sides and the top are rock pitched. The design and inscription do not go all the way to the bottom of the stone. The marker is situated northeast–southwest instead of north–south. The marker is inscribed as follows:

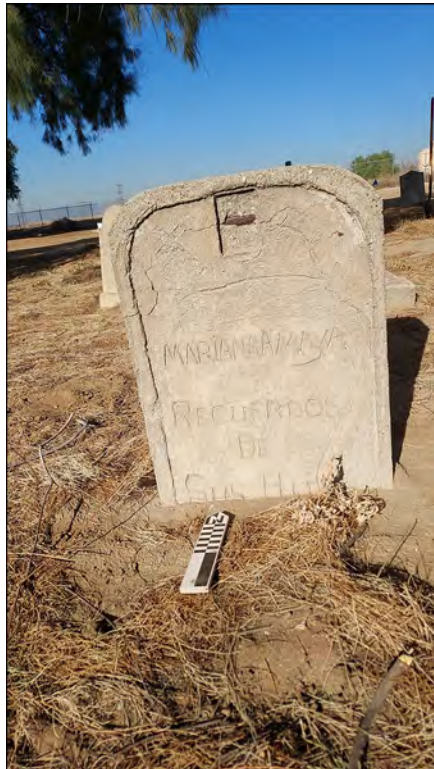
Feature PD: 486

Damage type(s): fragmentation—loss, buried/sunk, tilted/fallen, cracked

This grave is marked by a concrete headstone that is hand inscribed. There is an ornament missing from the top center of the face of the stone, and there is cracking along the face, as well. There is a cross-and-flower motif inscribed/hand drawn at the top, with the following inscription:

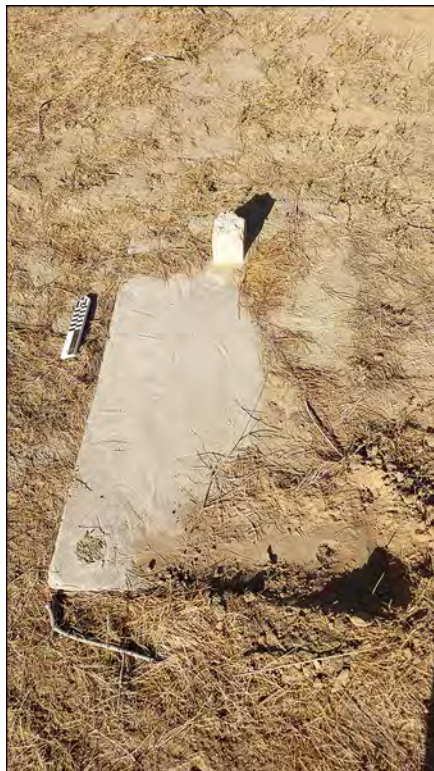
Feature PD: 488

Damage type(s): fragmentation—loss, buried/sunk, spalling

This grave is marked by a concrete ledger-style monument. At the head of the ledger are the remains of a possible cross that has been broken at the base and is missing from the site. The ledger is partially buried on the eastern half and has two holes for candles or flowers. The ledger has minor chipping along the edges, particularly on the corners.

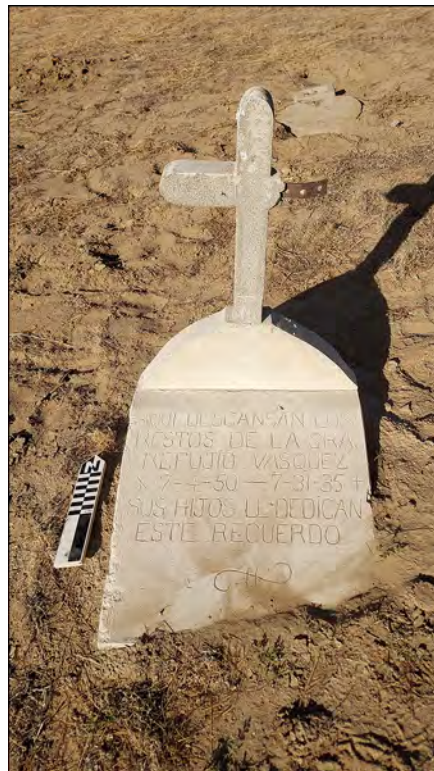
Feature PD: 490

Damage type(s): fragmentation—loss, buried/sunk, spalling

This grave is marked by a concrete cross and slant-marker monument. The cross is missing its eastern portion, leaving the metal reinforcement exposed. The southeastern corner of the ledger has begun to get buried. Small chips have fragmented off the edges of the slant marker, which is hand inscribed as follows:

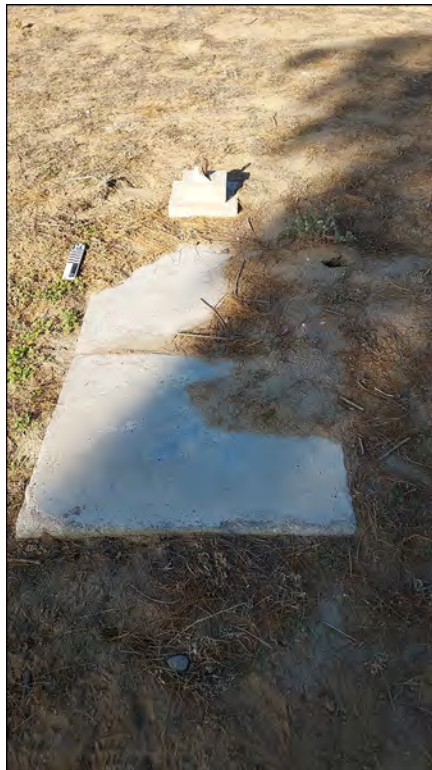
Feature PD: 492

Damage type(s): fragmentation—loss, buried/sunk, burrowing-animal disturbance, cracked, spalling

This grave is marked by a concrete base for a possible cross and ledger. The concrete ledger is cracked across the center and has chipping along the southern edge and corners. A possible cross had been broken from the base at the time of recording, and metal rebar was visible. Disturbance from animal-burrowing activity was observed on the eastern and northern edges. The northern and eastern edges of the ledger have started to become buried in soil. There is no inscription present on the remaining monument.

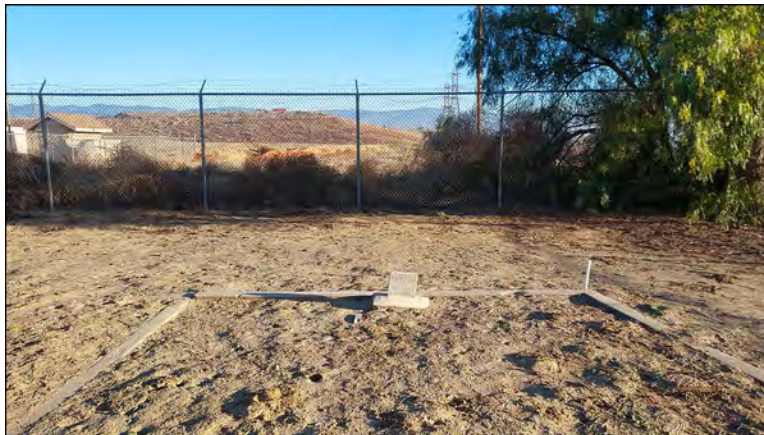
Feature PD: 494

Damage type(s): fragmentation—loss, buried/sunk, tilted/fallen, erosion, spalling

This grave is marked with a granite tab-in-socket monument with a concrete base. The monument has a large, squared coping (Feature 1025) that encloses both the headstone and enough space for multiple burials, although there are no indications that more than one person is buried there. Portions of the coping are buried. The headstone is broken, and only the bottom half remains; the top half is missing. The surface of the headstone is heavily eroded. The base is made of concrete and has a rough surface and a chamfered top. It appears that the headstone was inserted into the base while the concrete was still wet. There is some minor spalling along the base. The base and headstone are tilted. The remaining portion of the monument is inscribed with “FEB 14 1937/NOV 18 1914”.

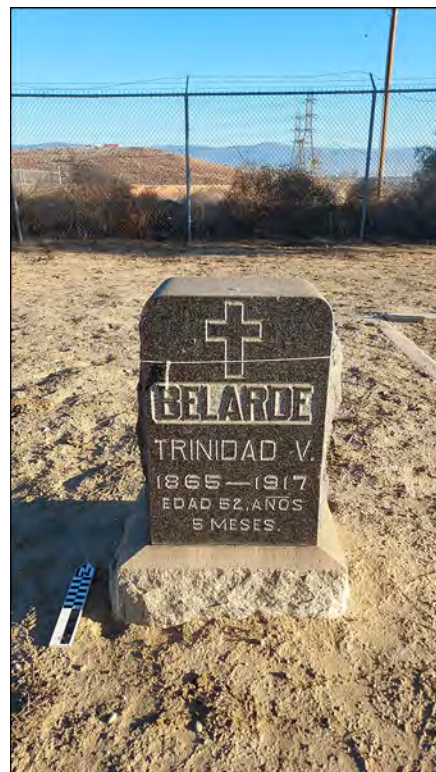
Feature PD: 496

Damage type(s): buried/sunk, open joints

This grave is marked with a granite die-on-base monument with a granite base. The headstone is roughly rectangular and has a basket arch. The sides are rock pitched, and the face and top are polished. The face is decorated with an incised cross above the inscription. A U.S. penny from 1969 is sitting on top of the headstone. The headstone is sitting on a white granite base that is rectangular and has a chamfered top and rock-pitched sides. The seam between the base and the headstone is open. Squared concrete coping runs around the feature. Portions of the coping are buried, and the coping appears to connect to the coping (Feature 1025) of Feature 494. The headstone is inscribed with “BELARDE/TRINIDAD V./1865–1917/EDAD 52. ANOS/5 MESES”.

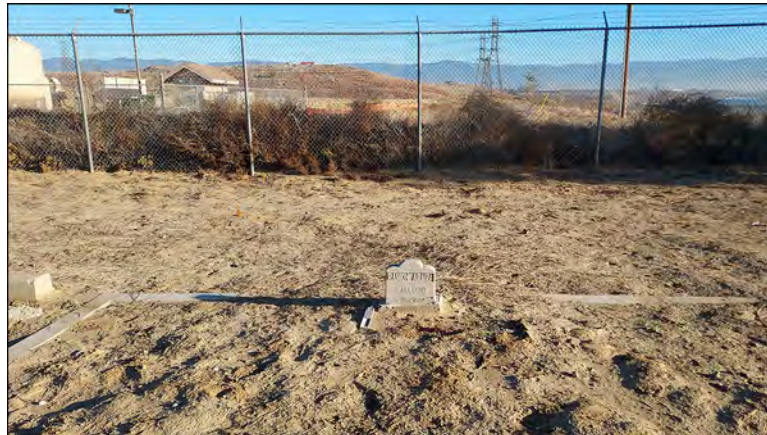
Feature PD: 498

Damage type(s): buried/sunk, erosion, spalling

This grave is marked with a concrete tab-in-socket monument with a concrete base. The monument has a large, squared coping (Feature 1025) that encloses both the headstone and enough space for multiple burials, although there are no indications that more than one person is buried there. Portions of the coping are buried. The headstone is roughly rectangular and has a semicircular arch and rounded caps. The surface of the headstone is heavily eroded. The base is made of concrete and has a rough surface and partially straight sides that look as though they had been roughly shaped rather than cured in a mold. It appears that the headstone was inserted into the base while the concrete was still wet, and the headstone has concrete slop on the lower face. There is some minor spalling along the base. The monument is inscribed with "RAMON ARAIZA/FALLECIO".

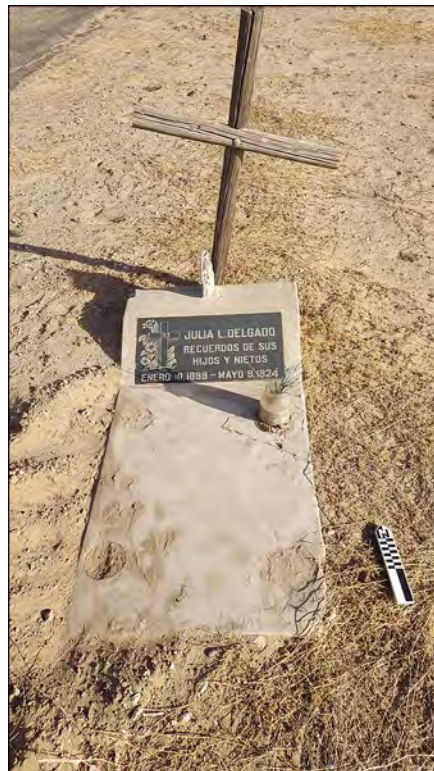
Feature PD: 503

Damage type(s): tilted/fallen, buried/sunk, fragmentation—loss

This grave is marked by a concrete ledger with a modern black marble plaque inset into a slant marker, along with a wooden cross. Additionally, a glass jar with the remnants of artificial flowers and the remains of an angel statue are on top of the slant marker. The statue has been broken off and lost. The cross is weathered and tilted. The ledger is cracked, missing a few pieces, and is sinking to the left. It has four holes for flowers or a vase at each corner. The black marble plaque has a cross with “ihs” inside it and a flower motif laser cut into the left side. The remainder of the plaque is inscribed as follows:

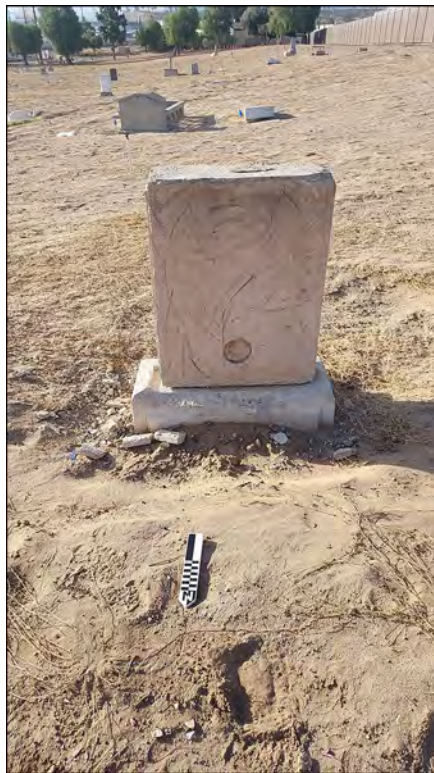
Feature PD: 505

Damage type(s): fragmentation—loss, cracked, open joints

This grave is marked by a concrete monument on a concrete base. The square base is fragmented, and pieces are missing. The headstone has a geometric pattern inscribed in the front and a circular hole toward the base. The back of the headstone has a protruding rectangular shape and is cracked. There is cement on the top of the headstone from possible repair or glue. The headstone has an open joint between the base and the stone. There is gravel surrounding the base. No inscription is visible.

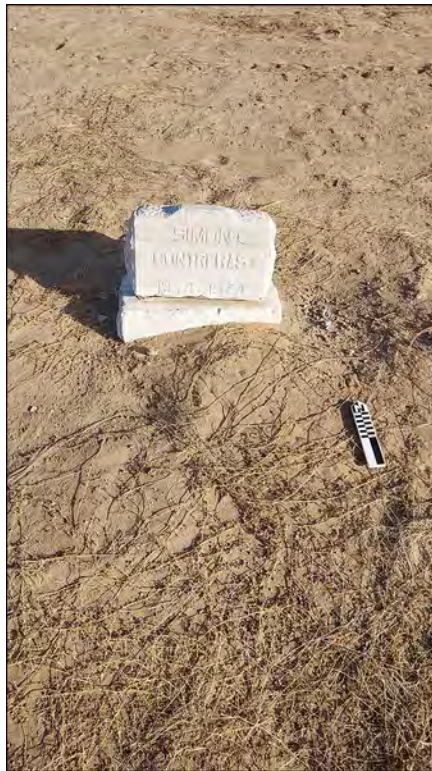
Damage type(s): open joints, buried/sunk

This grave is marked by a marble block headstone on a marble base. The headstone is sinking, has an open joint, and has been shifted from its original cemented location. The headstone is rock pitched around the top and edges. It has a cross motif at the top and the following inscription below: “SIMON/CONTRERAS/1874–1924”.

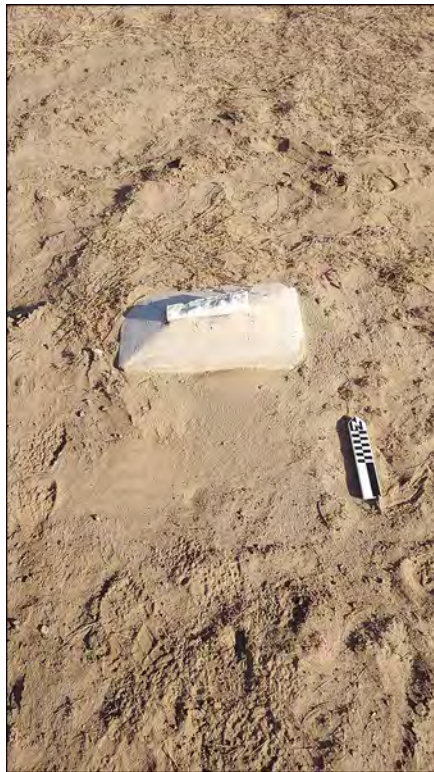
Feature PD: 509

Damage type(s): fragmentation—loss, cracked, buried/sunk

This grave is marked by a concrete base with a broken white marble headstone. The headstone is chamfered, and the corners have broken off. The base has cracks running throughout, and the northwestern corner has begun to sink. There is no inscription on the remaining monument.

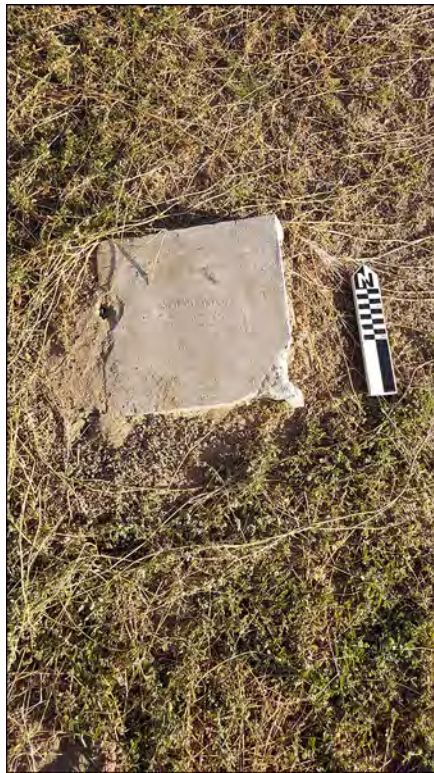
Feature PD: 511

Damage type(s): fragmentation—loss, cracked, burrowing-animal disturbance, buried/sunk, tilted/fallen

This grave is marked by a concrete block. The block has a name handwritten in the center. The inscription reads, “JULIAN AVILA/6-3-25”. The block is cracked, has rodent-burrowing activity nearby, and is missing fragments of its southeastern corner. It is also tilted and sinking.

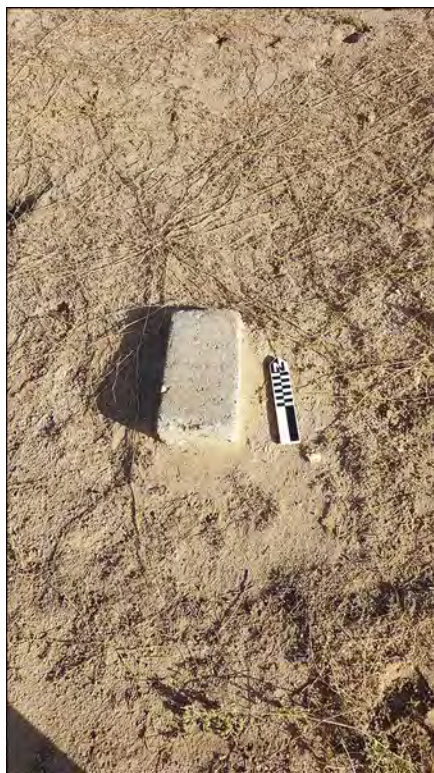
Feature PD: 513

Damage type(s): disassembled—loss, spalling

This grave is marked by a large, aggregate concrete block with no headstone. If this base had a headstone, it was set on top without any cementation. The edges of the base are squared and have spalling on the top edges. There is no inscription on the remaining monument.

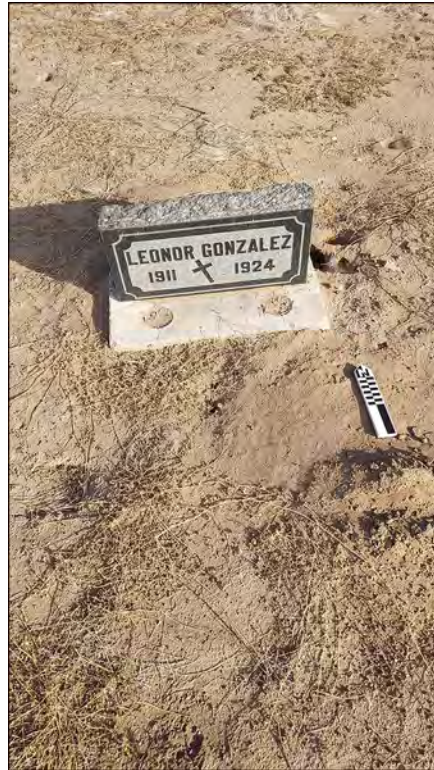
Feature PD: 515

Damage type(s): burrowing-animal disturbance, cracked, spalling

This grave is marked by a modern laser-etched black marble headstone resting on a concrete base. The base has two holes for a flower vase or candle, both filled with soil. The base has cracks and spalling around the edges. There is rodent-burrowing activity in the northeastern corner. The headstone is black marble and has rock-pitched sides and edges. The headstone is inscribed “LEONOR GONZALEZ/1911 [cross motif] 1924”.

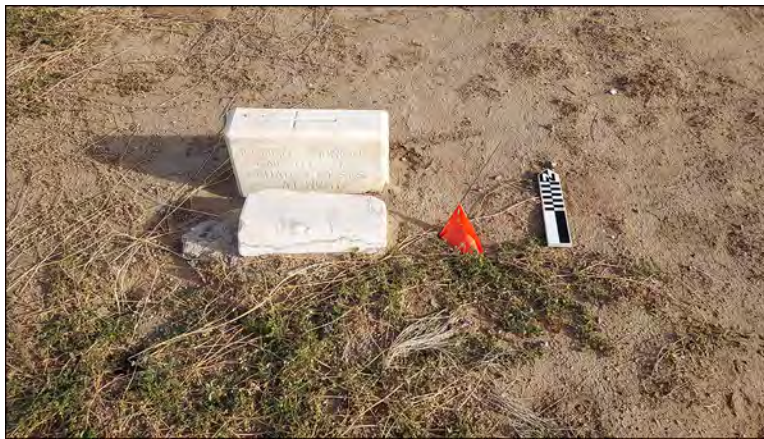
Feature PD: 517

Damage type(s): buried/sunk, ground loss, tilted/fallen

This grave is marked by a white marble headstone, footstone, and base. The headstone and footstone are very close in proximity, suggesting that the footstone is not in its original location. The footstone has a rough concrete base that has been exposed by shifting soils or relocation. The footstone has the corners cut out and is chamfered along the edges. The headstone has chamfered edging around the corners and a cross inscribed across the top edge, as well as the following inscription on the front:

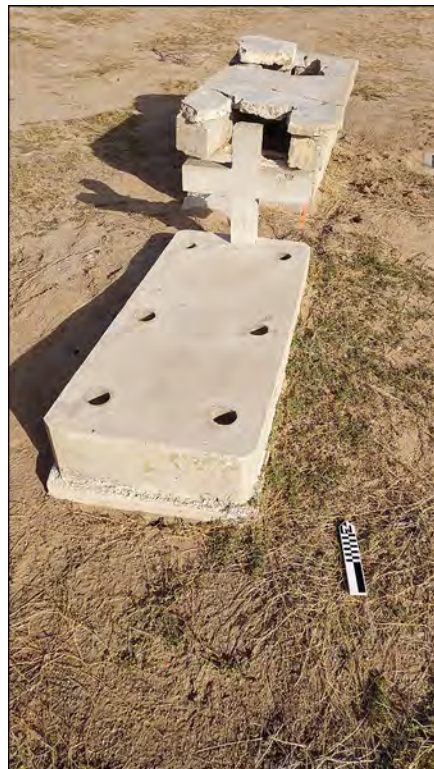
Feature PD: 519

Damage type(s): fragmentation—loss, burrowing-animal disturbance, ground loss

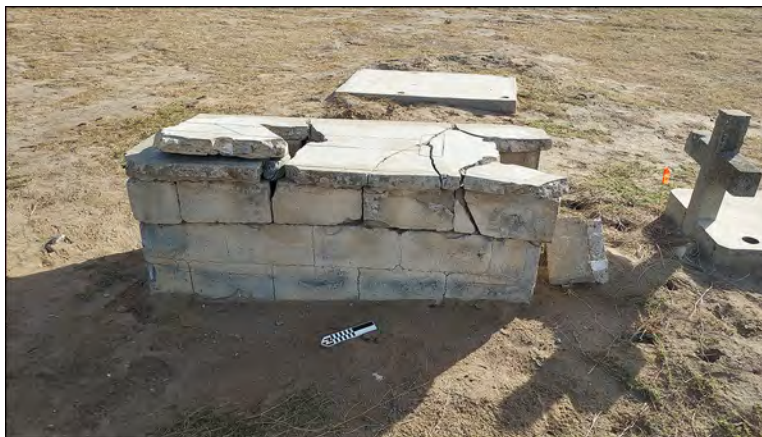
Feature PD: 521

Damage type(s): fragmentation—loss, cracked, burrowing-animal disturbance, buried/sunk

This grave is marked by a box tomb constructed with three rows of cinder blocks and a concrete ledger across the top. The structure is sinking into the ground, and the slab across the top has broken. The headstone was composed of white marble but has broken off. There is rodent-burrowing activity inside and around the grave. There is a cross engraved into the slab, but no inscription was identified.

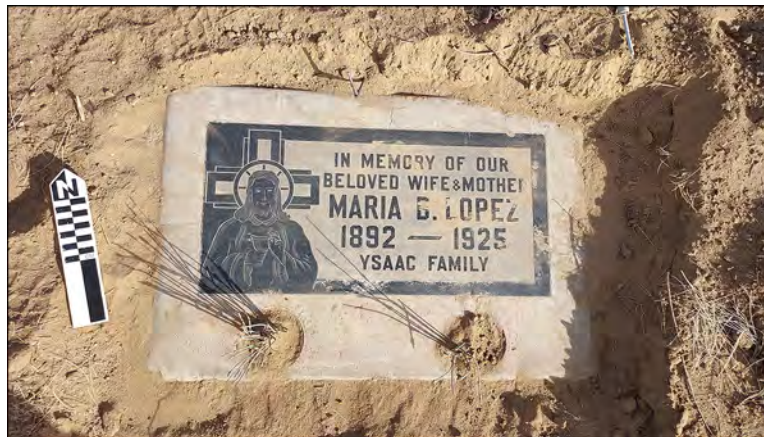
Feature PD: 523

Damage type(s): buried/sunk

This grave is marked by a modern black marble headstone set into concrete. The black marble headstone is etched and has two holes for flowers or candles. There are copper wires buried in the holes, possibly for artificial flowers. There are multiple solar lights nearby. The marker is in good shape but is sinking/getting buried. On the left side of the black marble is an etched depiction of Jesus standing in front of a cross. The remainder of the marble is inscribed with the following:

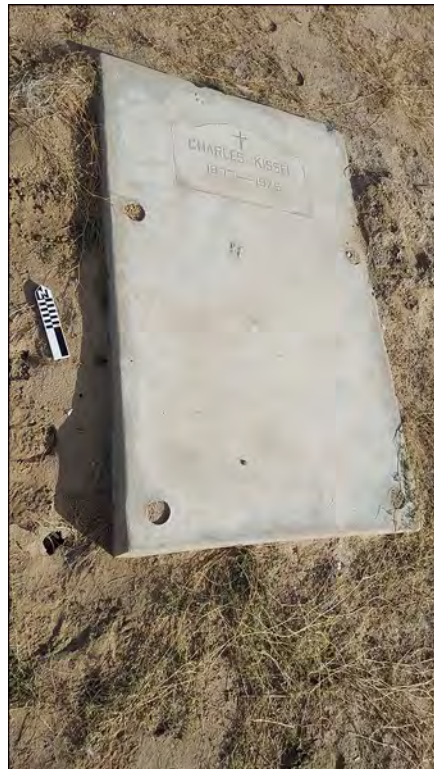
Feature PD: 525

Damage type(s): buried/sunk, burrowing-animal disturbance, cracked, fragmentation—loss

This grave is marked by a concrete ledger with four holes for flower vases or candles. A few pieces have broken off the edge along the top of the ledger. The southwestern corner is exposed, and the northeastern corner is flush with the surface. There is minor cracking on the ledger, which is inscribed with “[cross motif]/CHARLES KISSEL/1877–1925”.

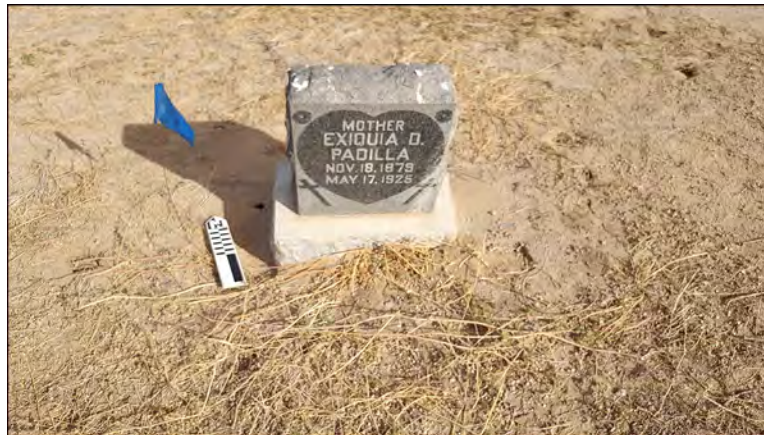
Feature PD: 527

Damage type(s): tilted/fallen, burrowing-animal disturbance, buried/sunk

This grave is marked by a modern black marble headstone set on top of a granite base. The granite base has a flat, smooth top and rock-pitched sides. There is rodent burrowing at the northwestern corner. The headstone is leaning forward, and soil is building up on the southeastern side. The headstone is gray in color and rock pitched on the top and sides. There are two black flower motifs etched in the top corners and two black cross motifs etched in the bottom corners, and the main inscription is inscribed over a polished black heart. The inscription reads,

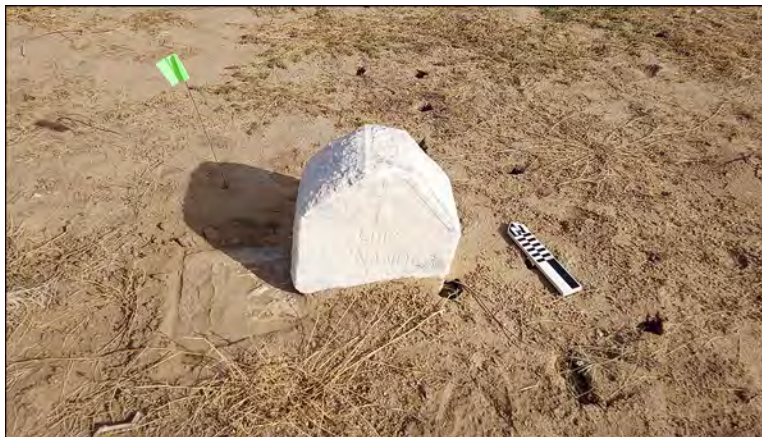
Feature PD: 529

Damage type(s): buried/sunk, fragmentation—no loss, burrowing-animal disturbance

This grave is marked by an arch-shaped marble block set atop a concrete base. The headstone has been broken off the base, and residue of the cement used to seal it is visible. The base is slightly buried. The headstone is in the shape of a pointed arch without the point and is chamfered on the side edges. The edges and top are all rock pitched and have flat fronts. There is rodent burrowing at the southeastern corner of the monument, spreading northward and southward on the eastern side of the monument. The headstone is tilting toward the rodent burrows. The headstone has a cross motif at the top and the following inscription:

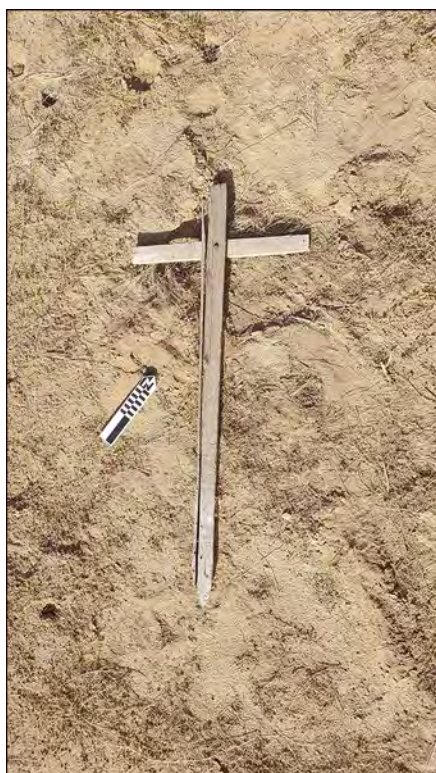
Feature PD: 531

Damage type(s): erosion, tilted/fallen

This grave is marked by a wooden cross that is weathered and has fallen over. The cross was constructed using lath. There is a piece of concrete approximately 10 feet south of the cross.

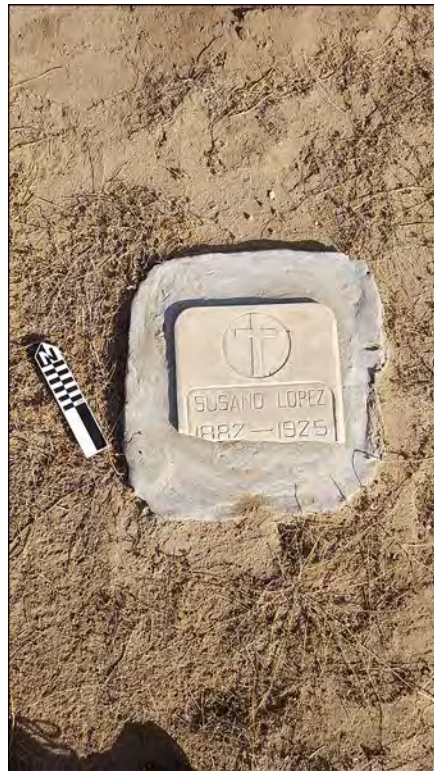
Feature PD: 533

Damage type(s): fragmentation—loss

This grave is marked by a broken white marble headstone that has been inset into concrete, creating a lawn-style monument. The headstone is broken in half, and the top half is present. The top of the headstone has rounded edges, a cross motif, and the following inscription: “SUSANO LOPEZ/1882–1925”.

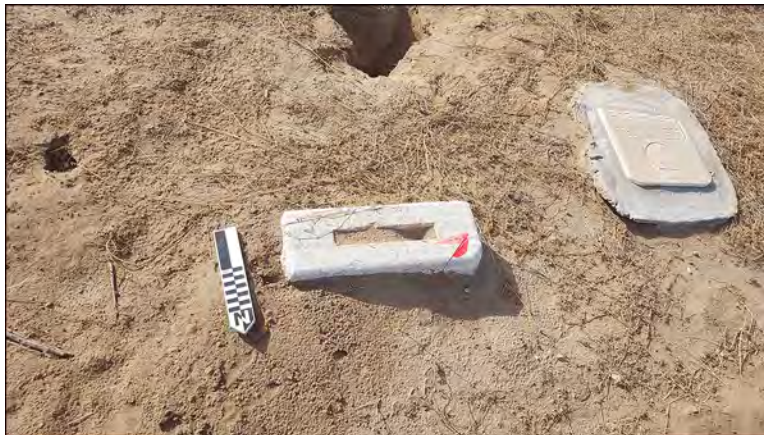
Feature PD: 535

Damage type(s): burrowing-animal disturbance, disassembled—loss, fragmentation—loss

This grave is marked by a granite base for a tab-in-socket-style grave marker. The headstone is missing. It is unclear whether the headstone was broken off or removed/disassembled. There is rodent-burrowing activity near the base, causing soil to build up on the northern and eastern sides of the base.

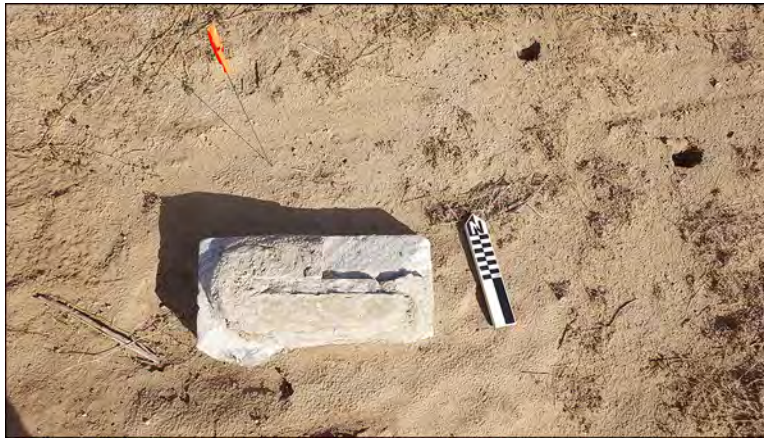
Feature PD: 537

Damage type(s): fragmentation—loss

This grave is marked with a tab-in-socket headstone. The headstone portion has fragmented off and is not present. The headstone and base appear to be composed of granite. The base is rectangular and has a chamfered edge. Approximately 75 percent of the concrete used to repair the headstone, or seal it to the base, is present.
