Archaeological Condition Assessment and Ground-Penetrating Radar (GPR) Surveys for Agua Mansa Cemetery, San Bernardino County, California

Technical Report 24-26
Statistical Research, Inc.
Redlands, California

April 2024

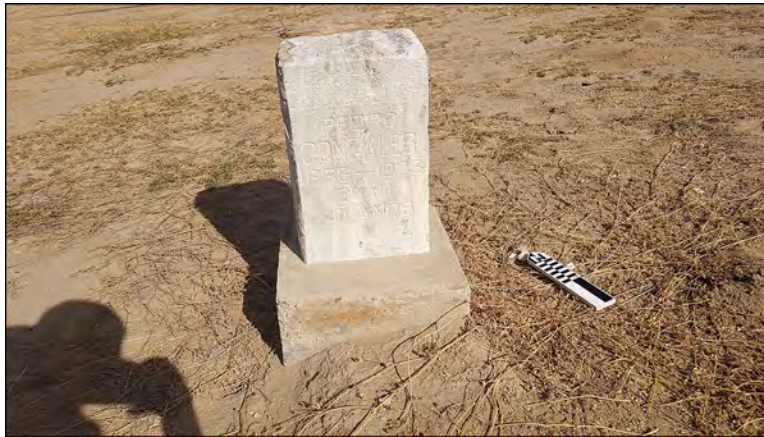
Feature PD: 539

Damage type(s): abrasion, fragmentation—loss, burrowing-animal disturbance

This grave is marked with a die-on-base headstone. The headstone is composed of granite, is squared, and has fragmentary loss on the top left, having been repaired with hard cement. There is possible mower-abrasion damage on the front-left corner of the concrete base. The top portion of the headstone has a clear line where the upper portion was unpolished. The plan view of the headstone is decorated with a cross motif. On the face of the headstone is the following inscription:

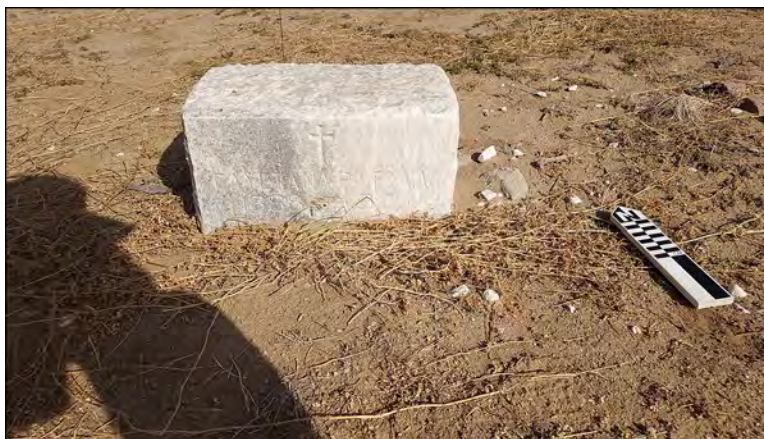
Feature PD: 541

Damage type(s): buried/sunk

This grave is marked with a rectangular shaped, block-style granite headstone. The front facing panel is smooth, and the other sides and top of the headstone are rock pitched. The headstone has a cross motif on the front, above the inscription. On the face of the headstone is the following inscription: “CAYETANA P LEYVA/1888–1925”.

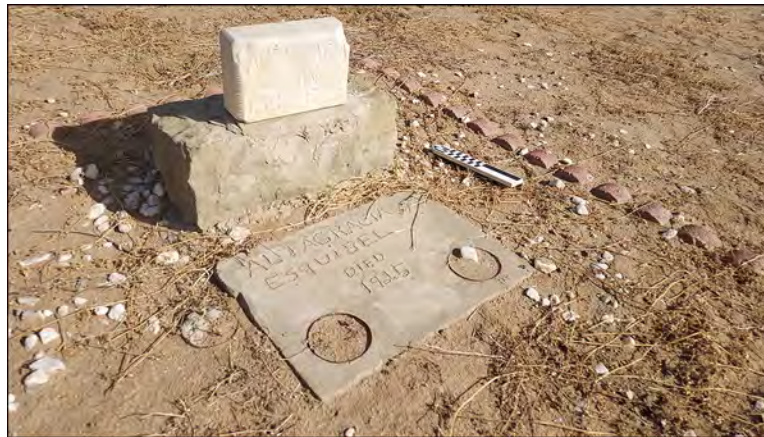
Feature PD: 543/545

Damage type(s): fragmentation—loss, abrasion, spalling

This grave is marked with an original tab-in-socket or die-on-base monument type, and a replacement headstone turned the monument into a die-on-base type. The headstone is composed of marble and has a chamfered edge around the front, with a linear pattern etched in. The base is composed of sandstone, is rock pitched, and shows signs of fragmentation and loss of the original headstone. There is cement/mortar visible on the base, possibly securing the new, marble headstone in place. There are also signs of cement/mortar on the front corner of the base, possibly where they were used to repair some spalling or breakage. The grave plot has modern red, scalloped concrete edger coping (Feature 545) around the boundary. There is a small, square cement ledger laid in front of the headstone and base. The ledger has two flower vases/holders, one at each of the bottom corners, and a third is outside and to the left of the ledger but still within the plot. The ledger has possible mower abrasion on the left edge. It looks original and has the inscription, “ALTAGRACIA/ESQUIBEL/DIED/1925”. Within the grave boundary is crushed granite scattered atop the grave.

The headstone atop the base is newer than the original and has beveled coping with a line pattern along the edges. The headstone has fragmentation/loss of the top front corners. This headstone is composed of marble and is inscribed, “ALTAGRACIA/MARTINES/1889–1925”.

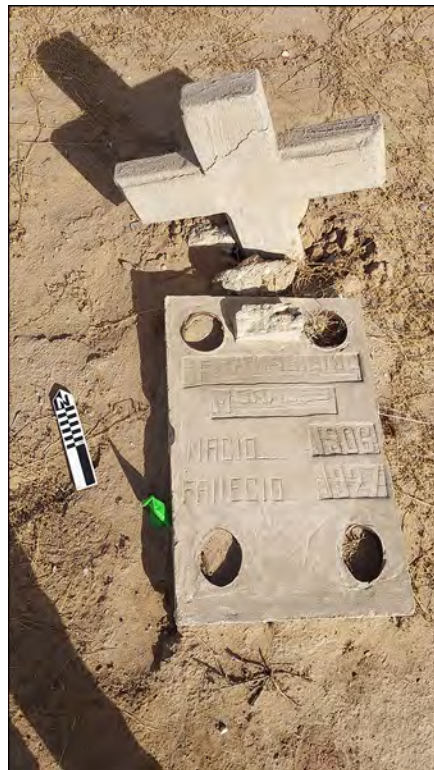
Feature PD: 547

Damage type(s): cracked, fragmentation—loss, abrasion, burrowing-animal disturbance

This grave is marked with a cross and a small, rectangular block. The cross and block are both composed of concrete. The inscribed name and dates look as though they had been stamped into the concrete. The block contains four metal-lined holes, one in each corner, for flowers or candles. The cross has been broken off but remains propped up with rocks, next to the block. It appears to have a chamfered edge. There is cracking present in the cross monument and possible mower abrasion damage on the left edge of the block. There is animal burrowing along the left side of the block. The block is inscribed, “ТRАИqUIЛИО [sic]/MORALES/NACIO 1906/FALLECIO 1927”.

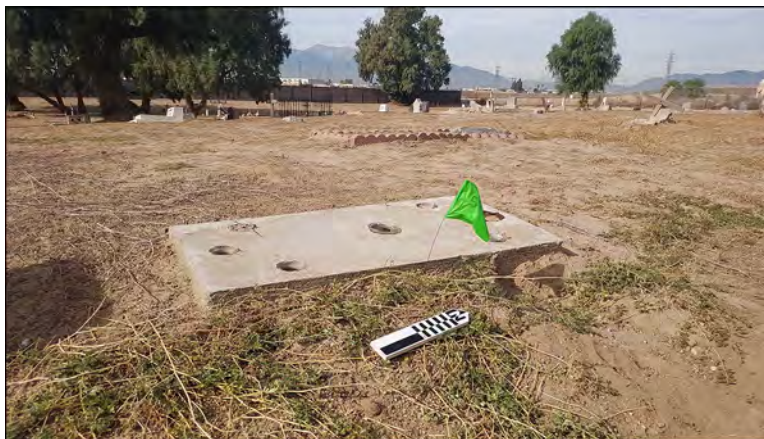
Feature PD: 549

Damage type(s): fragmentation—loss, burrowing-animal disturbance

This grave is marked with a rectangular ledger with no inscription present. The ledger is composed of granite and contains six glass-lined holes and one metal-lined hole for flowers or candles. The ledger is intact, but the glass is broken, and the metal is bent and rusted. There is animal burrowing along the right edge of the ledger.

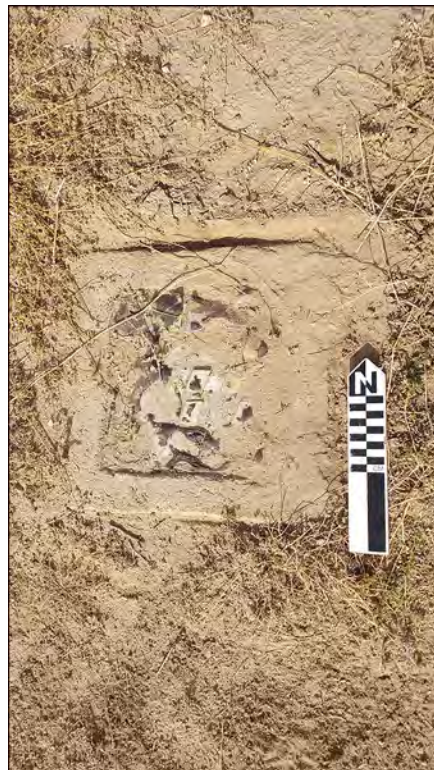
Feature PD: 552

Damage type(s): fragmentation—loss

This plot is marked by a square lawn-style marker created from concrete. The concrete base has several parallelogram-shaped metal plates epoxied to the surface. The epoxy is amber in color. The tiles are broken, and the epoxy is deformed from environmental factors. This marker was possibly for a family plot or section. This headstone is similar to Feature 558.

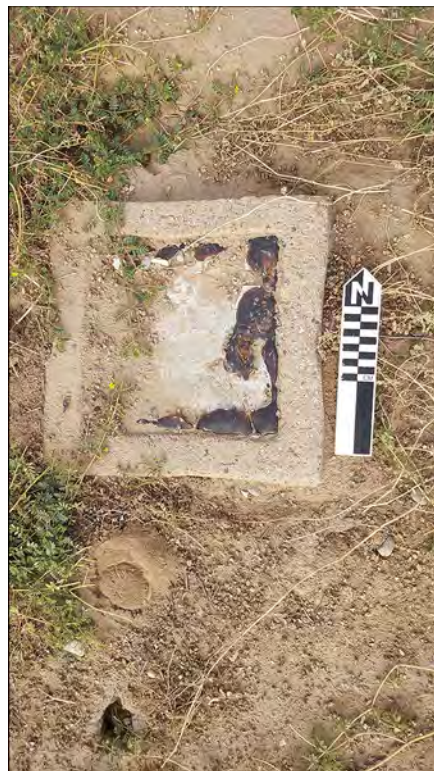
Feature PD: 558

Damage type(s): fragmentation—loss, bowed, abrasion

This plot is marked by a square lawn-style marker created from concrete. The concrete base has several parallelogram-shaped metal plates epoxied to the surface. The epoxy is amber in color. The tiles are broken, and the epoxy is deformed from environmental factors. This marker was possibly a marker for a family plot or section. The edges of the square seem bowed in a little. There is possible mowing-abrasion damage around the edge of the marker. This marker is similar to Feature 552.

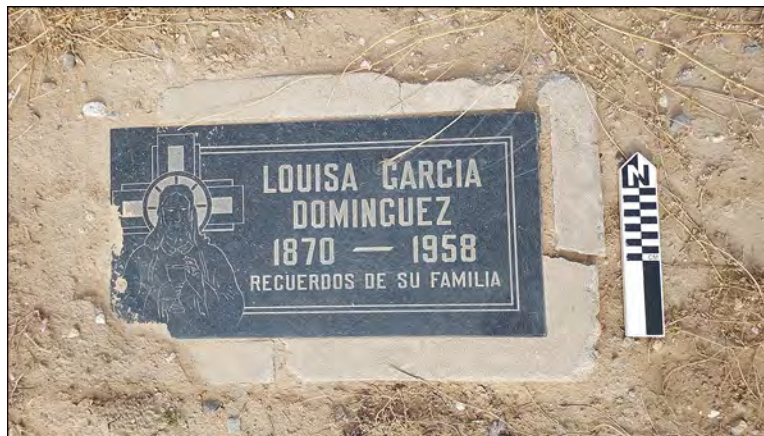
Feature PD: 560

Damage type(s): cracked, fragmentation—no loss, abrasion

This grave is marked with a lawn-style marker composed of a concrete block with a black marble inset. The headstone has a cross and a depiction of Jesus holding the holy chalice on the left side of the marble insert next to the name and date. The concrete border surrounding the marble insert is cracked in a few places, in addition to possible abrasion damage on the edges. The marker is inscribed as follows:

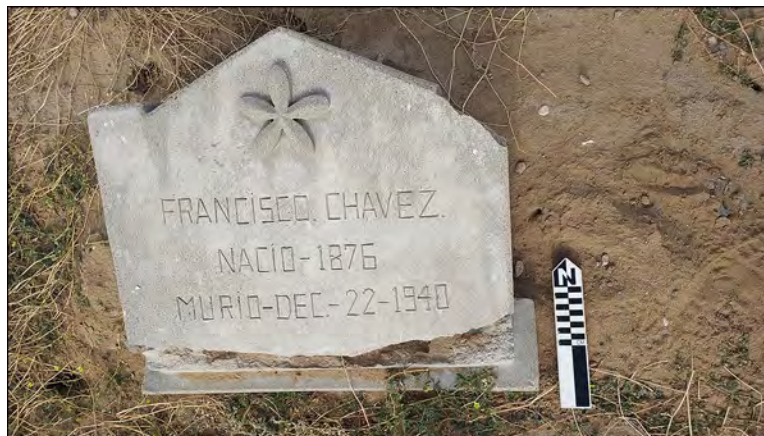
Feature PD: 562

Damage type(s): fragmentation—loss, fragmentation—no loss, burrowing-animal disturbance, cracked, buried/sunk

This grave is marked with a headstone in a socket that is shaped with a pointed arch and caps. The headstone, base, and ledger are all composed of concrete. The headstone appears to be original. The top-right corner of the headstone has been fragmented and lost. The headstone has fractured off from the base and is currently propped up with a two-by-four and leaning. Behind the leaning headstone, there is animal-burrowing activity present. The ledger is fragmented and is sinking. At the top of the ledger is a collection of nonnative rocks surrounded by artificial flowers. The headstone has a flower motif at the top and is inscribed as follows:

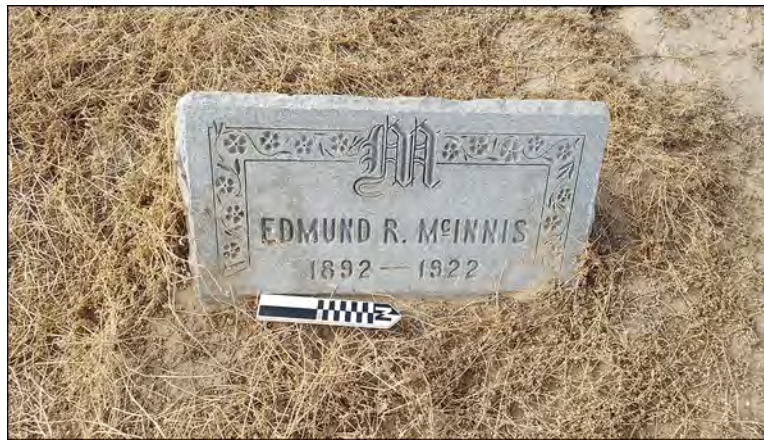
Feature PD: 566

Damage type(s): tilted/fallen, buried/sunk

This grave is marked with a marble slant marker. The front is smooth, and the sides are rock pitched. The headstone is modern and shows signs of tilting or minor sinking on the right side. It has a floral/vine motif on the border and an “M” at the top. This headstone is the only headstone in the cemetery that is oriented facing west. It is inscribed, “EDMUND R. M^CINNIS/1892–1922”.

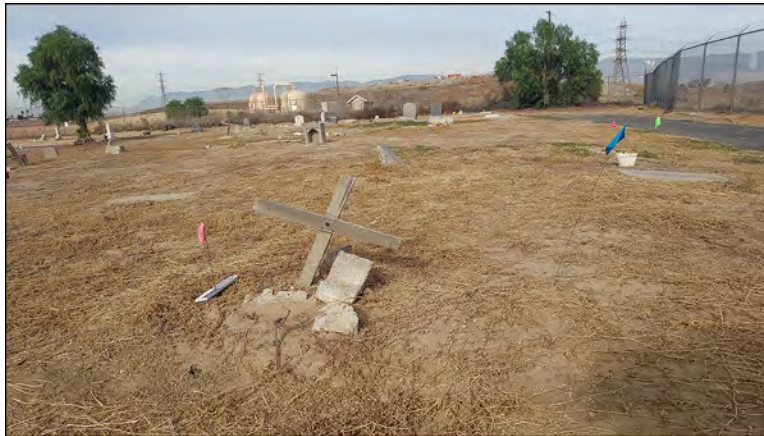
Feature PD: 568

Damage type(s): fragmentation—loss, fragmentation—no loss, tilted/fallen, buried/sunk

This grave is marked with a fragmented cinder block and a wooden cross. The cinder block is broken into several pieces. The cross is slanted and sinking into the ground. There is a possible fragment of the bottom of the original headstone, broken, at the surface level. There is metal hardware sticking out of the center of this fragment, within the ground. No inscriptions are present at this grave.

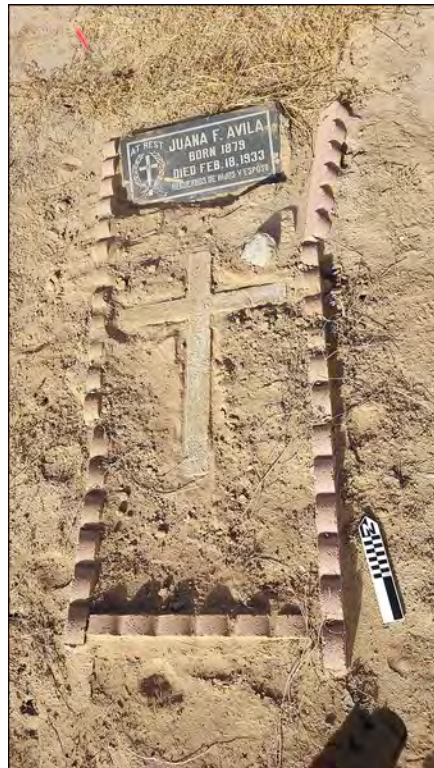
Feature PD: 570

Damage type(s): burrowing-animal disturbance, buried/sunk

This grave is marked with a black marble lawn-style monument and red, scallop-shaped-concrete edger coping (Feature 572) around the boundary. The monument is sinking into the ground. The scalloped coping is disturbed from natural ground adjustments; some are leaning, and others are almost covered in soil. There is a cement cross laid in the center of the grave, in good condition. The monument is decorated with cross and wreath-and-bow motifs and “AT REST” above the cross. The monument is inscribed as follows:

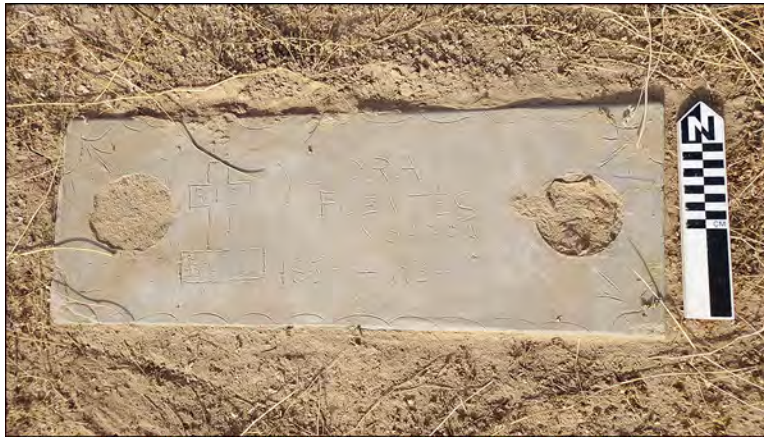
This grave is marked with a small, rectangular block composed of cement. The block has two holes for flowers or candles, one each on the left and right of the inscription. The block has no apparent signs of damage. The block has a hand-drawn scalloped design around the edge and corners and the motif of a cross and a block base on the left. The inscription reads as follows:

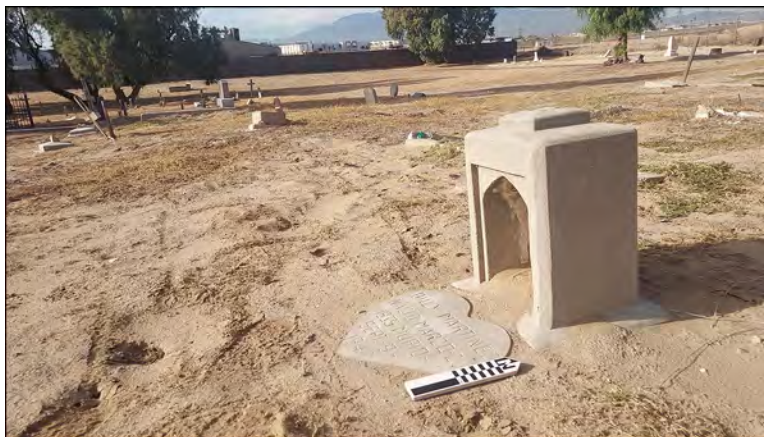
Feature PD: 576

Damage type(s): fragmentation—loss

This grave is marked by a heart-shaped cement block and a small cement shrine. The shrine is missing the ornament that goes atop the shrine, possibly a cross. The shrine has a pointed-arch opening with chamfered edges along the corners. The alcove appears to be used for housing flowers, candles, or a small statue. The heart-shaped block is similar to that of Feature 619 and is inscribed as follows:

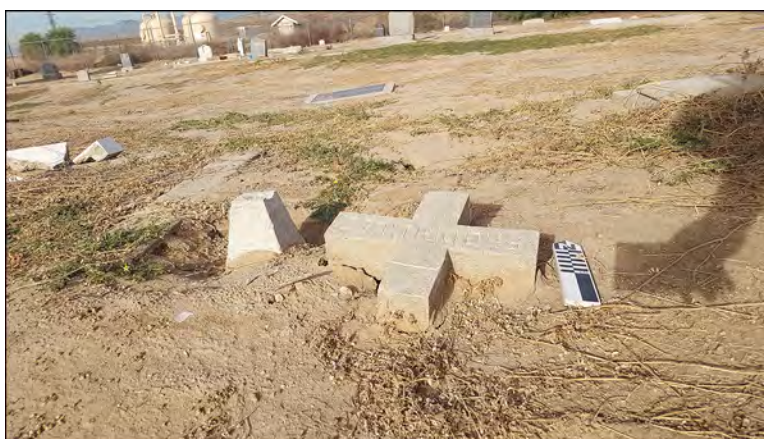
Feature PD: 580

Damage type(s): burrowing-animal disturbance, fragmentation—no loss

This grave is marked by an obelisk-shaped concrete base and a concrete cross headstone. The cross is broken from the base, but the two pieces apparently do not go together, because the sizes do not match. There is animal-burrow activity near the cross and base. The cross is inscribed, "F. RODRIGUEZ".

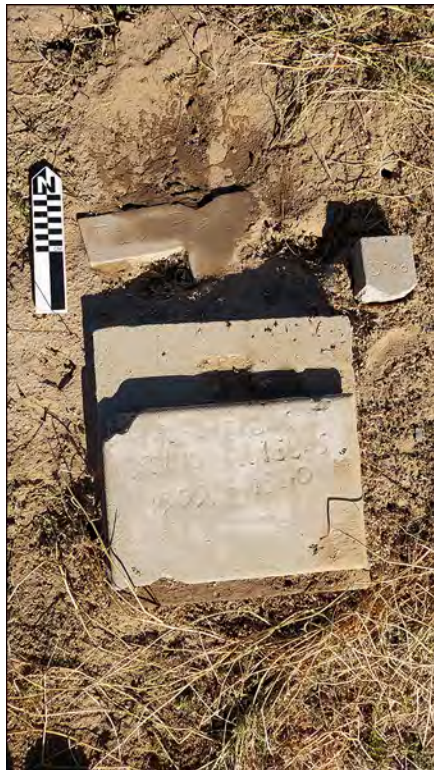
Feature PD: 582

Damage type(s): fragmentation—loss, abrasion, tilted/fallen

This grave is marked with a cement die lying flat on a base, and a cross. The cross is broken off the base and fragmented in two pieces. Two larger fragments of the cross are north of the base. One fragment is inscribed “Died”, and the larger piece is inscribed, “Paul P. AGU[. ..]”. The headstone has fragments broken off from along the edge, possibly from abrasion. The headstone is inscribed as follows:

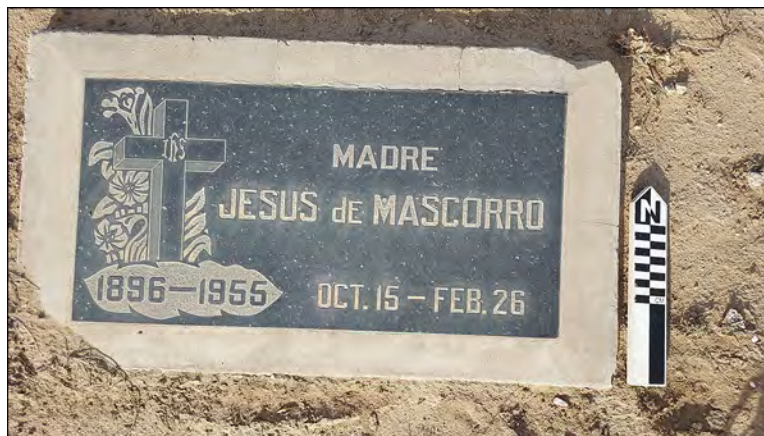
Feature PD: 584

Damage type(s): buried/sunk, spalling, fragmentation—loss

This grave is marked by a modern cement base with a black marble inset. The headstone has spalling around the border, along the edge. The left corner appears to be sinking slightly into the ground. There is a floral motif with a cross inscribed “Is” and the dates “1896–1955” inscribed beneath the cross, on the left side of the headstone. The right side of the headstone is inscribed as follows:

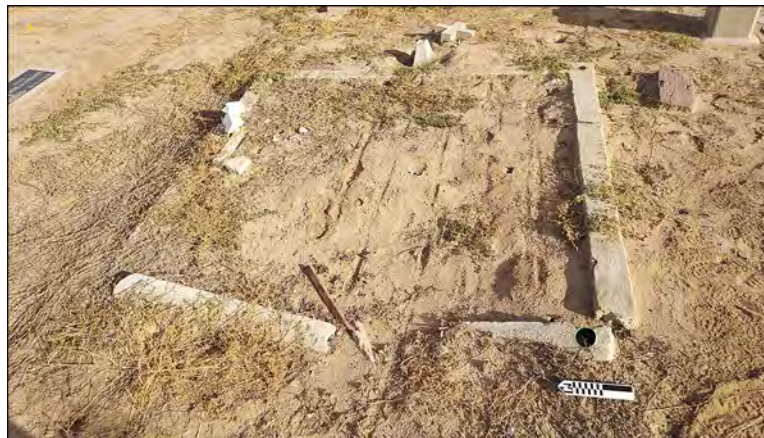
Feature PD: 586

Damage type(s): fragmentation—loss, buried/sunk, cracked, abrasion, burrowing-animal disturbance

This grave is marked with the bottom portion of a headstone; concrete coping surrounds the grave. The headstone has been broken at almost surface level, and two pieces of rebar stick out. There are a few fragmentary pieces adjacent to the headstone. The headstone is painted white, and the inscription at the bottom of the headstone is painted in black and reads, "RDO. DE. JOE. E. AGUILERA." The concrete coping is fractured, uneven, sinking in some areas, and covered in vegetation on another side. The coping has ceramic vases in three of the four corners. Two vases are yellow, and one is green. The fourth vase has been buried. One piece of metal rebar is between two fragments of coping, and its use or purpose is unclear. There is animal burrowing in the grave plot.

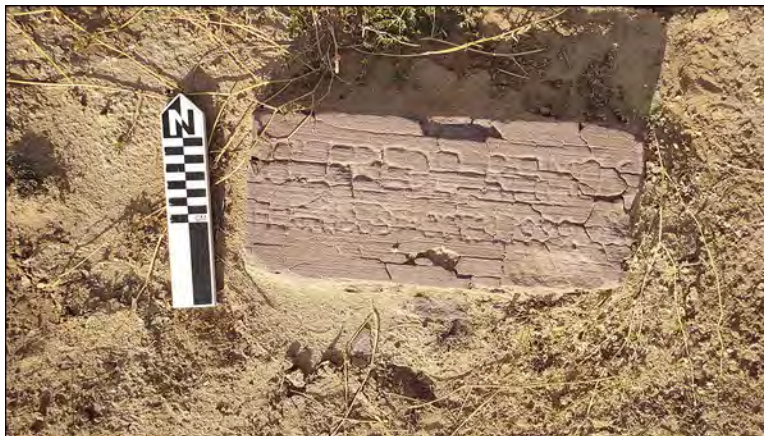
Feature PD: 588

Damage type(s): erosion, fragmentation—loss, cracked

This grave is marked with a brown or red sandstone block marker. The block is heavily worn, and the inscription is very faint. The block itself is inset into the ground and cracked all throughout. A few pieces have been broken off. The inscription reads as follows:

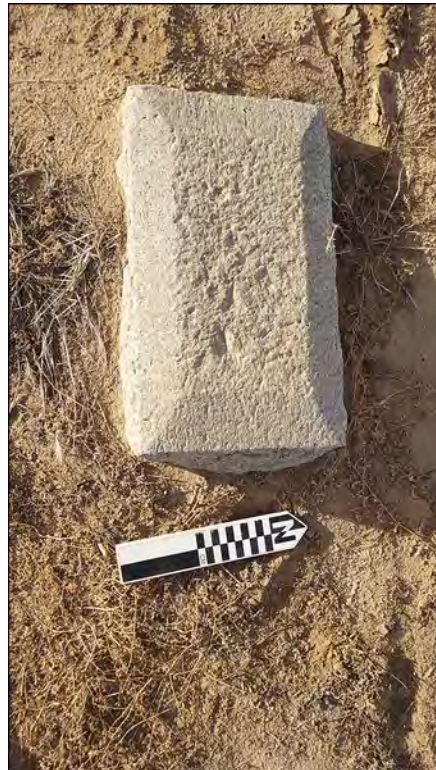
Feature PD: 590

Damage type(s): disassembled—loss

This grave is marked by a granite base without a headstone. The base has a chamfered edge along the top. No inscriptions are present on the base.

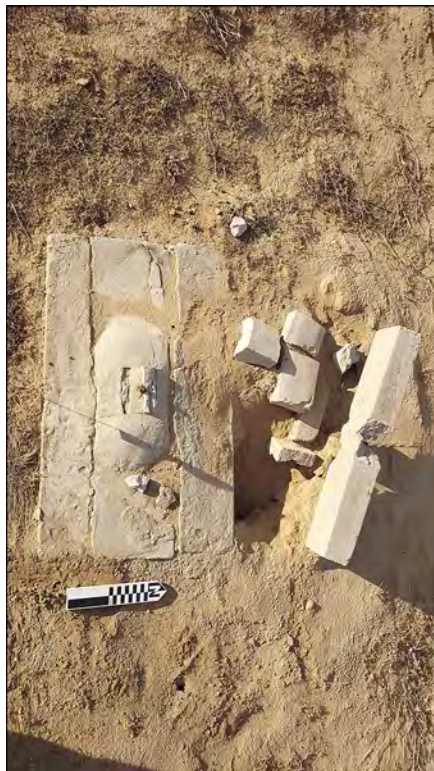
Feature PD: 592

Damage type(s): fragmentation—loss, cracked, burrowing-animal disturbance

This grave is marked by a concrete cross set in a rectangular concrete base. The cross has broken off from the base and is in seven pieces to the north of the base. The base has a twisted steel bar to reinforce the cross. There is rodent-burrowing activity under the base, and the base is cracked. No inscriptions were visible.

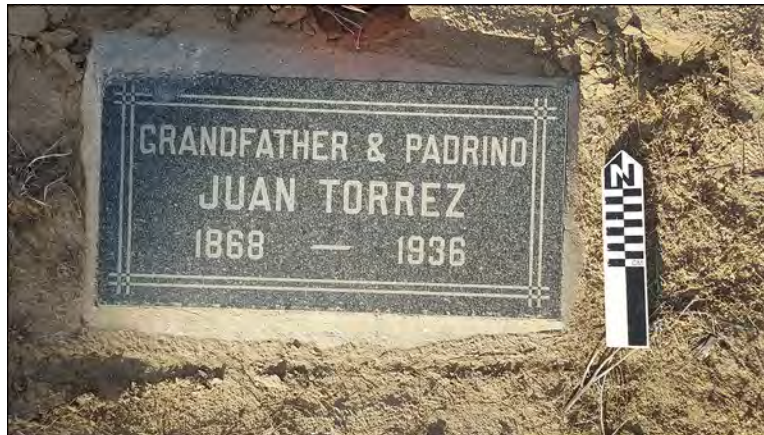
Feature PD: 594

Damage type(s): buried/sunk, fragmentation—loss

This grave is marked with a lawn-style marker composed of a concrete block with a black marble inset. The headstone is sinking slightly into the ground, and the top-left corner is fragmented. There is a metal bucket with the remains of flowers just north of the grave. The inset has a lined border and is inscribed as follows:

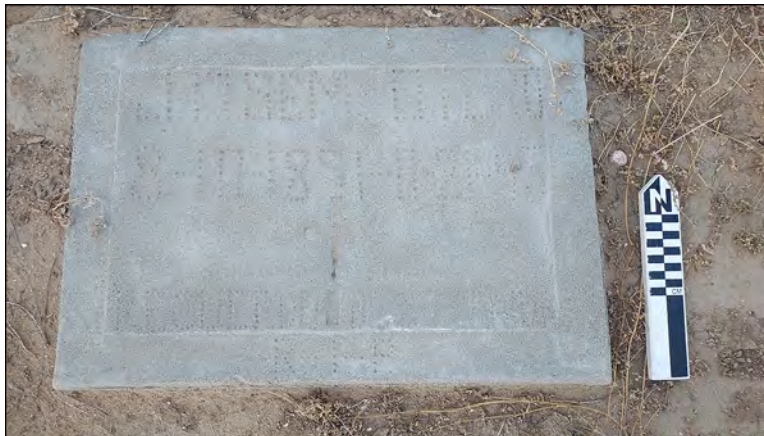
Feature PD: 596

Damage type(s): spalling

This grave is marked by a lawn-style marker with an inscription created through a dotting technique. There is a crucifix motif in the center of the inscription and minor spalling on the edges of the marker. This grave marker is similar to Feature 641. The inscription reads as follows:

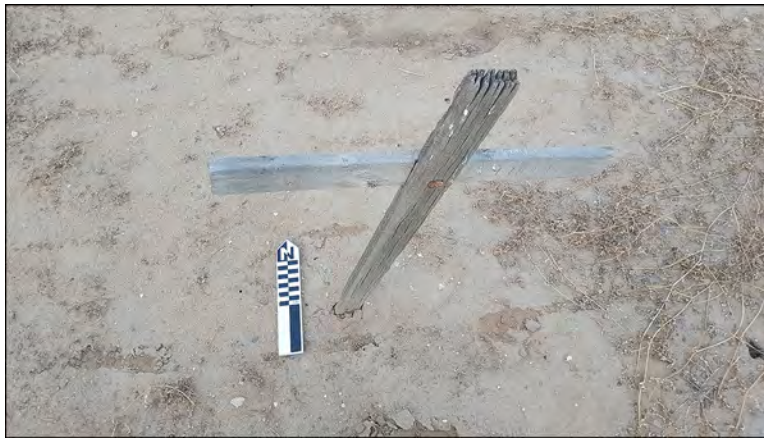
Feature PD: 598

Damage type(s): erosion

This grave is marked by a wooden cross held together with a screw. The wood has become weathered, and the inscription is difficult to read. The cross is inscribed, "PATRICK LI[. ..]".

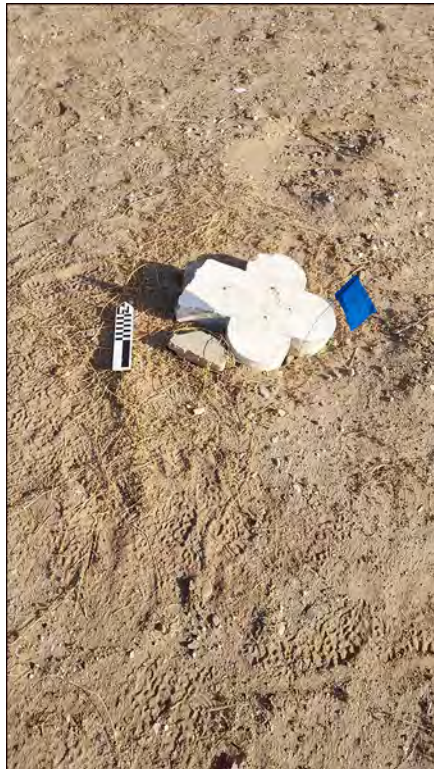
Feature PD: 603

Damage type(s): fragmentation—loss, disassembled—loss

This grave is marked by the top fragment of a concrete cross lying on the surface. The cross had an ornate cross attached, but it has since been removed or lost. There are no inscriptions present on the cross.

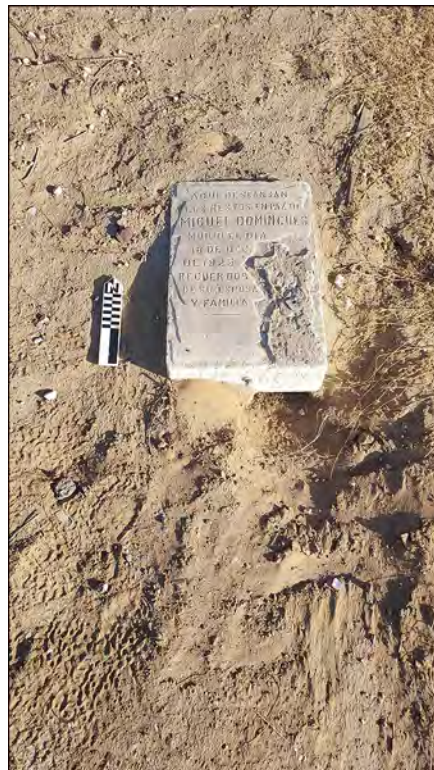
Feature PD: 605

Damage type(s): fragmentation—loss, burrowing-animal disturbance

This grave is marked by a marble headstone lying flat on the surface. The headstone appears to have had a decoration that has broken off. The headstone has a tablet appearance with a jagged edge design and the appearance of nails holding it onto the main stone. There is animal-burrowing disturbance beneath the stone. The stone is inscribed as follows:

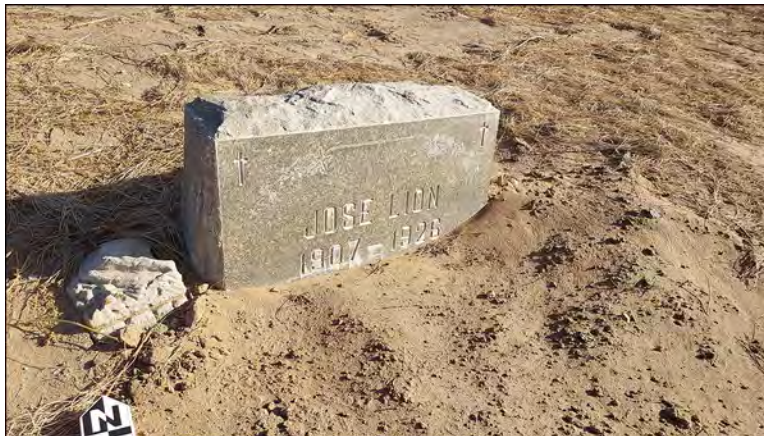
Feature PD: 607

Damage type(s): buried/sunk, fragmentation—loss

This grave is marked by a marble headstone that is sinking into the ground. There might be a possible base, but if so, it is unclear/not observable. There is a fragment of a statue or decoration of an angel adjacent to the headstone, but it is unclear whether it is directly associated with the grave. The headstone has two crosses, one in each of the top right and left corners, and an ornate flower inscription across the top. The edges are rock pitched in style. The inscription reads, “JOSE LION/1907–1926”.

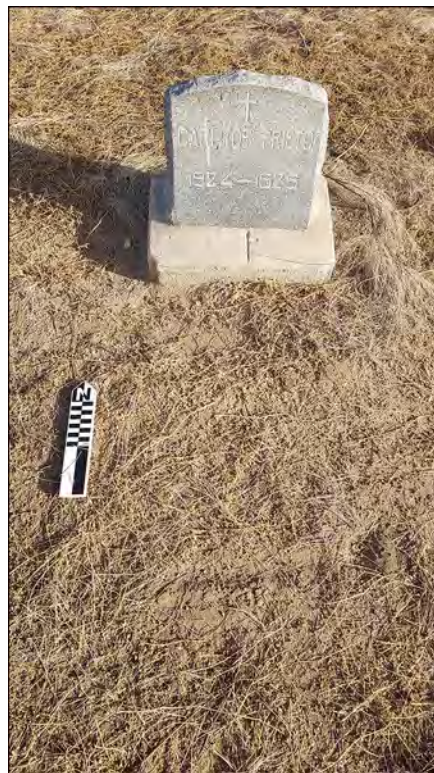
Feature PD: 609

Damage type(s): abrasion

This grave is marked by a marble headstone on top of a concrete base. The concrete base has chamfered edges along the corners, a cross motif inscribed in the front/center, and two fern impressions on the front corners. The marble slab has a basket-arch shape across the top and an abrasion mark across the inscribed “R”. The headstone is thicker at the bottom, almost giving a plaque-marker shape. This grave is similar to Feature 611. The headstone is inscribed with a cross along the top and the following: “CARLITOS PRIETO/1924–1926”.

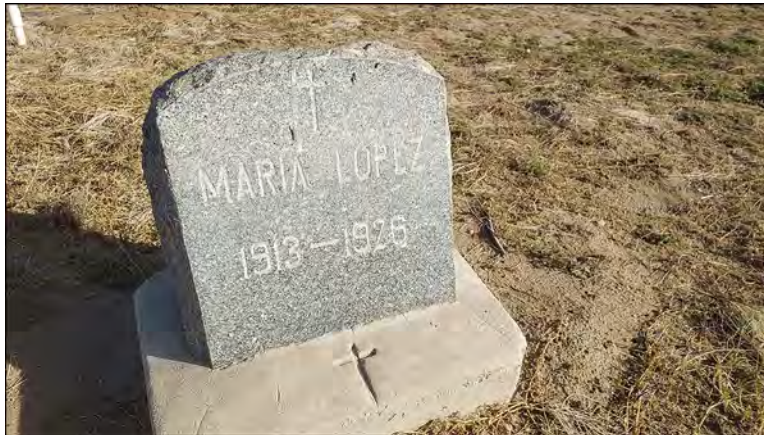
Feature PD: 611

Damage type(s): none

This grave is marked by a marble headstone on top of a concrete base. The concrete base has chamfered edges along the corners, a cross motif inscribed in the front/center, and two fern impressions on the front corners. The cross at the top appears to have been stamped twice. The marble slab has a basket-arch shape across the top. The headstone is thicker at the bottom, almost giving a plaque-marker shape. This grave is similar to Feature 609. The headstone is inscribed with a cross along the top and the following: “MARIA LOPEZ/1913–1926”.

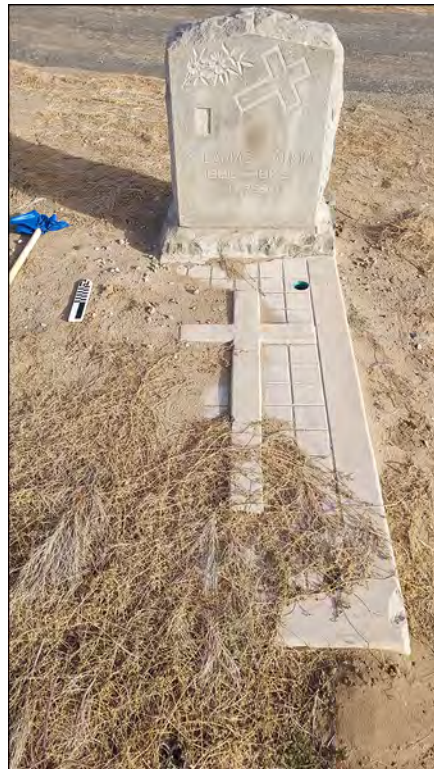
Feature PD: 613

Damage type(s): buried/sunk, fragmentation—loss

This grave is marked by a granite headstone and base with a concrete ledger. The ledger has a tiled pattern and a large cross. It is sinking into the ground and has a piece chipped off the right side, and it has a blue vase at each of the top- and lower-right corners. The bottom-left portion of the ledger is covered in soil. It is similar to Feature 617. The marble headstone is rock pitched around the edges and top and is in a pointed-arch shape. It has a flower motif and a sideways cross inscribed across the top. There is a slot for a photo in the headstone, below the imagery and above the name inscription. The headstone is inscribed, “ZACARIAS GARSIA/1896–1926/AT REST”.

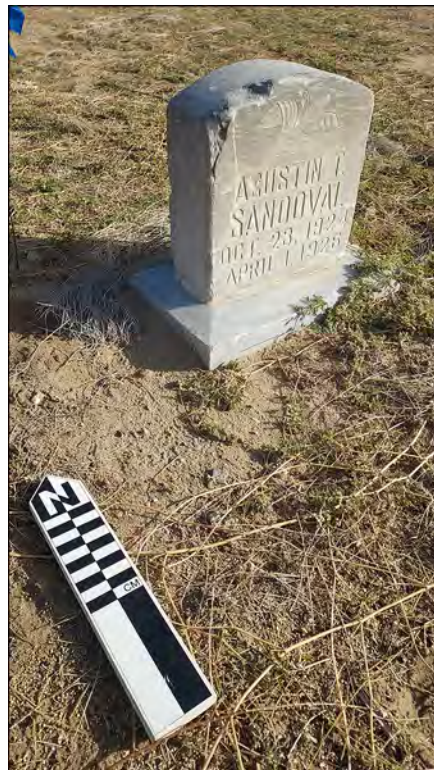
Feature PD: 615

Damage type(s): fragmentation—loss, abrasion

This grave is marked by a marble headstone on a marble base. The base has missing corners that have been fractured off, possibly from mowing. There are abrasions across the headstone and fragmented pieces missing from the upper-left edge. The headstone has a basket-shape arch across the top, where the fragments have broken off. There has been some erosion or fragmentation of the “G” in the inscription. The headstone has a lily of the valley inscribed at the top, above the following:

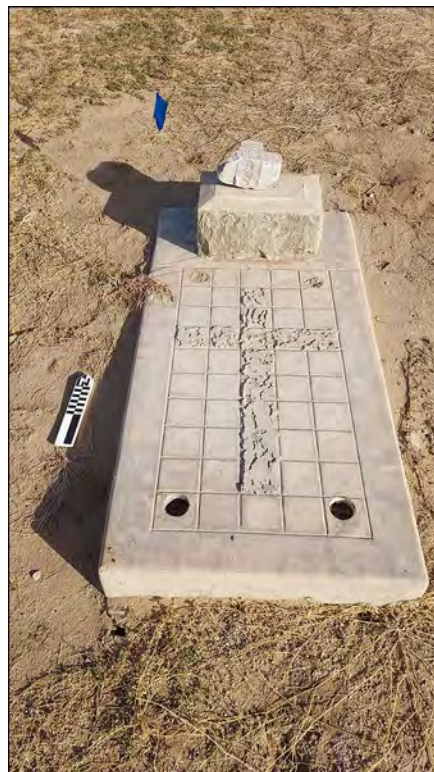
Feature PD: 617

Damage type(s): fragmentation—loss, burrowing-animal disturbance

This grave is marked by a granite base, without the headstone, on top of a concrete ledger. The ledger has a tiled pattern with a large cross in the center. The cross's condition indicates that a cross was likely glued onto the concrete and then removed. There is a hole in each corner of the ledger for a candle or flowers. The granite base is rock pitched on the sides and has chamfered edging around the top. There is cement residue on the top of the base and a chunk of a marble cross the headstone, sitting atop the base, although it is unclear whether this is associated with the burial or not. The marble cross fragment is inscribed with "[. . .]ANCISCO/MESA".

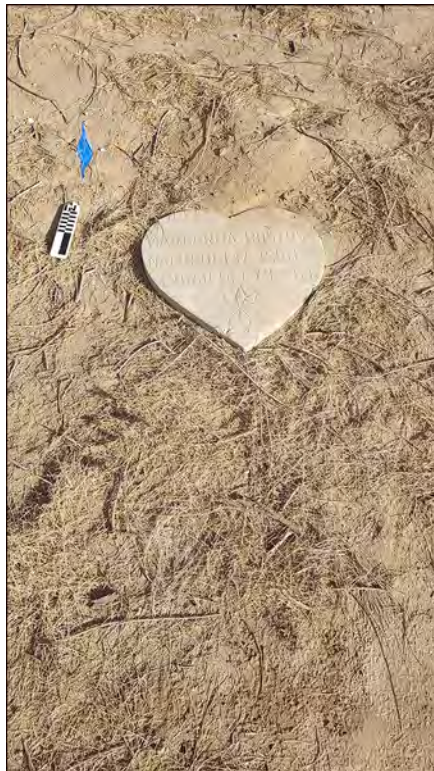
Feature PD: 619

Damage type(s): spalling

This grave is marked by a heart-shaped block that is flat against the ground. The block is concrete and has minor spalling to the southern edges. The stone is inscribed as follows:

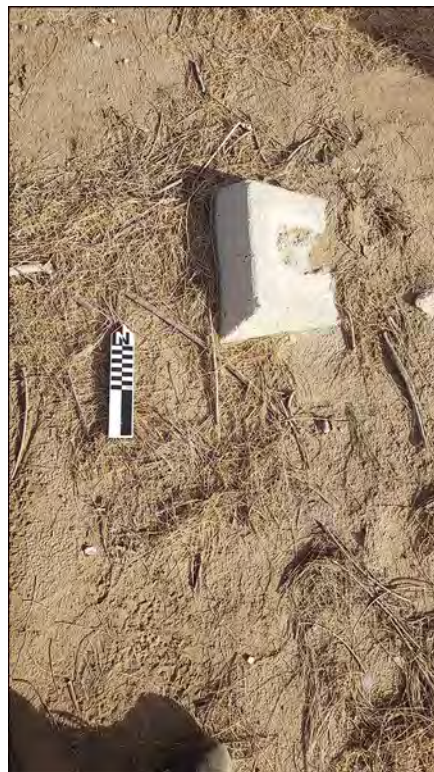
Feature PD: 621

Damage type(s): fragmentation—loss, buried/sunk

This grave is marked by a partially buried trapezoidal concrete base with a circular hole on the top. No inscriptions were identified.

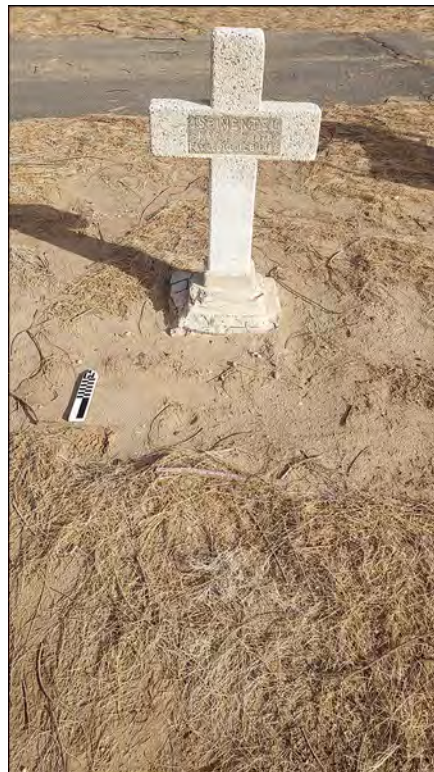
Feature PD: 623

Damage type(s): buried/sunk, tilted/fallen, fragmentation—loss, cracked

This grave is marked by a concrete cross on a concrete base. The cross is decorated with sand and white stone embedded in the concrete. The base is cracking and fragmented. It is inscribed with “[. . .]DICADO PO[. . .]”, with the other letters broken away. The base is sinking and tilted. The cross is inscribed as follows:

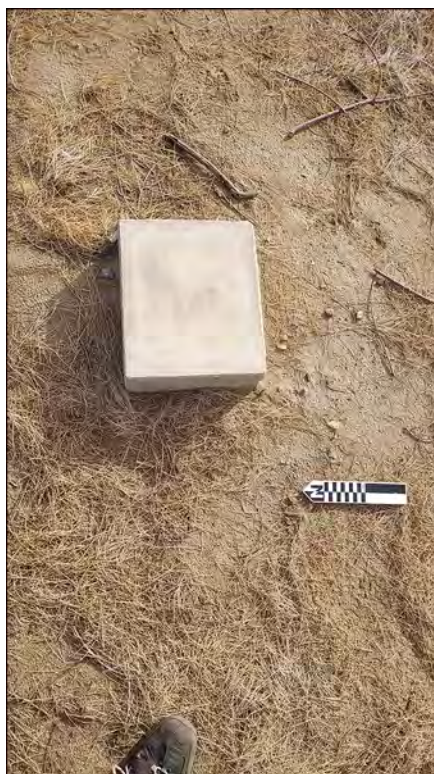
Feature PD: 625

Damage type(s): disassembled—loss

This grave is marked by a concrete block missing the headstone or marker, which would have been cemented to the squared base. There is a shadow of where the previous marker sat, but no remains of the marker are present.

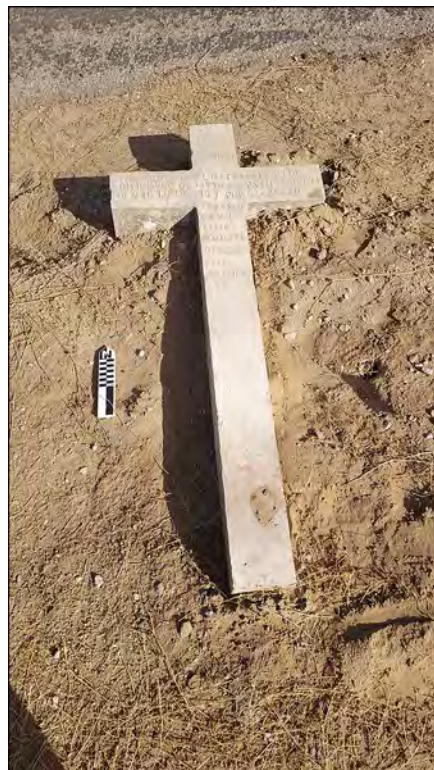
Feature PD: 627

Damage type(s): tilted/fallen, spalling

This grave is marked by a concrete cross monument that has fallen over. The cross is in good condition and has minimal spalling on the edges. The cross is inscribed as follows:

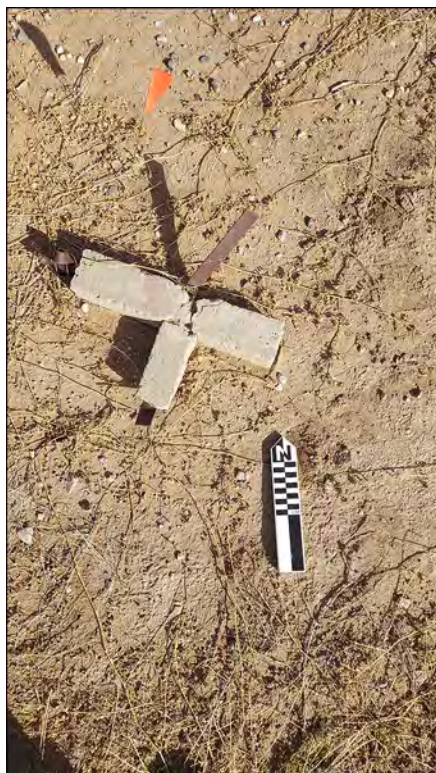
Feature PD: 629

Damage type(s): fragmentation—loss, tilted/fallen

This grave is marked by a concrete cross monument. The cross has been broken into pieces, and flat steel bars for reinforcement are visible. The cross has fallen over, and one remaining metal piece stands upright. There is no inscription on the monument fragments.

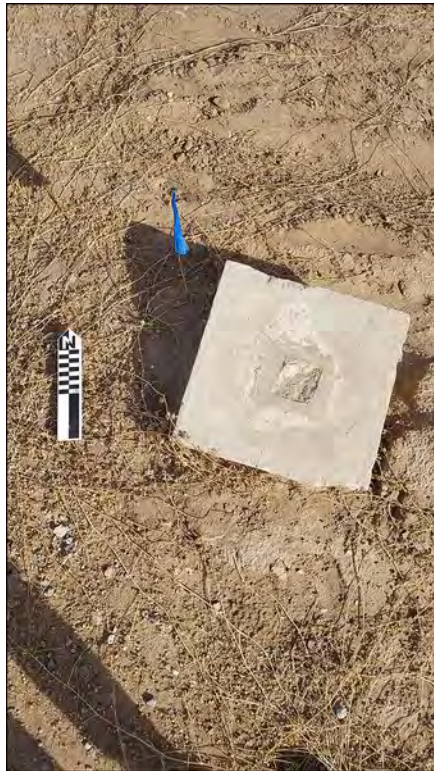
Feature PD: 631

Damage type(s): fragmentation—loss, buried/sunk, burrowing-animal disturbance

This grave is marked by a concrete base with a square-shaped hole in the center. The hole was likely for a cross. A few chips are broken off the edges of the base, and the base appears to be sinking slightly. There is animal burrowing at the eastern edge of the monument base.

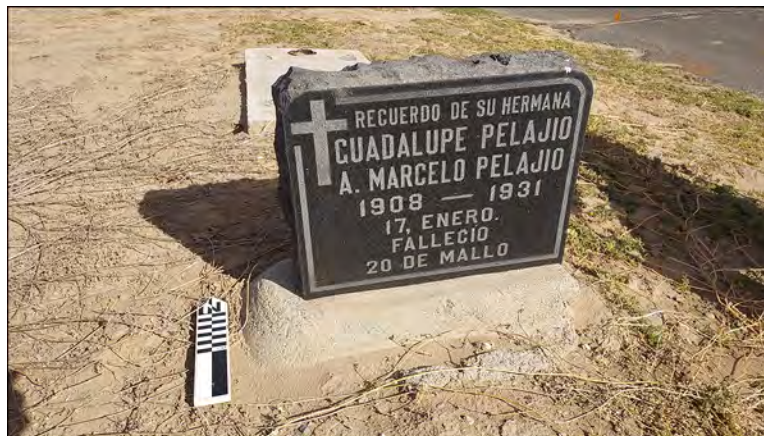
Feature PD: 633

Damage type(s): fragmentation—loss, ground loss

This grave is marked by a black marble headstone on a concrete base. The concrete base has a rounded edge on the top. The foundation of the base is exposed in the front as a result of ground loss on the southern side. The black marble headstone is rock pitched along the edges and has rounded corners on the top. There is a line inscribed around the edge of the headstone and a cross motif in the upper-left corner. The headstone is inscribed as follows:

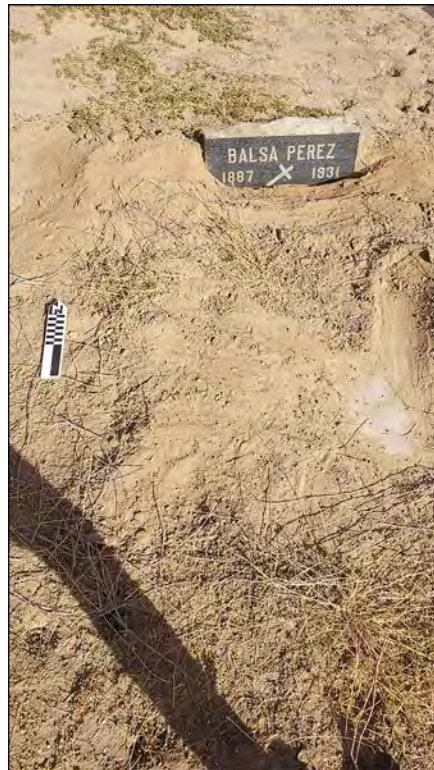
Feature PD: 635

Damage type(s): buried/sunk, fragmentation—loss

This grave is marked by a black marble headstone and concrete ledger. The concrete ledger is completely covered in soil. The marble headstone has a cement layer on the top edge, suggesting that something was once attached above it. The headstone is sinking into the ground and is engraved with “BALSA PEREZ/1887 [slanted cross motif] 1931”.

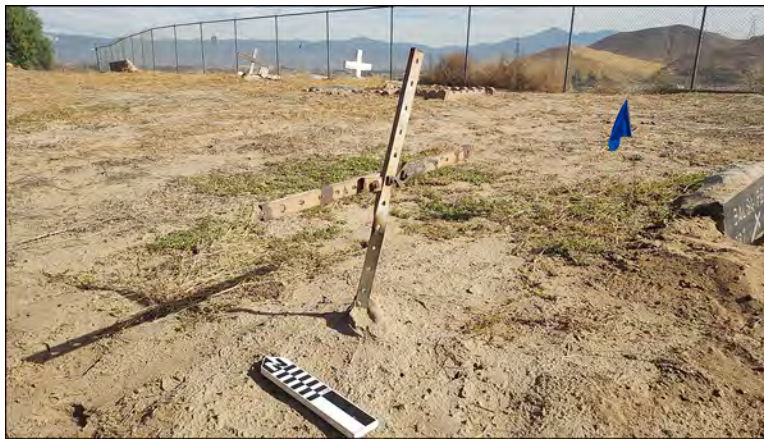
Feature PD: 637

Damage type(s): erosion

This grave is marked by a steel cross that is bent. The cross is held together with washers and screws and has two additional pieces of steel attached for an unknown reason.

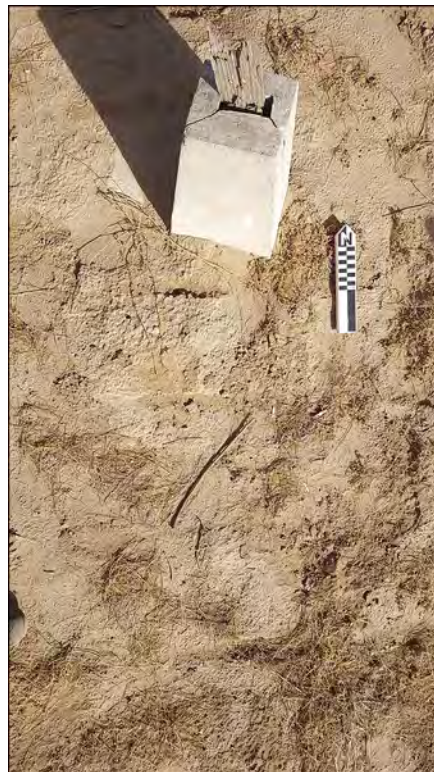
Feature PD: 639

Damage type(s): cracked, fragmentation—loss, erosion

This grave is marked by a concrete block with the distal end of a wooden cross inserted in the center. The block base is cracked, and the wooden cross is broken and weathered.

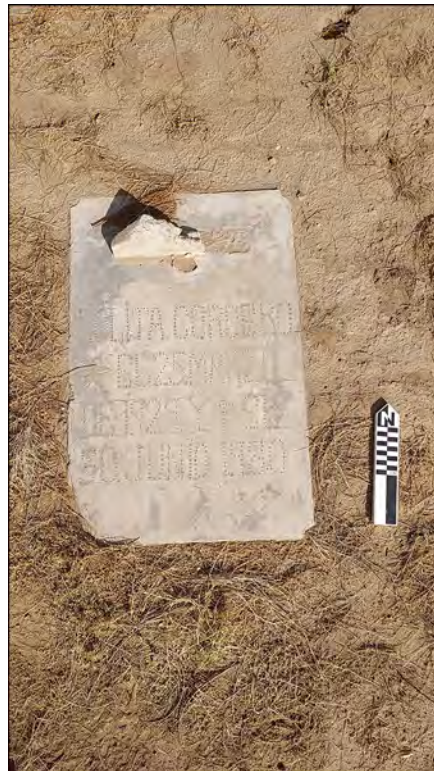
Feature PD: 641

Damage type(s): fragmentation—loss

This grave is marked by a tab-in-socket headstone and a small ledger. The headstone is fragmented and broken at the base. There is a flower or candle vase at the base of the headstone. The ledger has a rounded cut in the corners. The ledger was inscribed by using a dotting technique similar to that of Feature 596. The ledger is inscribed with a flower before the birthdate and a cross before the death date, as follows:

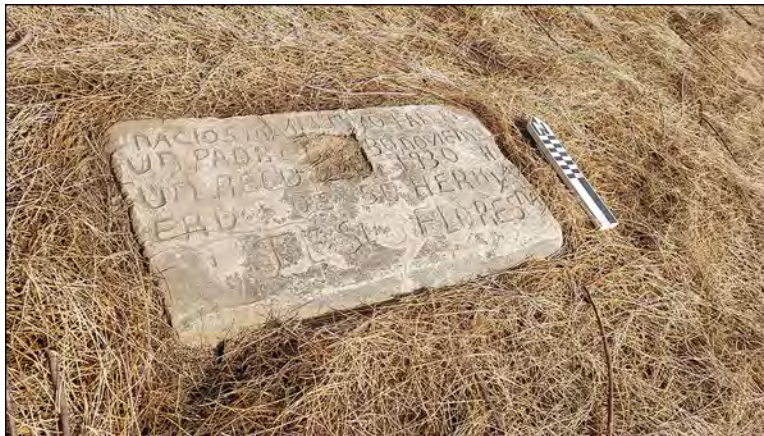
Feature PD: 645

Damage type(s): fragmentation—loss, cracked, buried/sunk

This grave is marked by a concrete ledger. The ledger has two white, circular, cement fragmented corners (a possible design feature). The ledger is sinking into the soil; it is cracked, and there are pieces missing from around the edges. The ledger has a cross motif under the inscription, which reads as follows:

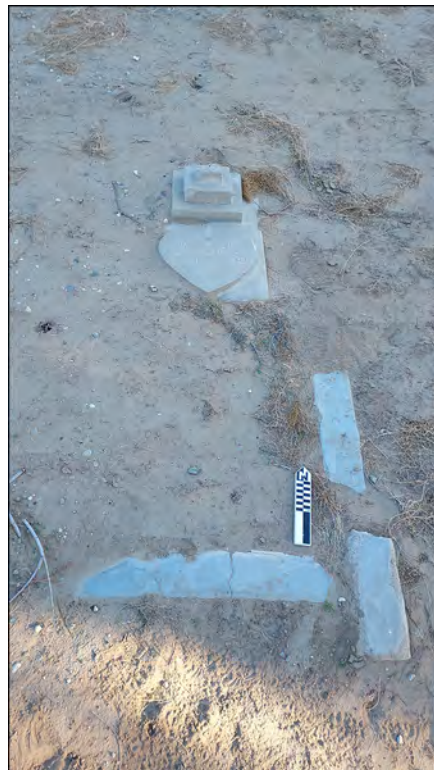
Feature PD: 688

Damage type(s): fragmentation—loss, cracked, buried/sunk

The grave features a base for a die-on-base-style monument that has been incorporated into a concrete curb that surrounds the grave. The headstone has been removed; so, there is no information on the individual buried in the grave. A concrete curb has been built around the perimeter of the grave, and the ends have been built onto the edges of the monument. The coping is cracked, and the western edge is starting to sink but is otherwise in good condition.

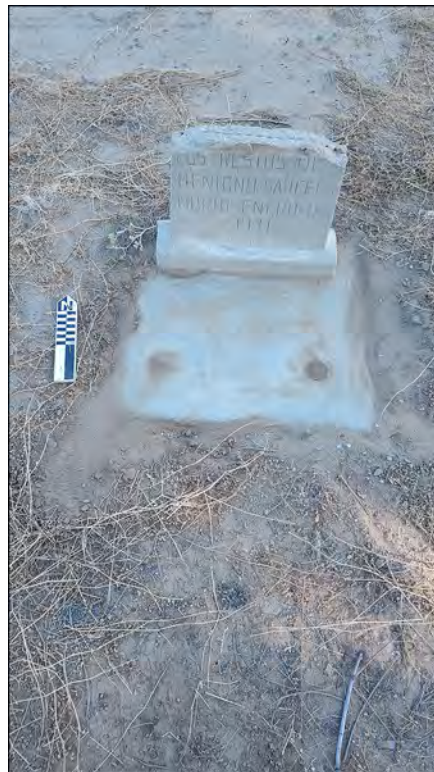
Feature PD: 701

Damage type(s): erosion

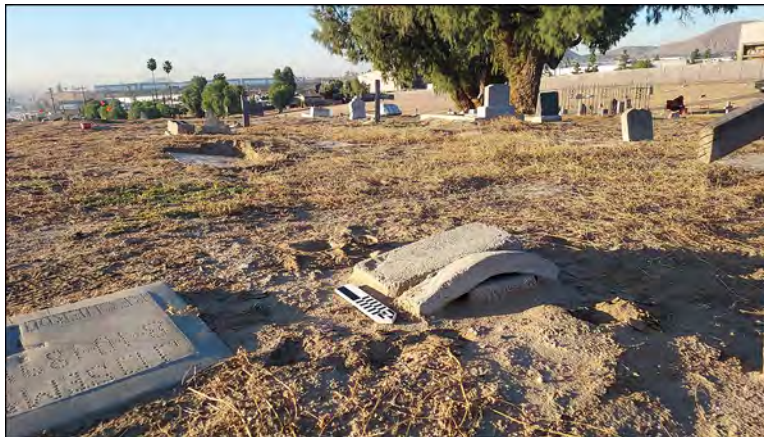
It is not clear whether this represents an intact monument. The monument consists of a rectangular concrete block with an arched piece of concrete on the northern side of the block. The block is weathered and has "LUCERO" written on it in green paint. There is a 4-inch-diameter metal cup/vase buried in front of the block.

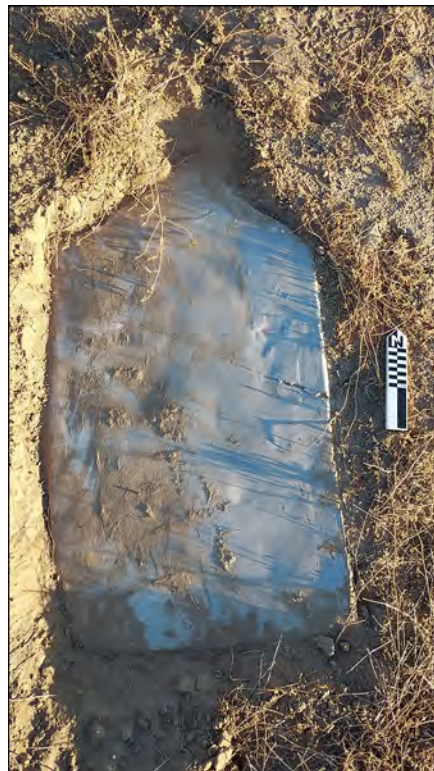
Feature PD: 703

Damage type(s): fragmentation—loss, buried/sunk, tilted/fallen

The grave marker consists of a fragment of a rectangular concrete ledger. The northern half of the ledger is missing; so, there is no information on the individual buried in the grave. The ledger is tilted and buried, as well.
