Archaeological Condition Assessment and Ground-Penetrating Radar (GPR) Surveys for Agua Mansa Cemetery, San Bernardino County, California

Technical Report 24-26
Statistical Research, Inc.
Redlands, California

April 2024

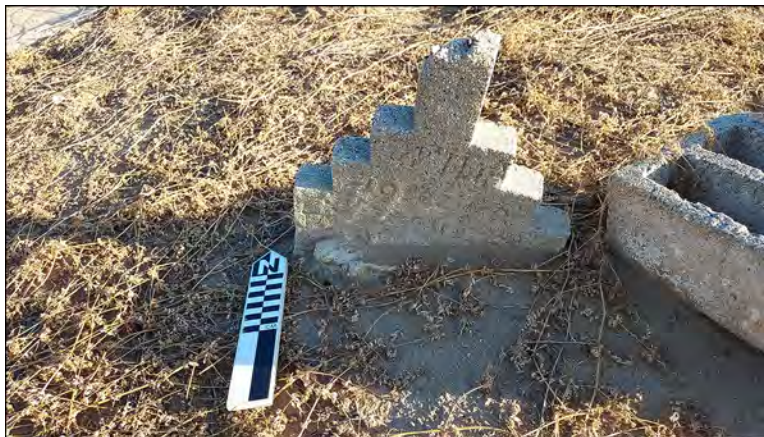
Feature PD: 705

Damage type(s): fragmentation—loss, buried/sunk, tilted/fallen, erosion

The grave consists of a die-on-base monument that is broken, eroded, and tilted. Two concrete blocks (Feature 707), one stacked on top of the other, are to the east of the monument. It is not clear whether they are related to the grave. The headstone is stepped on each side, leading to a central point that likely featured a cross on top, but the cross has broken off and is missing. The text on the headstone reads, “[. . .]/JOSEFINA/YZAGUIRRE”. There is an inscription above the name, but it is not legible. The inscription was made while the concrete was still wet. The headstone is tilted to the east and is partially buried.

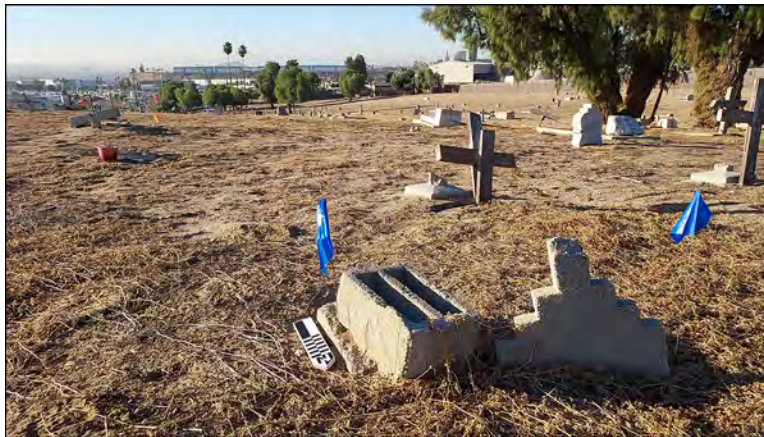
Feature PD: 707

Damage type(s): unknown

This feature is marked by two stacked blocks on top of each other. There is no evidence of a headstone, and the blocks are sitting adjacent to Feature 705.

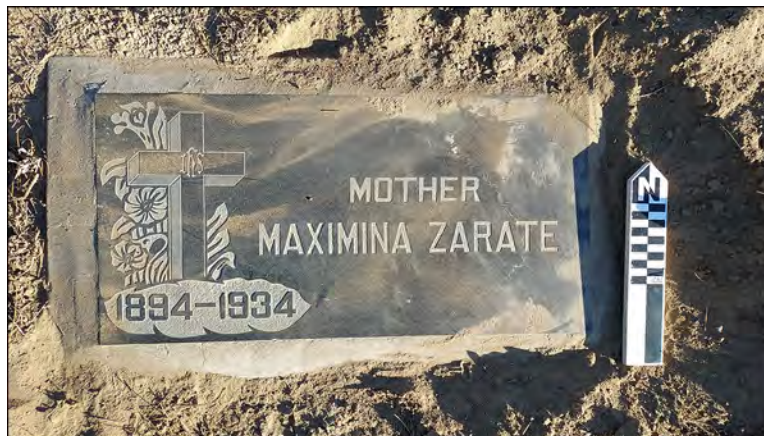
Feature PD: 709

Damage type(s): buried/sunk

This is a lawn-style monument with a concrete base and a polished marble plaque inset. The monument is partially buried but is otherwise in good condition. The inscription on the plaque reads, “MOTHER/MAXIMINA ZARATE/1894–1934”. The date is written to the left of the name and is part of a decoration carved into the plaque that features a cross and flowers.

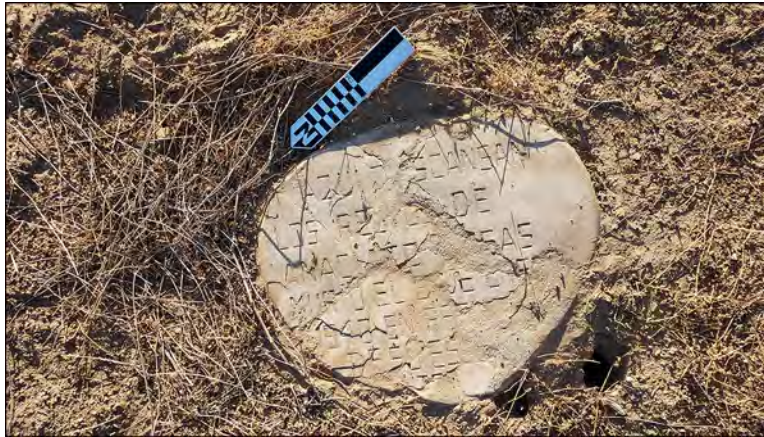
Feature PD: 715**Name:** Anac[. . .]to [. . .]sas**Dates:** January 6, 1940 (death)**Monument type:** block**Enclosure:** none**Damage type(s):** fragmentation—loss, erosion, burrowing-animal disturbance, spalling**Repair type(s):** none**Description:**

This is a roughly heart-shaped concrete slab lying flat on the ground. The surface of the slab is inscribed, but the inscription is badly eroded/has spalling, and several of the words, including the name, are illegible or difficult to decipher. The inscription reads, “AQUI D??SCANSAN/LOS RESTO[. . .] DE/ANAC[. . .] TO[. . .] SAS/MURIO EL 6 DE ENE[. . .]/1940 EN RE[. . .]/DE SUS [. . .]” The monument has a similar type of concrete to that of Feature 703, which is a nearby broken ledger. There is animal burrowing beneath the monument. The monument is facing approximately west, in contrast to the rest of the graves in this area, which are oriented north–south. It is possible that this monument was broken off Feature 703.

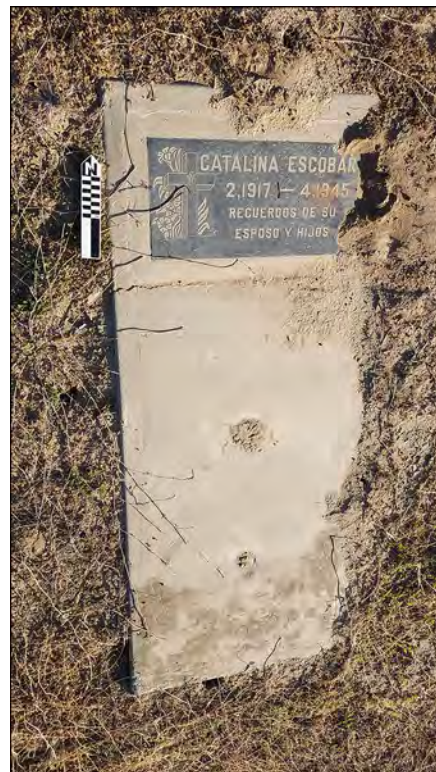
Feature PD: 717

Damage type(s): buried/sunk, cracked, fragmentation—loss, burrowing-animal disturbance

This appears to be a new grave for Catalina Escobar. A second grave with an older-looking monument is approximately 25 feet west of this monument. The monument here appears to be a black granite lawn-style monument inset into a concrete ledger. The plaque is inscribed, “CATALINA ESCOBAR/2, 1917–4, 1945/RECUERDOS DE SU/ESPOSO Y HIJOS”. There is a seam on the southern side of the monument where additional concrete has been added to make a ledger. The ledger has two circular scars where something was affixed to the concrete, likely vases or receptacles for candles. The entire monument is partially buried but is otherwise in fair condition. There is animal burrowing on each side of the monument.

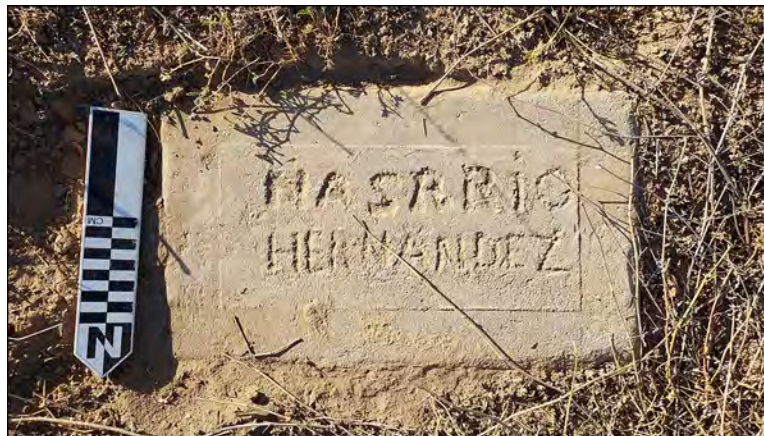
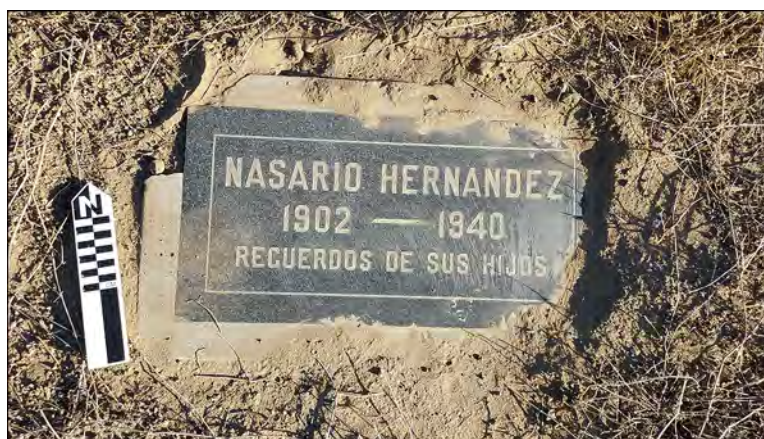
Feature PD: 719/721

Damage type(s): buried/sunk, fragmentation—loss

This grave contains two monuments: a modern lawn-style headstone (Feature 721) and an older, likely original lawn-style headstone (Feature 719) that is now a footstone. The current headstone contains a concrete base with a black marble or granite plaque inset into the base. The plaque is inscribed, “NASARIO HERNANDEZ/1902–1940/ RECUERDOS DE SUS HIJOS”. The northwestern corner of the concrete base is broken, and part of the plaque extends over the fracture. The plaque is not broken. The second monument is 6.5 feet south of the first. It is a concrete lawn-style base with no plaque. The concrete is inscribed, “NASARIO/HERNANDEZ”. The inscription was made while the concrete was still wet. The monument is partially buried but is otherwise in good condition.

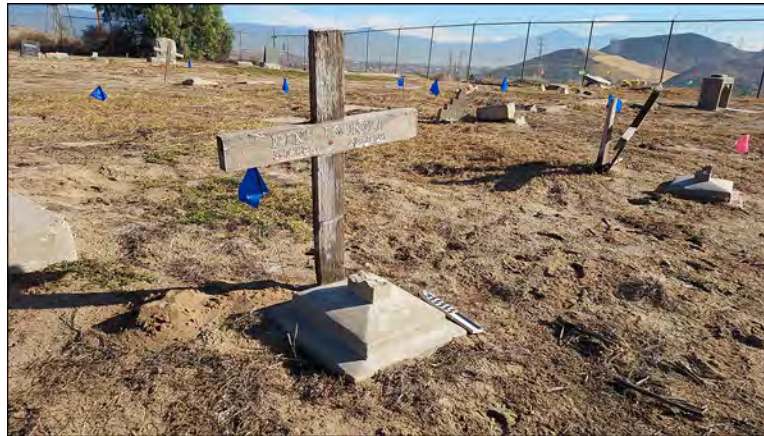
Feature PD: 723/725

Damage type(s): fragmentation—loss, buried/sunk, erosion

This grave is marked with two monuments: a concrete base (Feature 725) and a wooden cross (Feature 723). The base is concrete and square and has chamfered edges along the top. The broken remains of a possible cross were observed at the top of the base. Directly north of and behind the monument is a wooden cross made from pieces of two-by-fours held together with a metal bolt. The cross is inscribed, “IRENE ESPINOZA/3-7-1896 1-4-1938”. The letters on the cross are carved and filled with white paint. This monument is just west of Feature 711/713, and the original monuments and later wooden crosses of both features are similar.

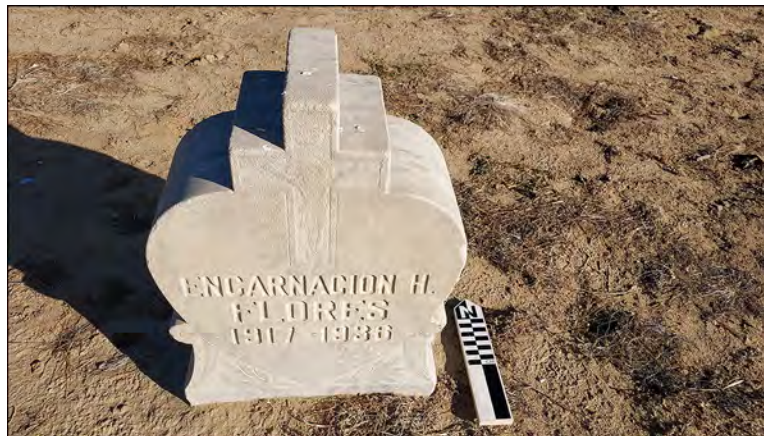
Feature PD: 727

Damage type(s): spalling

This grave is marked by a heart-shaped granite headstone. The headstone has a little spalling on the edges but otherwise has no visible damage. There is a cross with a depiction of Jesus on the cross inscribed at the top and the following inscribed below: “ENCARNACION H./FLORES/1917–1936”. Below the inscription are two leaf motifs, at the base.

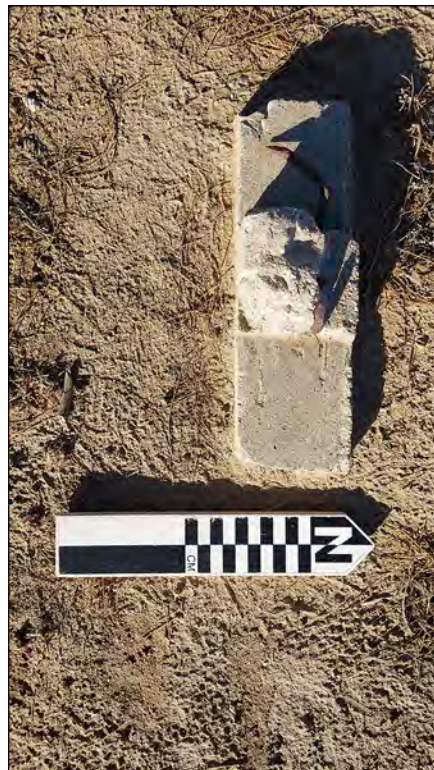
Feature PD: 729

Damage type(s): fragmentation—loss

This grave has a broken die-on-base monument that is missing everything but the base. The base is a rectangular concrete block with chamfered edges. There is a smaller rectangular mark in the center of the base where an upper part of the monument, likely a cross, was once present, but it has broken off and is missing. There is no information on the individual buried in the grave.

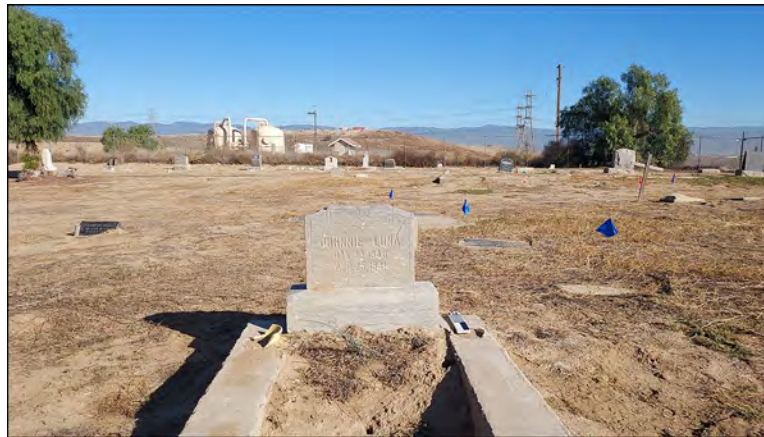
Feature PD: 731/733

Damage type(s): fragmentation—loss, burrowing-animal disturbance

The grave features a die-on-base monument made of marble with concrete coping (Feature 731) around the edges of the grave. The monument features a tall, rectangular marble base with chamfered edges. The headstone is made of the same type of marble as the base and is inscribed, “JOHNNIE LUNA/JAN. 30, 1940/AUG. 25, 1941”. There is an inscribed cross above “Luna” and another decorative motif at the top of the headstone. The headstone features scotia-haunch corners at the top. The concrete curbs extend from the headstone base and wrap around the other three sides of the grave. They are relatively high curbs, almost creating a bedstead-style monument. The curbs are in good condition, but the two ceramic vases set into the curb, one on either side of the headstone, are partially broken. Also, there is extensive rodent burrowing in the center of the grave.

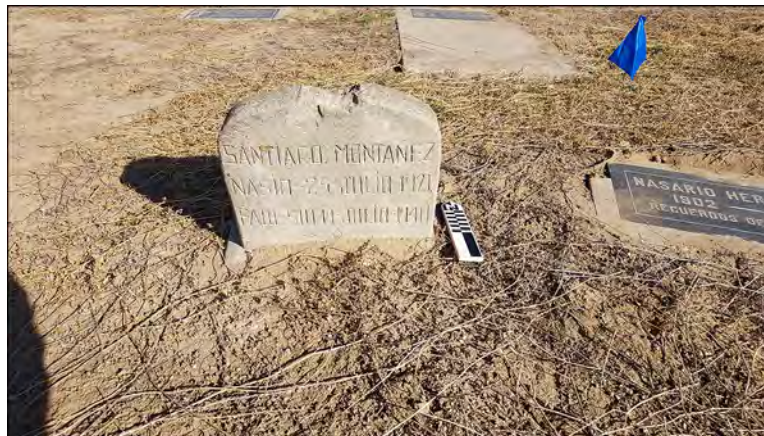
Feature PD: 735

Damage type(s): buried/sunk, fragmentation—loss, tilted/fallen

This grave marker consists of a concrete die-on-base monument. The base is partially buried but appears to be a rectangular concrete base with rounded edges. The top of the headstone contains a basket arch that once had a decorative addition that has broken off and been lost. The tombstone is inscribed, “SANTIAGO MONTAÑEZ/NASIO [sic] –25–JULIO–1921/FALLESIO [sic] –19—JULIO–1940”. The inscription apparently was made after the concrete was dry. The entire monument is leaning forward.

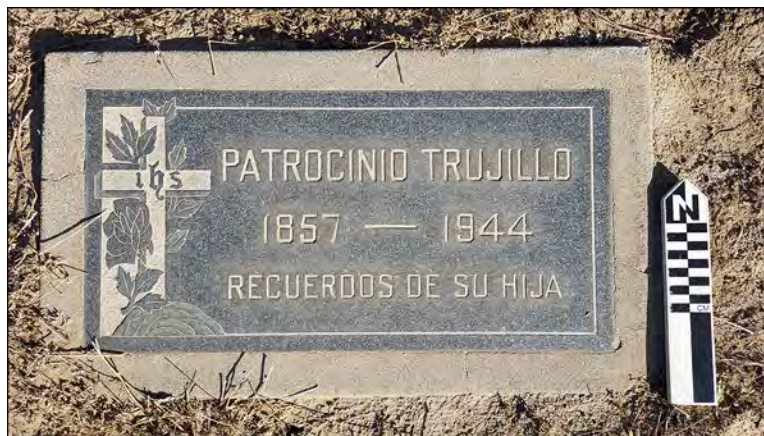
Feature PD: 737

Damage type(s): buried/sunk, cracked

This monument is a lawn-style headstone made with a concrete base and a black granite plaque. The base is rectangular and has square corners and a few small cracks along the sides. The southwestern corner is partially buried. The plaque is inscribed, “PATROCINO TRUJILLO/1857–1944/RECUERDOS DE SUS HIJOS”. The left side of the plaque features an inscribed decoration featuring a cross and flowers.

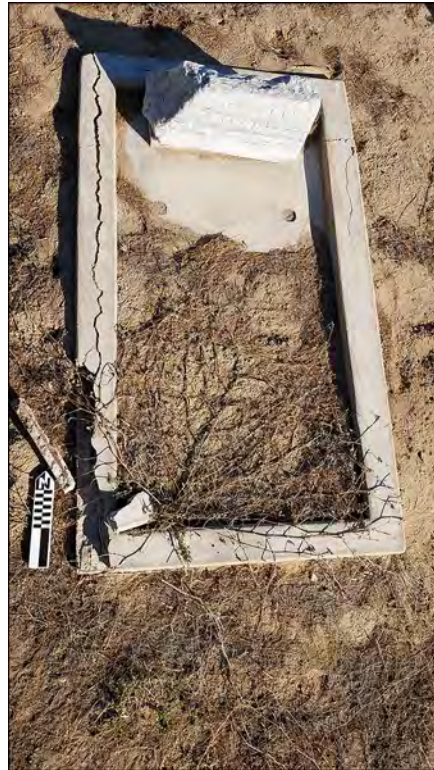
Feature PD: 739/741

Damage type(s): abrasion, buried/sunk, burrowing-animal disturbance, cracked, fragmentation—loss, tilted/fallen

This grave consists of a marble headstone on top of a partial concrete ledger and concrete coping (Feature 739) around the ledger. The headstone is marble and is not finished. The face of the headstone is mostly finished but has some scratches. The base and right side are partially finished. The left side, top, and back are partially shaped and not finished. The headstone is inscribed, "JACINTO/CORTEZ". The inscription is not finely carved, and it appears that the headstone was quickly made. It is sitting on a small concrete base but has slipped off to the eastern side. The ledger takes up the northern 40 percent of the area defined by the coping; south of that is open dirt. The ledger is in fair condition but is partially buried, and there are two holes for flowers/candles that have filled in. The coping wraps around the entire ledger and extends south of the ledger, covering the entire grave site. The coping is cracked in several places; a large crack runs down the middle of the coping on the western side of the grave. Two pieces of the coping in the southwestern corner have fallen off and are at the side of the curb.

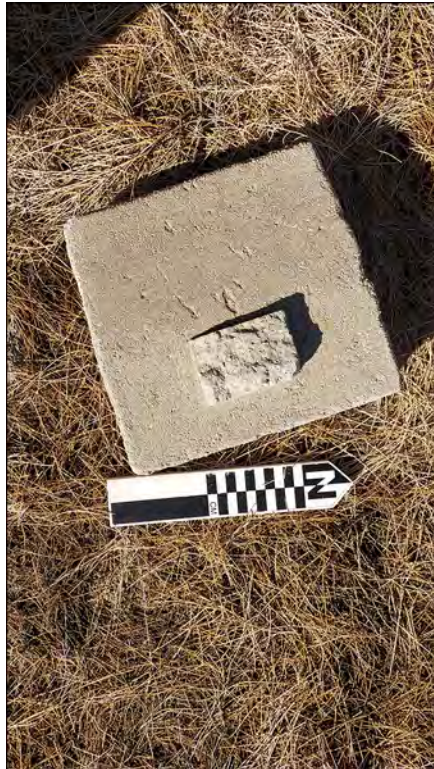
Feature PD: 743

Damage type(s): fragmentation—loss, spalling

The grave includes a broken, disassembled-component monument fragment. The base is a rectangular block of concrete that is apparently facing west. The presumed front half of the base is sloped, suggesting that it once may have had a plaque for an inscription. The back half of the base is flat and has a scar where a cross or some other decorative piece would have been. There is no inscription visible on the remaining monument.

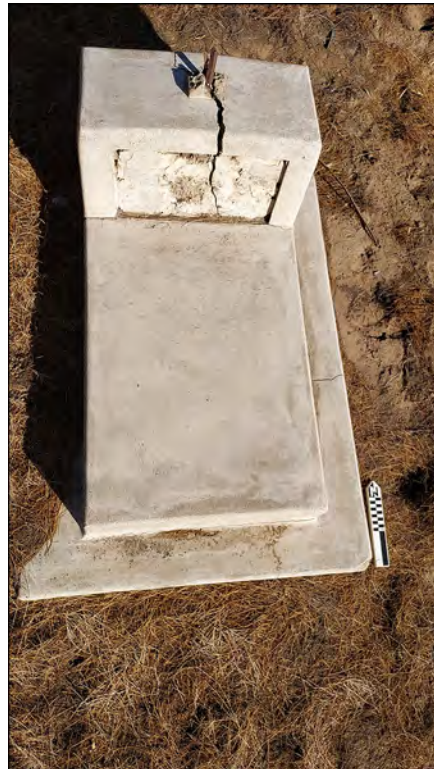
Feature PD: 745

Damage type(s): fragmentation—loss, cracked, buried/sunk

This is a two-tiered concrete tomb that is cracked and missing the inscription plaque and part of the decoration on top, likely a cross. The tomb features a partially buried rectangular concrete base that has a few cracks on the sides. The second tier, above the base, is a larger concrete block shaped like a cradle. The southern part is a smooth concrete block. The northern part of the second tier is another rectangular block that is twice as tall as the southern part. The face of the northern part that would be the opening of the cradle once had a plaque that presumably contained information about the individual buried in the grave. There is a scar where the plaque was, but the plaque is now missing. The northern part of the second tier also has a large crack down the middle. There is a scar on top of the northern part, and metal rebar is sticking out of the scar, which must have held a decoration, likely a cross. Because the plaque is missing, there is no information on the name or age of the individual buried in the grave.

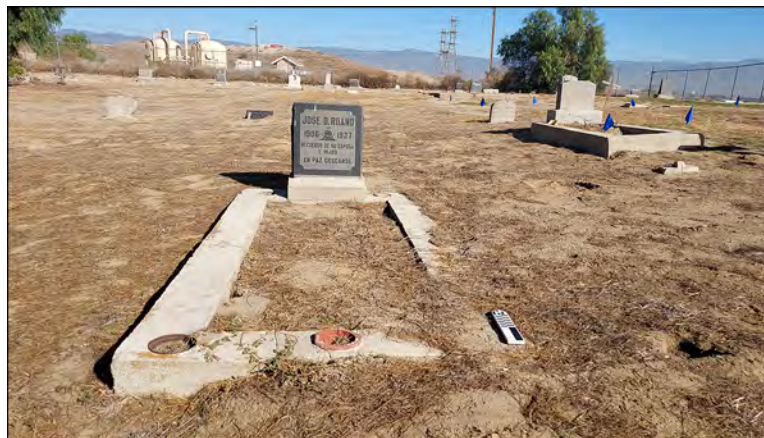
Feature PD: 747/749

Damage type(s): buried/sunk, fragmentation—loss

The grave features a die-on-base headstone with concrete coping (Feature 747) around the grave. The monument is a black granite headstone on a concrete base. It has a polished front with rock-pitched sides and back. The front is inscribed, “JOSE D. ROANO/1906–1937/RECUERDO DE SU ESPOSA/E’ HIJOS/EN PAZ DESCANSE”. There is a symbol inscribed in the center of the monument, between the birth and death dates, that appears to be a tree stump with an axe and hammer at the base and a bird with a twig flying over the stump. The stump has the initials “P.W.L.A.”, which could be for the Portland Wholesale Lumber Association, which began in 1922. The base is a rectangular concrete block with chamfered edges. The coping appears to have been built first, and the base sits on top of the coping. The coping has square edges and has two metal receptacles, one in each of the northeastern and northwestern corners. There is a metal receptacle in the southwestern corner of the coping and a ceramic receptacle in the center of the southern part of the curb. The southeastern corner of the curb is buried but likely has another metal receptacle. The metal receptacles are deteriorated, and the ceramic receptacle is broken. There are also some dog footprints in the curb concrete that were made while the concrete was still wet.

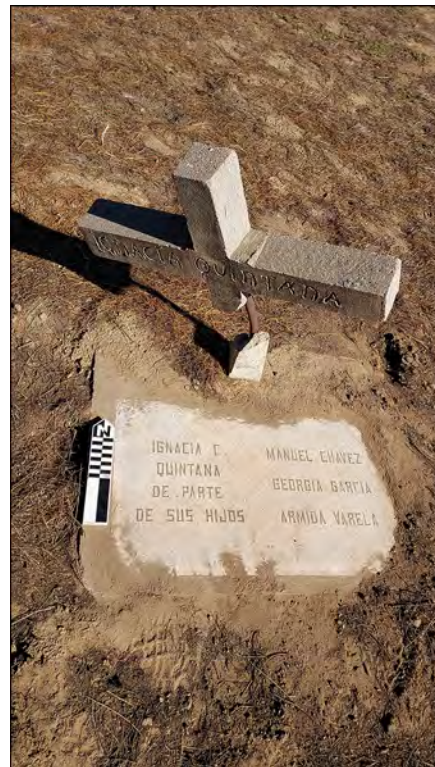
Feature PD: 751

Damage type(s): fragmentation—loss, buried/sunk

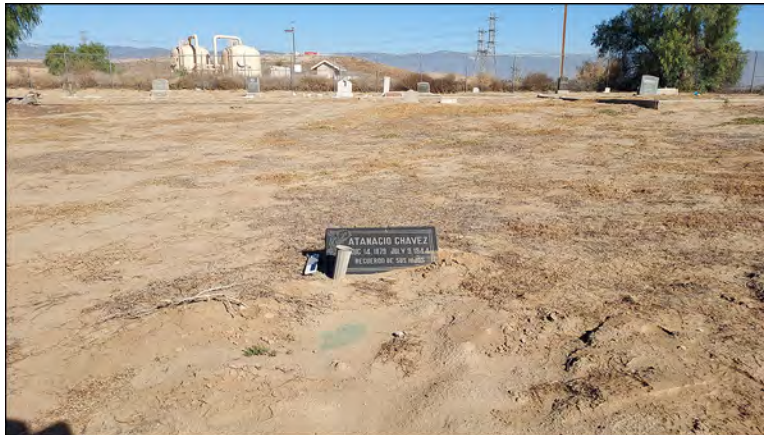
Feature PD: 753

Damage type(s): buried/sunk

The grave features a black granite slant marker sitting on top of a rectangular concrete ledger. The marker is made entirely of granite and features a polished front with rock-pitched sides and back. The monument is inscribed, “ANATACIO CHAVEZ/AUG. 14, 1879 JULY 9, 1944/RECUERDO DE SUS HIJOS”. There is a rose inscribed on the plaque, to the left of the rest of the inscription. The ledger is fully buried and had to be cleared. It is a simple concrete slab. There are four holes, one near each of the corners, for flowers or candles. There is currently a metal vase in front of the marker.

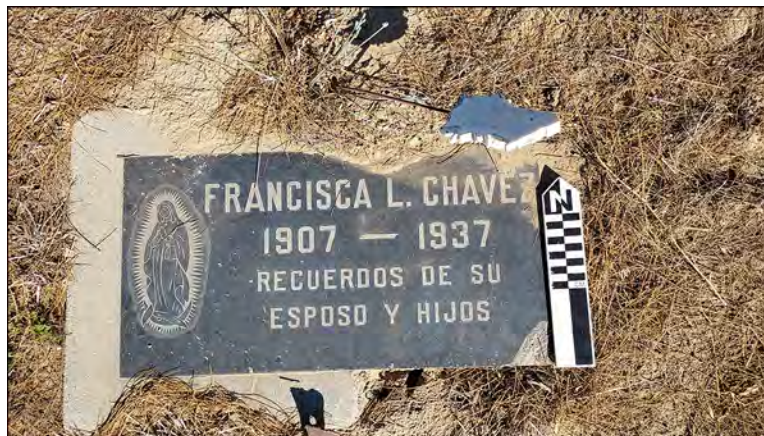
Feature PD: 755

Damage type(s): fragmentation—loss, buried/sunk, spalling

This grave is marked by a black marble plaque inset into a concrete lawn-type marker. The marker is partially buried and has a piece of metal exposed at the bottom. The plaque is chipped on the southeastern corner. It includes a depiction of the Virgin Mary and is inscribed as follows:

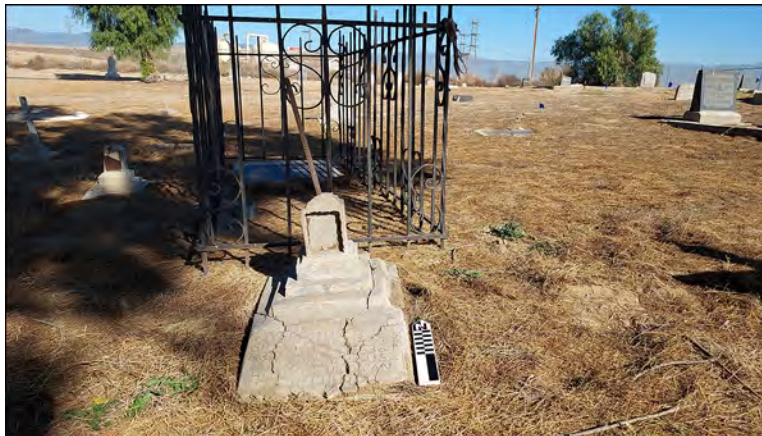
Feature PD: 757**Name:** Eulojio L. Torres**Dates:** March 11, 1884–January 25, 1936**Monument type:** disassembled component/component fragment**Enclosure:** none**Damage type(s):** fragmentation—loss, cracked, buried/sunk, tilted/fallen**Repair type(s):** none**Description:**

This is the original grave marker for Eulojio Torres. The modern grave marker is just north of this marker. This marker consists of a four-tiered concrete base for a possible cross. The southern half of the base is beveled and is inscribed, “AQUI DESCANSAN/LOS RESTOS DEL/SR. EULOJIO TORRES/*3-11-84–1-25-36+/SU ESPOSA Y SUS/HIJOS LE DEDICAN/ESTE RECUERDO”. The next three tiers are all rectangular and have slightly beveled edges. The fourth tier is approximately twice as tall as the second and third tiers. On top of the fourth tier is a small concrete alcove that is broken at the top. A piece of rebar sticks out of the broken top. A cross was likely on top of the monument, but it has been broken off. The entire monument is tilting to the west. Several large cracks are visible on the base.

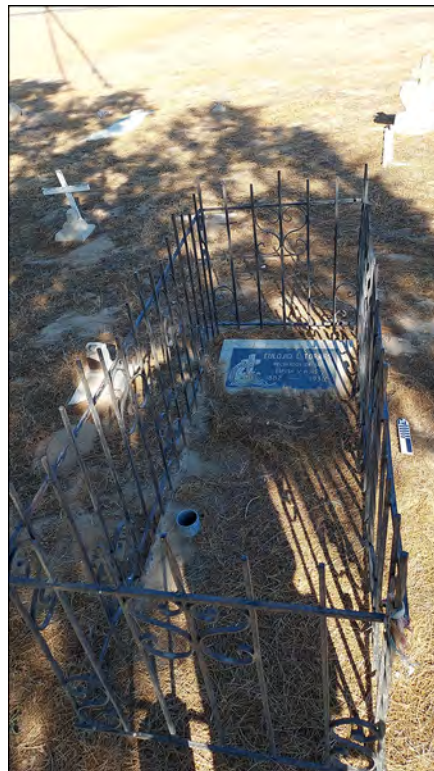
Feature PD: 761

Damage type(s): buried/sunk

This is the new grave for Eulogio Torres, immediately north of the original grave. The grave features a concrete ledger with a lawn-style marker. A metal milled-point fence surrounds the grave (Feature 759). The ledger is a smooth concrete slab and is almost completely buried. There is a metal pipe sticking out of the center-left side of the slab, likely for flowers. The lawn-style marker features a concrete base with a black granite plaque. It is inscribed, “EULOJIO L. TORRES/RECUERDOS DE SU/ESPOSA Y HIJOS/1882–1936”. There is an inscription of an angel kneeling in front of a cross and flowers to the left of the rest of the inscription. The metal fencing is bent into the edge of the ledger. It is painted black, but the paint is eroding. There are S-shaped decorations between some of the bars of the fence.

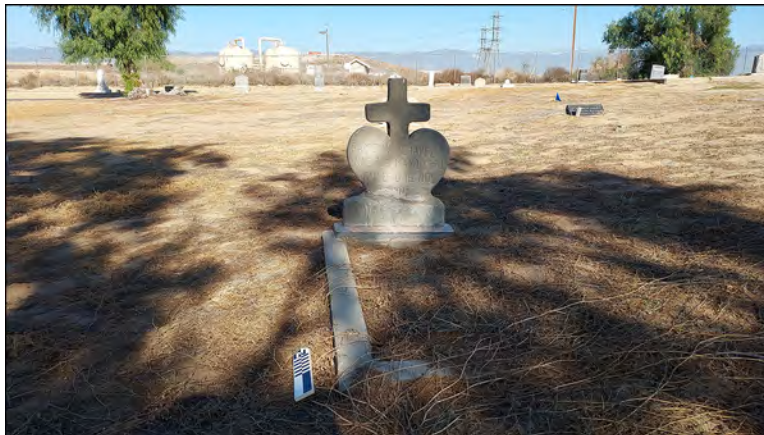
Feature PD: 765

Damage type(s): fragmentation—no loss, buried/sunk, tilted/fallen

This grave is marked by squared concrete coping (feature 763) and a heart-and-cross-shaped die on base. The coping is buried at the southern and eastern edges. The headstone has a cross at the top and a heart shape at the base, both composed of concrete. The heart has visible signs of having broken across the bottom and been repaired with hard cement to reattach the headstone to the base. There is a second sign of repair on the headstone, between the cross and the heart. The heart portion of the headstone is inscribed as follows:

Repair type(s): repair—hard cement

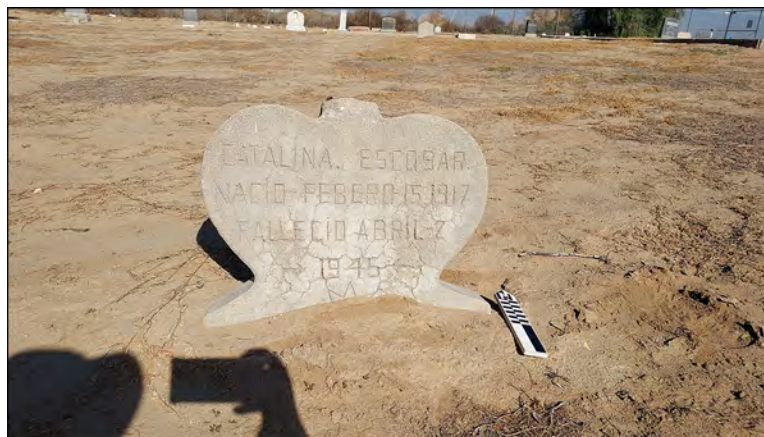
Feature PD: 767

Damage type(s): fragmentation—loss, buried/sunk, erosion, spalling

This is the original headstone for Catalina Escobar. It consists of a concrete headstone that is heart shaped and has a rectangular base. The heart and base are all a single piece of concrete. There is a scar at the top of the heart where a cross or other ornament was present. That ornament has broken off and is missing. The concrete is inscribed, “CATALINA ESCOBAR/NACIO FEBERO 15 1917/FALLECIO ABRIL 2/1945”. The face of the headstone is eroded and has spalling, but the text is still legible.

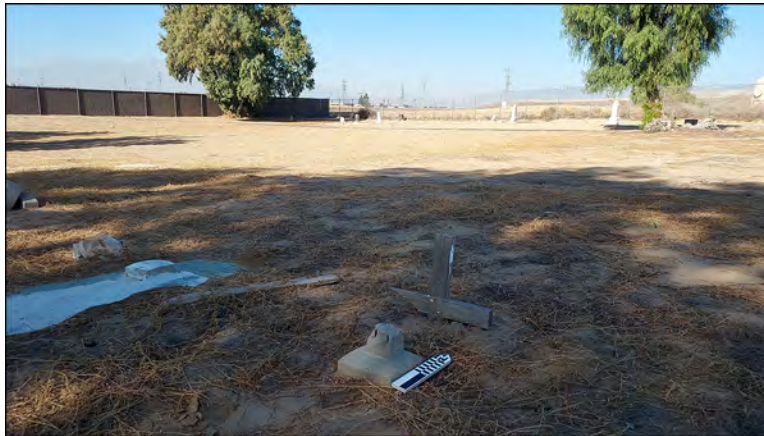
Feature PD: 769/771

Damage type(s): buried/sunk, erosion, fragmentation—loss

This grave is marked with two monuments, a concrete base (Feature 769) and a wooden cross (Feature 771). The base is square in shape and has chamfered edges along the top; the remains of a possible cross are still present on top. Directly north of and behind the monument is a wooden cross made of two-by-fours held together with a metal bolt. The cross is no longer in its original position and has been placed in a metal vase that is partially buried in the ground. The cross is deteriorated but seems relatively modern.

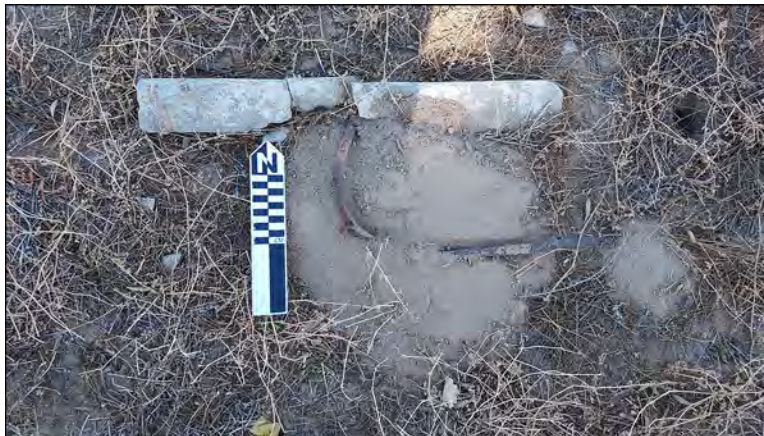
Feature PD: 773

Damage type(s): fragmentation—loss, tilted/fallen

This grave is marked with a fragment of broken cement, possibly from a cross. There is rebar coming from the center of the piece of concrete, likely the remnants of the cross.

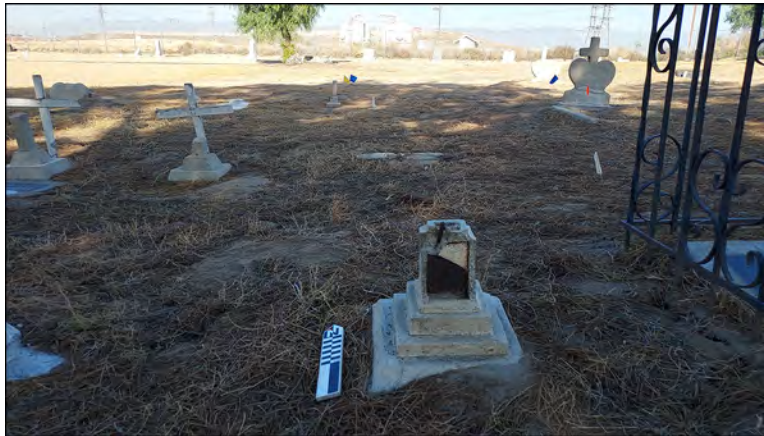
Feature PD: 775

Damage type(s): fragmentation—loss, buried/sunk

This grave is marked by the remains of a monument base similar to the one associated with Eulijio Torres (Feature 757). Like Feature 757, this base is also missing the top portion but may have been a cross. There are three tiers to the base; the top two tiers have smooth, squared sides, and the bottom level has a chamfered edge. A piece of rebar is exposed where the monument was broken. There is also a fragmented metal plate or panel on the southern side of the monument. The southeastern corner is partially buried in the soil.

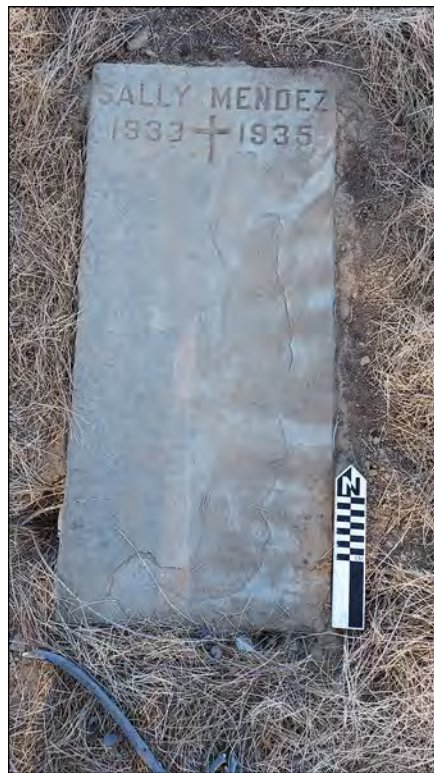
Feature PD: 777

Damage type(s): burrowing-animal disturbance, erosion

This grave is marked with a granite ledger. The face of the ledger is smooth, but the edges are rock pitched. The head of the ledger is inscribed, “SALLY MENDEZ/1933 [cross] 1935”. There is a cross carved between the two years. The surface of the ledger has a large, spalled area, but otherwise, the marker is in good condition.

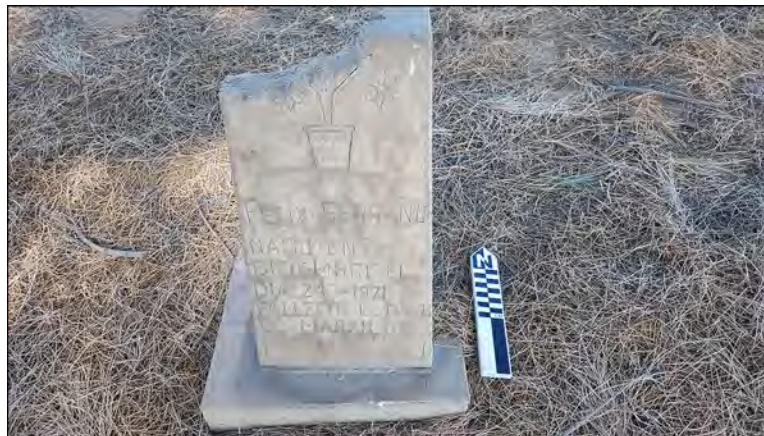
Damage type(s): cracked, erosion, fragmentation—loss, open joints

The grave is marked by a concrete die-on-base monument. The base is a rectangular concrete slab with squared edges. The headstone is tall and narrow. The top of the monument is broken off and missing, but the top was squared off. The slab is inscribed, “FELIX SERRANO/NACIO EN/DICEIMBRE EL/DIA 24-1921/FALLECIO EL DE 1/DE MARZO DE/1934”. The top of the marker is inscribed with a flowerpot and flowers. These inscriptions were made while the concrete was still wet. The flowers are only partially visible, because of the broken top of the monument. The joint where the headstone meets the base has begun to open and shows signs of wear.

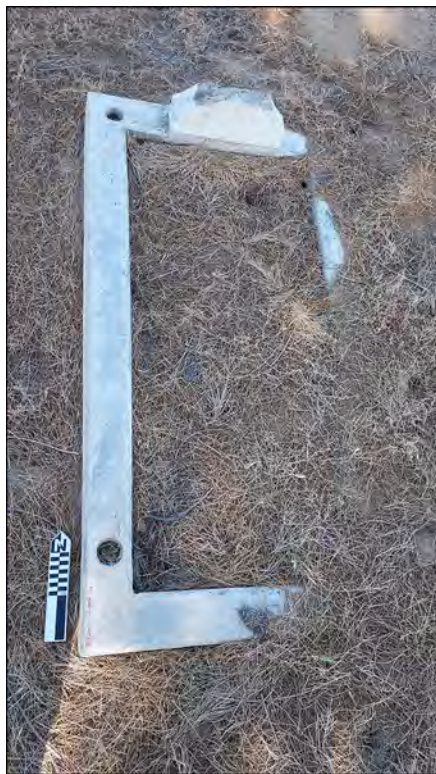
Feature PD: 781

Damage type(s): fragmentation—loss, buried/sunk, burrowing-animal disturbance

This grave is marked by a headstone on top of squared concrete coping, with an insert in each corner for a candle or flowers. The eastern half of the coping is buried in soil and vegetation. There is animal-burrowing activity inside and outside the grave coping. The headstone is a die-on-base style; it has been broken and mostly lost. There is no inscription present on the remaining fragment of the headstone.

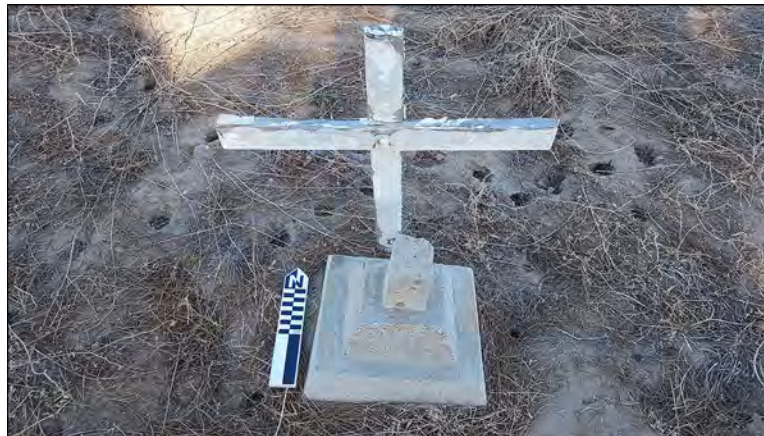
Feature PD: 783

Damage type(s): buried/sunk, erosion, fragmentation—loss, tilted/fallen

This grave is marked with three monuments: a broken monument base, a wooden cross, and a lawn-style marker. The broken base appears to be the original monument, and the cross and the lawn-style monument likely were added more recently. The base is square-shaped and tilted. The remains of an adornment were observed at the top of the base and are possibly from a cross. Directly north of and behind the monument is a wooden cross made of 1-by-4-inch pieces of lumber held together with a metal bolt. The cross is painted white, but the paint is peeling. In front of the broken base is a lawn-style monument. It consists of a black granite plaque set into a rectangular concrete base with square edges. The plaque is inscribed, “ELENA VELARDE/MOTHER & SISTER”. The monument was buried in sand. (*Note:* The photos of the grave were taken before the lawn-style monument was uncovered.)

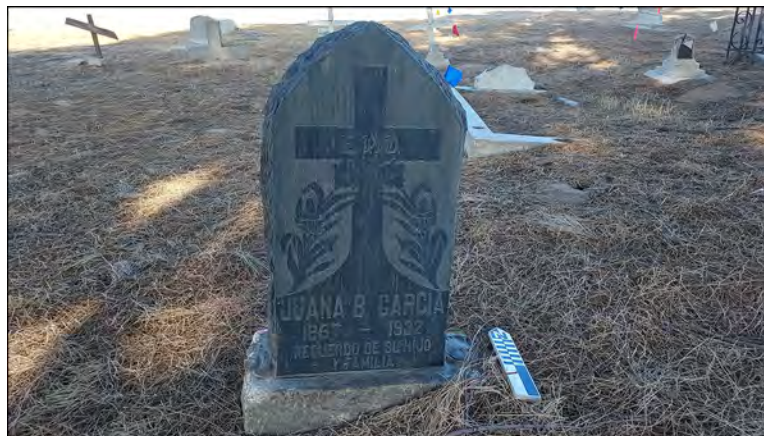
Feature PD: 785

Damage type(s): none

The grave is marked by a die-on-base monument with a white/gray granite base and headstone. The base is a rough-hewn rectangular granite block with a rock-pitched finish. The headstone is made of black granite with a semicircular or slightly pointed arch. The face is polished, but the sides and top have a rock-pitched finish. The base of the monument is inscribed, “JUANA B. GARCIA/1857—1932/RECUERDO DE SU HIJO/Y FAMILIA”. The middle and upper parts of the monument are decorated with a cross that has flowers on each side. The cross is inscribed, “E.P.D.”, which likely stands for “En Paz Descanse”. There is a glob of concrete on either side of the headstone where it attaches to the base, possibly indicating a messy installation or repair. The glob on the eastern side has been stamped with “Packed by Cal[. . .]”. The end of the inscription is illegible.

Repair type(s): hard cement

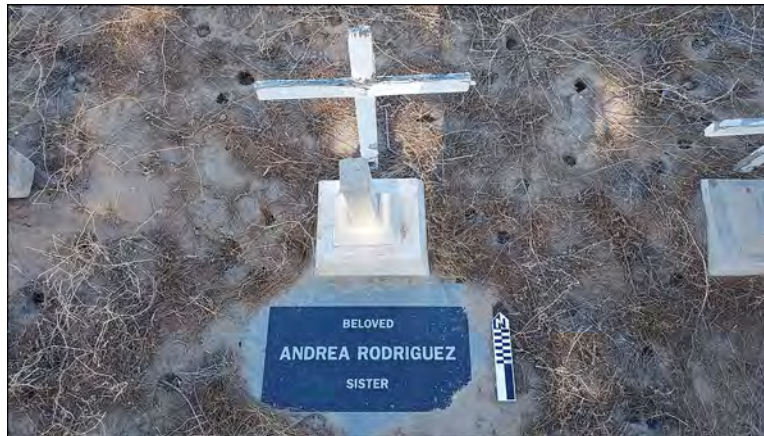
Feature PD: 787

Damage type(s): buried/sunk, erosion, fragmentation—loss, tilted/fallen

This grave is marked with three monuments: a broken concrete base for a cross monument, a wooden cross, and a lawn-style marker. The cross base appears to be the original monument, and the wooden cross and the lawn-style monument likely were added more recently. The cross base consists of a tilted square concrete base with the remains of the cross still present. Directly north of and behind the monument is a wooden cross made of 1-by-4-inch pieces of lumber held together with a metal bolt. The cross is painted white, but the paint is peeling. In front of the cross is a lawn-style monument. It consists of a black granite plaque set into a rectangular concrete base with square edges. The plaque is inscribed, “BELOVED/ANDREA RODRIGUEZ/SISTER”. The monument was buried in sand.

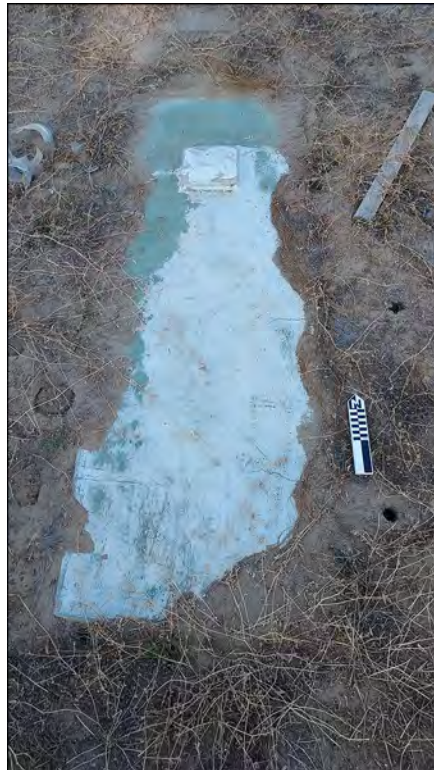
Feature PD: 789

Damage type(s): buried/sunk, burrowing-animal disturbance, cracked, fragmentation—loss

This grave consists of a concrete ledger that has a small, broken monument component on top. The ledger was painted green, but much of the paint has faded/eroded. The name at the top of the ledger is inscribed, “ANACLETO/ROSAS”. The inscription was crudely written in the concrete while it was still wet. Below the inscription is a small, disassembled monument component. The base of the monument component is square and painted white. The center of the component features a scar where an adornment, likely a cross, once stood but has broken off and is missing.

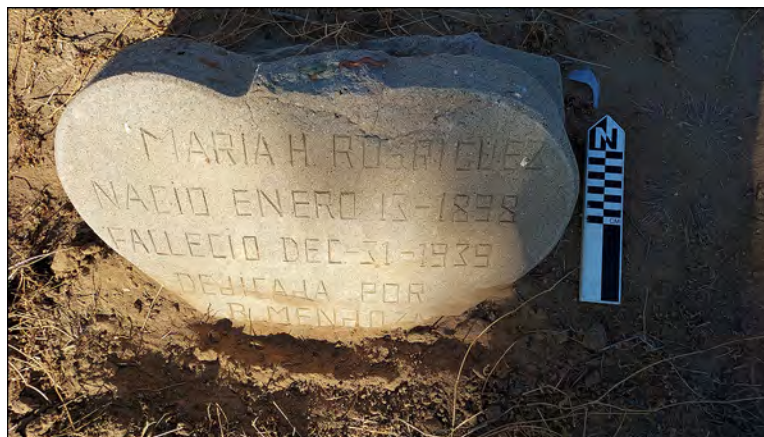
Feature PD: 791

Damage type(s): buried/sunk, erosion, fragmentation—loss

This grave marker consists of a concrete headstone that is heart shaped and has a rectangular base that is buried. This grave marker matches marker Feature 767. There is a scar at the top of the heart where a cross or other ornament was present but has broken off and is missing. The concrete is inscribed, “MARIA H. RODRIGUEA/NACIO ENERO 13-1898/FALLECIO DEC-31-1939/DEDICADA POR/B. MENDOZA”. The face of the tombstone is eroded, but the text is still legible.

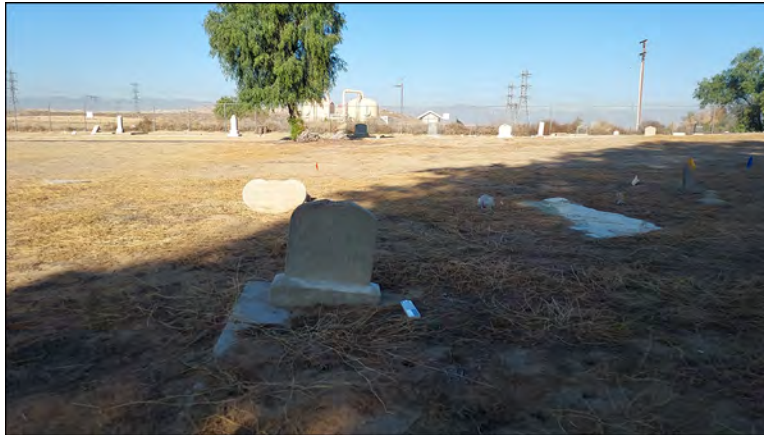
Feature PD: 793

Damage type(s): buried/sunk, fragmentation—loss, tilted/fallen

This grave monument consists of a die-on-base headstone with concrete coping. The headstone features a basket arch on top and a broken center section that likely held a cross on top. It is inscribed, “EVANGELINA E. CAMPA/NACIO 11-13-1938/FALLECIO 10-12-1938”. It sits on top of a rectangular concrete base with chamfered edges. The base, in turn, sits on a rectangular concrete slab. A concrete curb extends along the western side of the grave. The rest of the area is buried; so, it is not clear whether there are curbs on the southern and eastern sides.

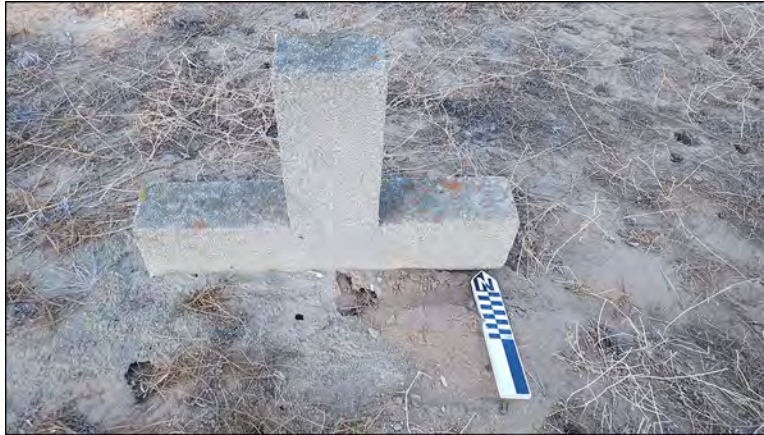
Feature PD: 795

Damage type(s): buried/sunk, erosion, cracked, burrowing-animal disturbance

This grave marker features a partially buried concrete cross. The monument is too deeply buried to see what type of base is present. There is no inscription of the visible portion of the cross; so, no information is present on the individual buried in the grave. There is animal-burrowing activity near the monument.

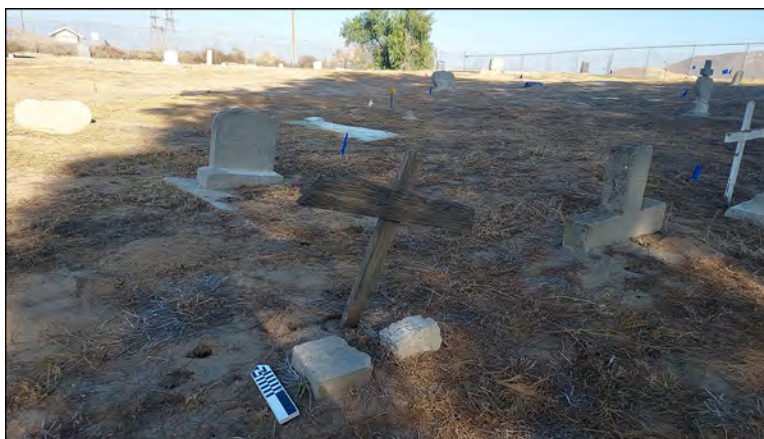
Feature PD: 797

Damage type(s): burrowing-animal disturbance, erosion, fragmentation—loss

This grave features a highly fragmented concrete marker and a wooden cross that is likely a more-recent addition. The original concrete marker consists of two pieces; one contains no inscription, but the other contains a partial word: “MIC[. . .]”. The wooden cross is highly eroded and has been standing for some time.

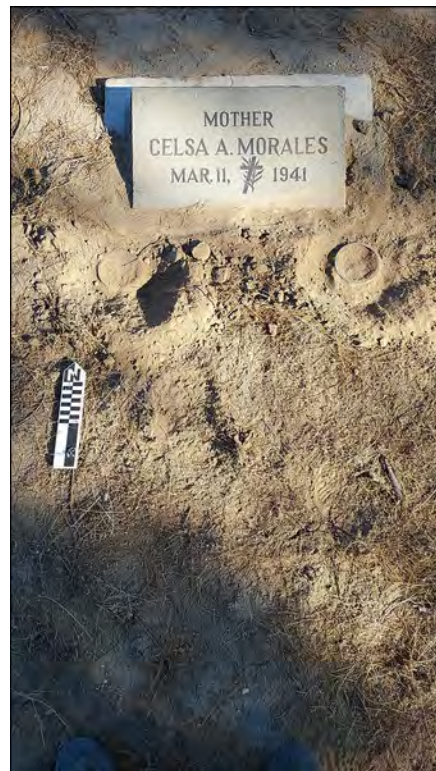
Feature PD: 801

Damage type(s): buried/sunk

The grave features a slant marker headstone that is partially buried. The headstone consists of a granite block sitting on top of a concrete slab. The headstone is polished on the front face and has rock-pitched sides. It is inscribed, "MOTHER/CELSA A. MORALES/MAR. 11, 1941". There is a cross and a branch symbol carved into the marker, in the middle of the date. The slab is buried on the southern side. Two metal pipes are sticking up out of the ground in front (south) of the marker. It is not clear whether these are just stuck in the ground or are attached to part of the base that is buried farther underground.

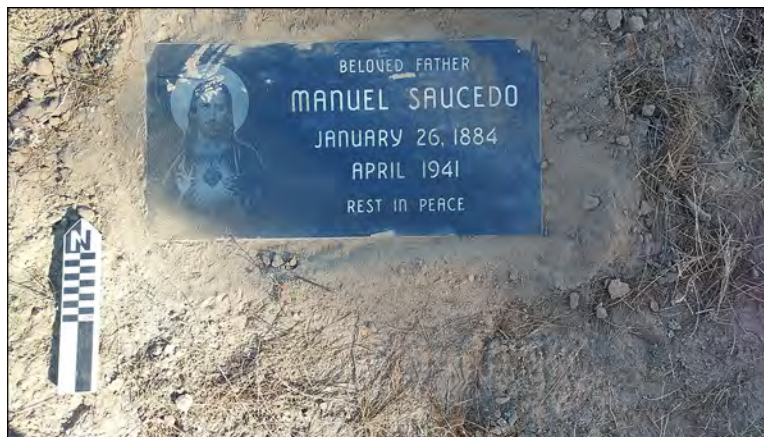
Feature PD: 803

Damage type(s): buried/sunk

This grave is a lawn-style headstone made of a black granite plaque set in concrete. The plaque is inscribed, “BELOVED FATHER / MANUEL SAUCEDO / JANUARY 26, 1884 / APRIL 1941 / REST IN PEACE”. An image of Jesus is to the left of the inscription. The headstone appears to be a modern monument, but no older monument is present.

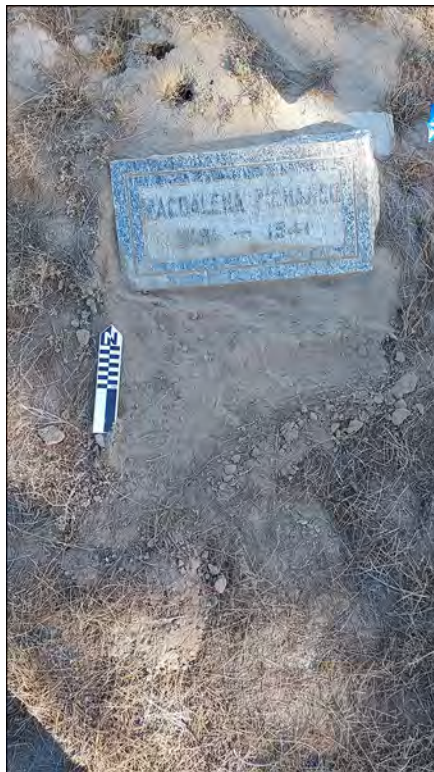
Feature PD: 805

Damage type(s): buried/sunk, tilted/fallen

The grave is marked by a raised-top monument with a granite headstone on a concrete base. The base is a simple concrete slab that is tilted to the west. It is rectangular and has a flat polished face and rock-pitched sides. The face is inscribed, “MAGDALENA PICHARDO/1881–1941”. Approximately one-third of the marker face was buried beneath the soil.

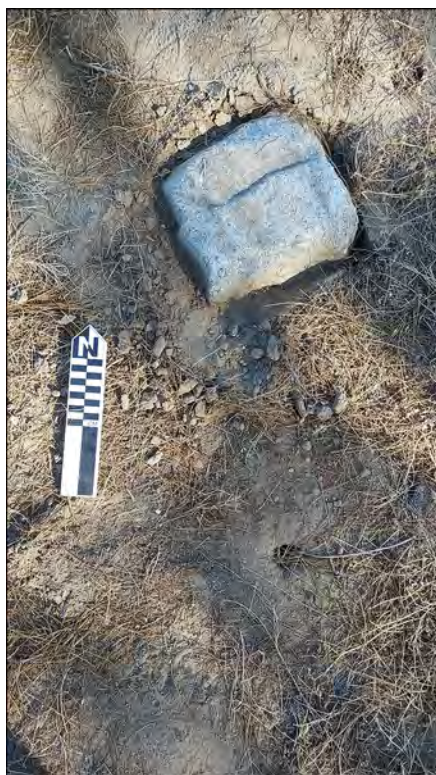
Feature PD: 807

Damage type(s): buried/sunk, fragmentation—loss

The grave is marked with a disassembled monument component or fragment. The component/fragment is a square piece of concrete with irregular edges. The top has a flattened area that once may have held a headstone, but no other pieces are present.

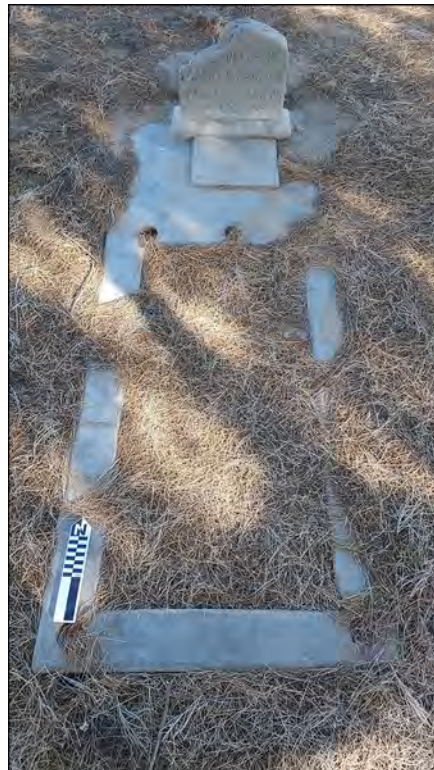
Feature PD: 809

Damage type(s): buried/sunk, burrowing-animal disturbance, fragmentation—loss

This grave feature is marked by a die-on-base headstone sitting on a concrete slab and also contains a lawn-style marker at the foot of the headstone. There is concrete coping around the remainder of the grave. The headstone is a concrete marker with a basket-arch top. Part of the broken top is from an adornment that must have been on top of the headstone. The headstone is inscribed with “[. . .]Z VELASQUEZ / NACIO-3-MAYO-1892 / FALLECIO 9 AGOSTO 1938”. The base of the headstone is a rectangular concrete block with chamfered edges. The headstone and base are sitting on top of a larger concrete slab that takes up the northern third of the grave. A concrete lawn-style marker is on the slab, at the foot of the concrete base for the headstone. The marker is rectangular and is inscribed with “RECUERDOS/DE SUS HIJOS” and a flowerpot below the words. Three holes are at the southern edge of the concrete slab and would have held flowers or candles. Concrete coping extends southward from the slab, delimiting the western, southern, and eastern sides of the graves.
