Archaeological Condition Assessment and Ground-Penetrating Radar (GPR) Surveys for Agua Mansa Cemetery, San Bernardino County, California

Technical Report 24-26
Statistical Research, Inc.
Redlands, California

April 2024

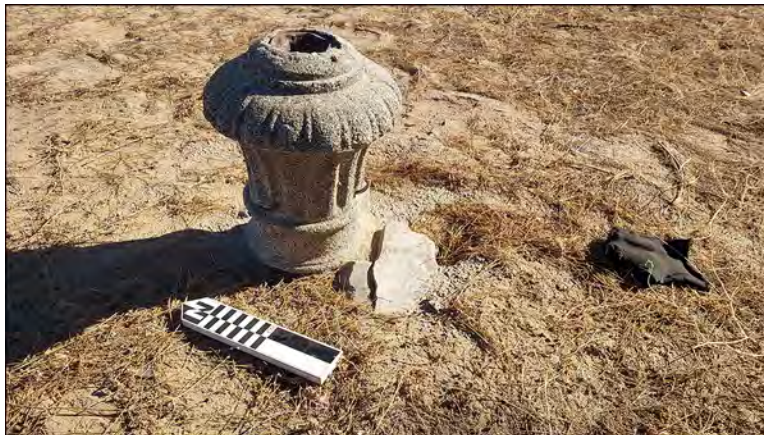
Feature PD: 811

Damage type(s): fragmentation—loss, burrowing-animal disturbance

This grave marker consists of a French-vase-style marker that is broken; it is unclear whether this is the entire monument or part of a composite monument. The vase is made of concrete, and the upper half is missing. The lower portion that is present consists of a mushroom- or flower-shaped body. There are four metal hooks extending from near the base, one on each of the four sides. The hooks are pointing upward like they may have once supported some decoration. The inside of the monument is hollow, and there is a threaded polyvinyl-chloride (PVC) pipe visible inside the opening. The PVC pipe may be part of the anchor used to attach the vase firmly to the ground. At the broken top of the vase, there is a rusted metal collar that likely served to secure the upper half of the vase, which is now missing.

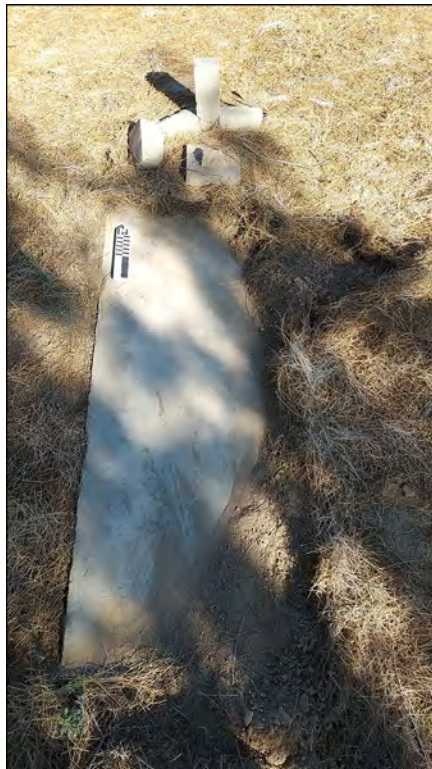
Feature PD: 813

Damage type(s): fragmentation—loss, buried/sunk, erosion, tilted/fallen

The grave is marked by a concrete cross monument and ledger. The concrete ledger is smooth and has sinking on the eastern side/is buried in the eastern portion. The headstone monument is a concrete cross that has been broken from the base, and a few pieces are missing. The inscription on the cross is difficult to read because of natural weathering. The following can be read on the right arm of the cross:

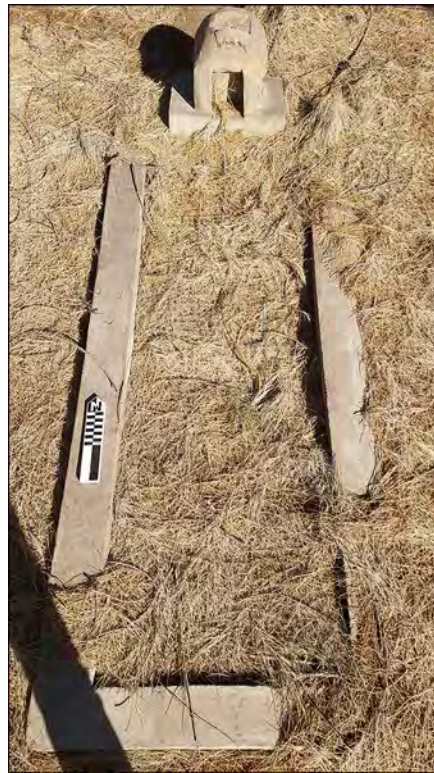
Feature PD: 815

Damage type(s): fragmentation—loss, buried/sunk, cracked

The grave is marked by a small grotto- or shrine-style monument and squared concrete coping. The coping is smooth and has no visible fragmentation. The headstone monument has a small opening on the front to insert a candle; the top of the encasement is cracking, and a piece has broken off. The coping is slightly buried on the eastern corners.

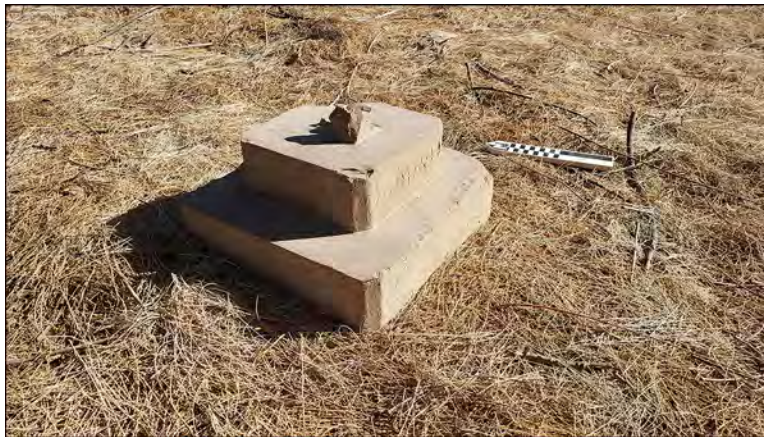
Feature PD: 817

Damage type(s): fragmentation—loss, cracked, spalling

The grave is marked by a concrete base. The bottom level is partially cracked and has chipping/spalling on the edges. The bottom level has a smooth finish, and the corners have chamfered edges. The second level also has chamfered edges on the corners, removing the point. The upper layer has an imprint of a leaf on each side. There is minor cracking and chipping present on the second layer. The cross likely protruded from this layer, because there is a small square in the center and some metal rebar sticking out, for reinforcement. The cross or monument on the top has broken off and been lost.

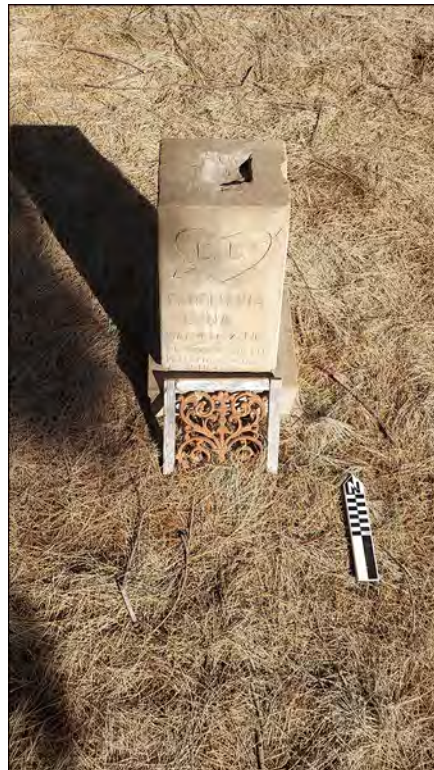
Feature PD: 819

Damage type(s): fragmentation—loss, cracked, ground loss, spalling

The grave is marked by a square concrete die on a block base. There was an item on top of the headstone that has broken off and been lost. There are cracking and spalling on the top of the headstone. The base has an exposed foundation. There is a decorative metal grate fragment with a wooden border leaning against the base of the grave marker. The headstone is hand inscribed and includes a heart motif with an arrow going through it and the initials “C. L.” The remaining inscription reads as follows:

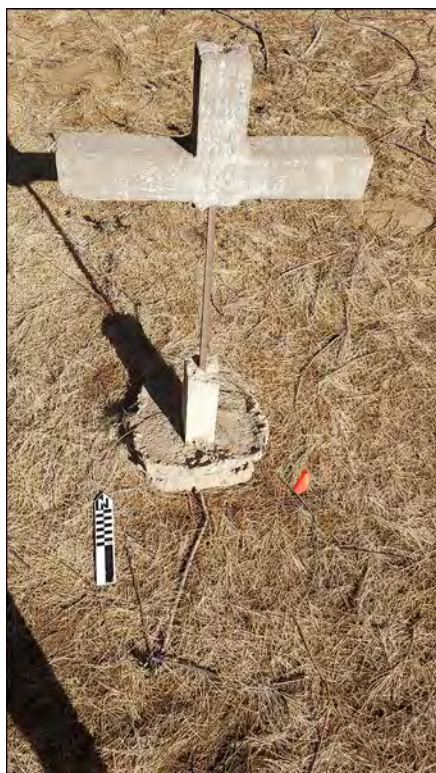
Feature PD: 821

Damage type(s): fragmentation—loss, ground loss

The grave is marked with a concrete cross that has squared, smooth edges. The concrete portion on the bottom segment of the cross has broken off, and the reinforcement rebar is visible. The poured-cement foundation is almost completely aboveground, suggesting that this may not be the original location of the monument.

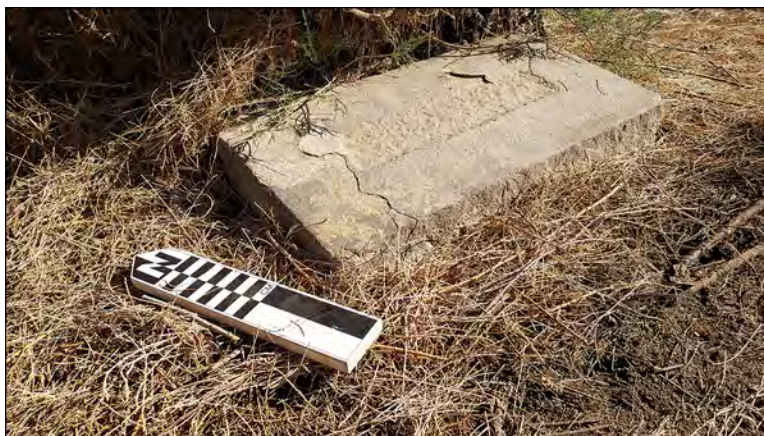
Feature PD: 823

Damage type(s): fragmentation—loss, cracked, spalling

The grave is marked by a concrete-block base. The headstone for the grave marker is no longer present, but the socket location is still visible on the base. The base is cracked and has spalling on its face. No inscriptions are visible.

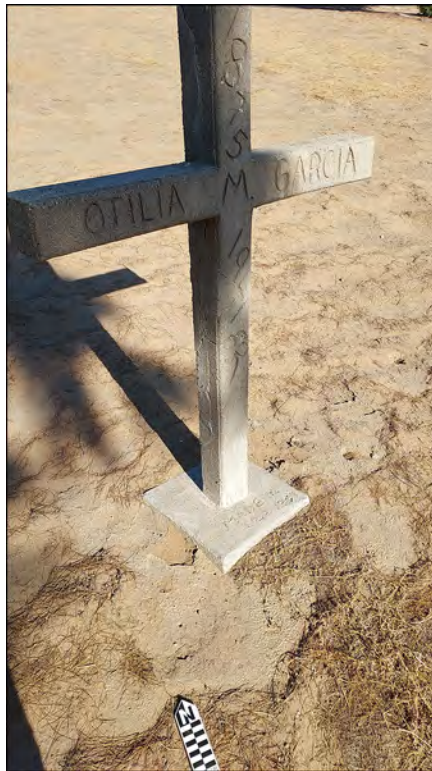
Feature PD: 825

Damage type(s): cracked

The grave marker is composed of a concrete cross on a square concrete base. The base is inscribed, "1875/OTILIA M. GARCIA/1941". The name is written horizontally across the cross, and the birth and death dates are written vertically, above and below the name. A four-leaf clover is inscribed below the death date. At the bottom of the cross, where it attaches to the base, are initials: "A. [or R.?] Q." The base of the monument is a square concrete block. The bottom of the base is inscribed, "MADE IN/USA 1957". Given that the death date provided on the monument is 1941, this cross may be a more-recent monument installed in 1957 to replace an earlier monument that is now gone.

Repair type(s): concrete patching

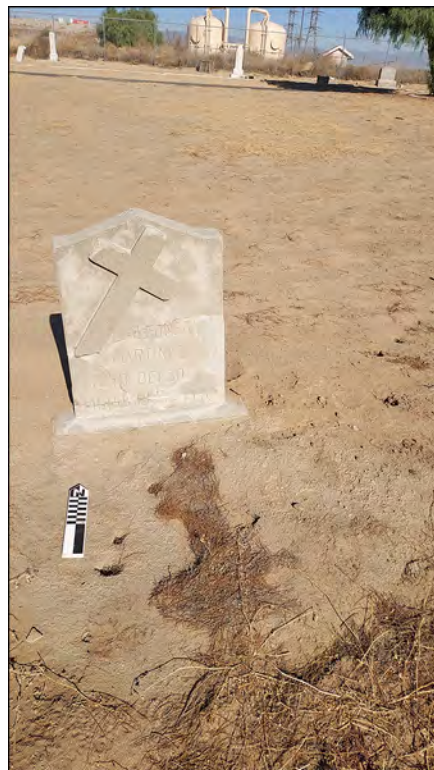
Feature PD: 827

Damage type(s): cracked, fragmentation—loss, buried/sunk, burrowing-animal disturbance

This grave is marked with a die-on-base headstone that has broken into several pieces and been repaired. The headstone is concrete and has a pointed arch on top. It appears to be broken in two at the base and broken again halfway up the monument. The bottom piece is broken into four smaller pieces. When the headstone was repaired, two broken pieces on the eastern side of the headstone were replaced with a concrete patch, which erased some of the inscriptions. One of the two pieces that was replaced is still present, lying on the ground. Based on the text still present on the headstone and on the displaced piece, the inscription reads, “ALFONSO/MARTINEZ/NACIO OCT. 30 1912/MURIO DEC. [. . .] 1941”. The portion of the headstone where the day of death would have been has been lost. There is a large cross decoration above the inscription. The base is a rectangular concrete block with chamfered edges.

Repair type(s): concrete patch

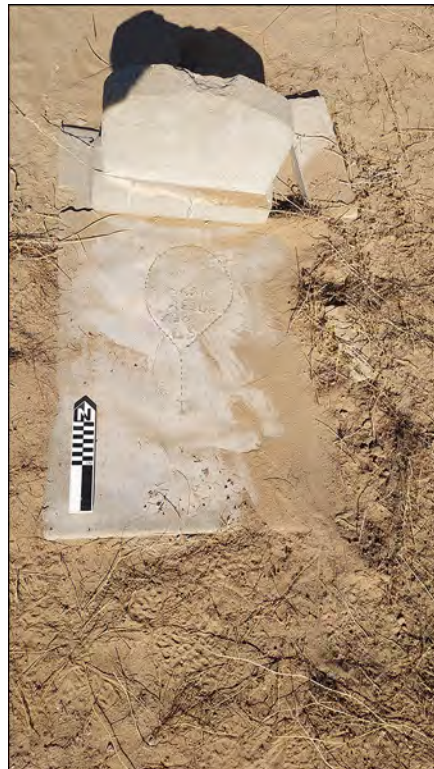
Feature PD: 829

Damage type(s): buried/sunk, fragmentation—loss

The grave marker is composed of a concrete die-on-base headstone and a concrete ledger. The die-on-base headstone features a basket-arch top that held a cross or some other ornament on top that has broken off and been lost. The headstone is set in a rectangular concrete base with chamfered edges. The base is, in turn, sitting on a concrete slab. The headstone is inscribed, “MARIANA DE SALGADO/NACIO JUNIO 26–1872/MURIO MARSO 12-1942”. The inscription was made while the concrete was still wet, using stamped letters. A concrete ledger in front of the base is inscribed, “UN/ROSARIO/RECUE/RDO/L.S.” The inscription was made while the concrete was still wet. A rosary was pressed into the concrete around the inscription, leaving the bead impressions. The ledger is partially buried. A piece of concrete coping is present on the eastern side of the headstone and ledger, but it is displaced. There is no indication that the grave was surrounded by coping; so, this piece may be from another grave.

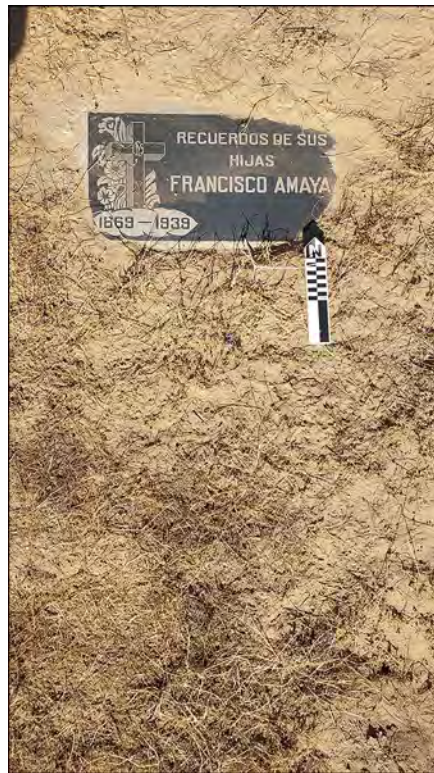
Feature PD: 831

Damage type(s): buried/sunk

This is a lawn-style monument with a concrete base and a polished marble plaque inset. The monument is partially buried but is otherwise in good condition. The inscription on the plaque reads, “RECUERDO DE SUS HIJAS FRANCISCO AMAYA”. The date is written to the left of the name and is part of a decoration carved into the plaque that also features a cross and flowers. The design for the cross and flowers is identical to the one on the Feature 709 plaque.

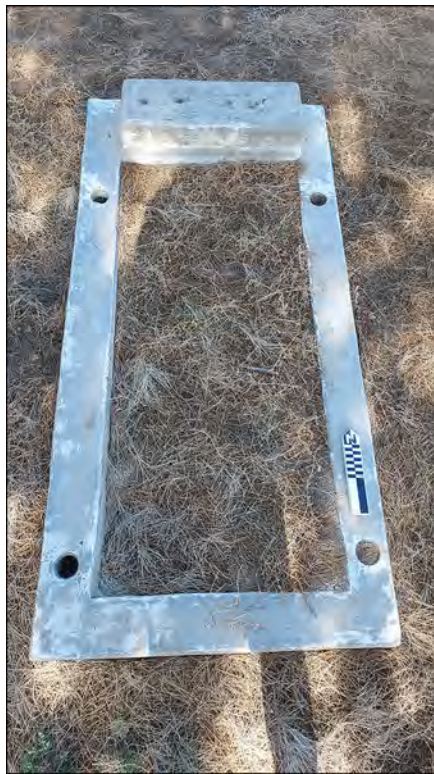
Feature PD: 833

Damage type(s): fragmentation—loss, cracked

This is a die-on-base monument with concrete coping around the grave. The headstone is missing, and all of the monument that is present is the rectangular concrete base, which has square edges. The holes for reinforcement of the headstone are still present. The concrete coping is present on the western, southern, and eastern sides. There are four holes for flowers or candles, two on the western side and two on the eastern side (one near each of the four corners of the grave).

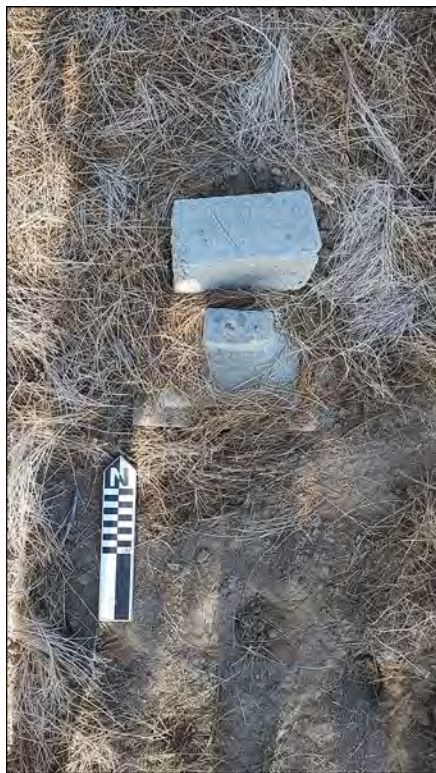
Feature PD: 835

Damage type(s): fragmentation—loss, ground loss, burrowing-animal disturbance

The grave marker is composed of a disassembled concrete monument component, a block or base. The original monument style is unclear because something was broken off from the center of the base. There is a concrete block next to the base with a “V” inscribed on the side. This block is smooth on three sides but rough on the western side. The foundation of the base is exposed. There is animal-burrowing activity near the grave marker.

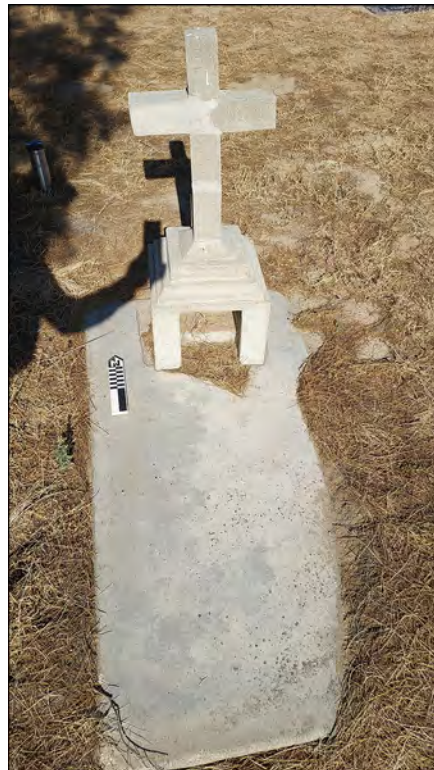
Feature PD: 837

Damage type(s): buried/sunk, displacement, cracked

The grave is marked by a concrete cross on top of a grotto or shrine, atop a concrete ledger. The grave marker overall is in excellent condition. The ledger is smooth and has no visible cracking or chips. The grotto/shrine feature has a square opening for an item of religious or spiritual significance. The grotto/shrine has been dislocated from the original installation spot, and the original location shadow is visible. The cross is cracked and has visible signs of repair with plaster. It was repaired in the center of the bottom portion as well as the western portion. The repaired areas of the cross were not reinscribed; therefore, the remnants of the original inscription are all that is present. The cross is inscribed as follows:

Repair type(s): repair—hard cement

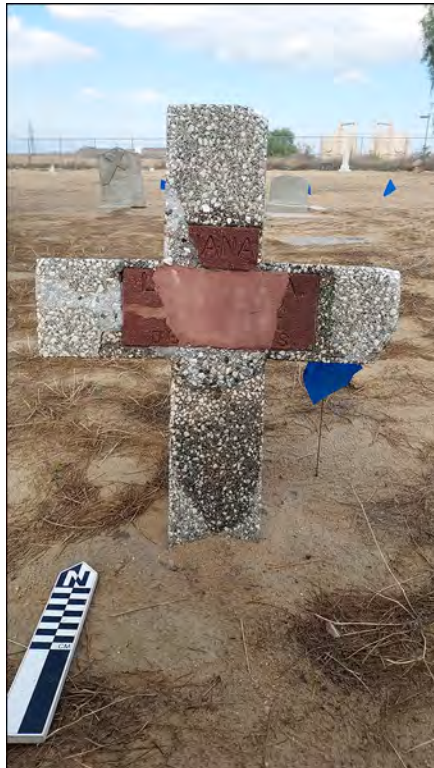
Damage type(s): tilted/fallen, cracked, spalling

The grave feature is marked by a concrete cross. The concrete has a larger pebble inclusion with an inset brick-colored plaque. The plaque is inscribed but is fragmented and has had plaster repairs over time. There is patching in the center of the inscription, making it illegible. The cross is tilted slightly to the east. There are a few fragments missing/chipped from the corners.

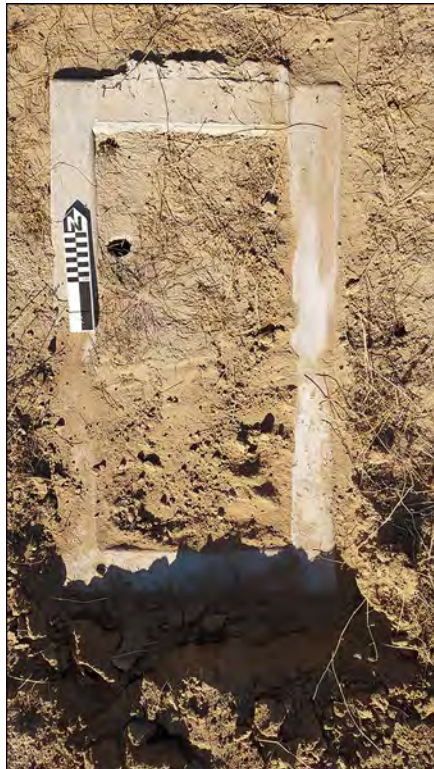
Feature PD: 841

Damage type(s): fragmentation—loss, buried/sunk, burrowing-animal disturbance

The grave is marked by rectangular concrete coping and a missing headstone. On the northern edge of the coping was the original headstone that is now missing. The coping is partially buried on the southern end of the grave plot. There is rodent-burrowing activity both inside and outside the grave-marker coping.

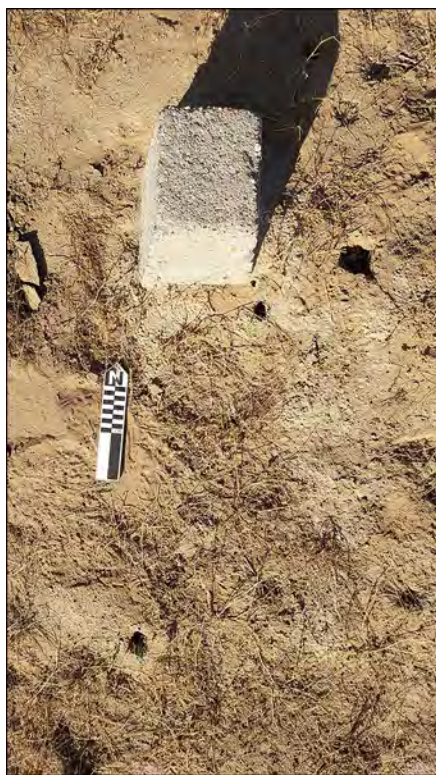
Feature PD: 843

Damage type(s): disassembled—loss, burrowing-animal disturbance

The grave marker is composed of a coarse concrete block. This block has no inscription, and it is unclear whether there are any missing pieces. There is rodent-burrowing activity on the southern and eastern sides of the block.

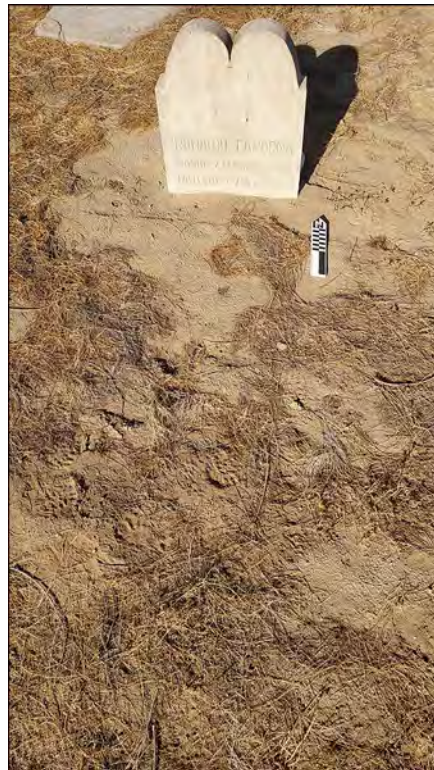
Feature PD: 845

Damage type(s): cracked, disassembled—loss

The grave is marked by a cement headstone. The headstone has minor cracks on the face and is in good condition overall. There was a photo or image attached to the face of the headstone, but it has been removed and lost. The headstone is hand inscribed as follows:

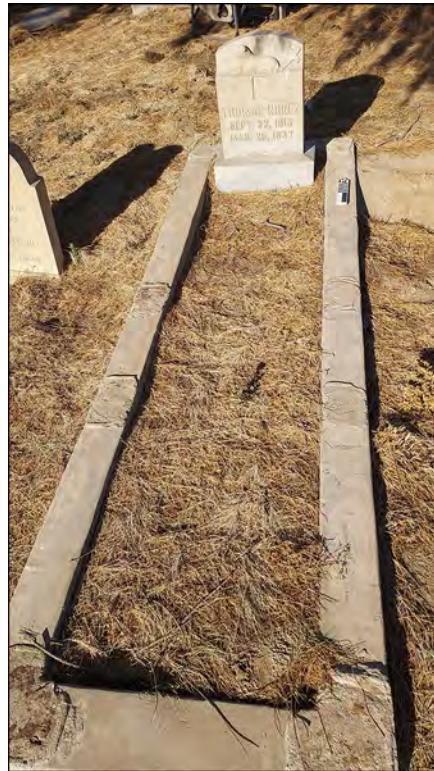
Feature PD: 847

Damage type(s): fragmentation—loss, cracked, disassembled—loss

The grave is marked by smooth, squared concrete coping and a concrete headstone on a base. The coping has cement remnants in eight different spots on top of the coping, likely to attach additional bricks or features that are no longer present. The coping has a few minor cracks. The headstone is in good condition and appears to possibly have been a modern addition. The base is smooth on all sides and has chamfered edging along the top. On top of the headstone are a lamb figurine and a cross. There is a placeholder for a photo or insert that has been disassembled or removed. The headstone is inscribed, “THOMAS NUÑEZ/SEPT. 22, 1913/MAR. 28, 1937”.

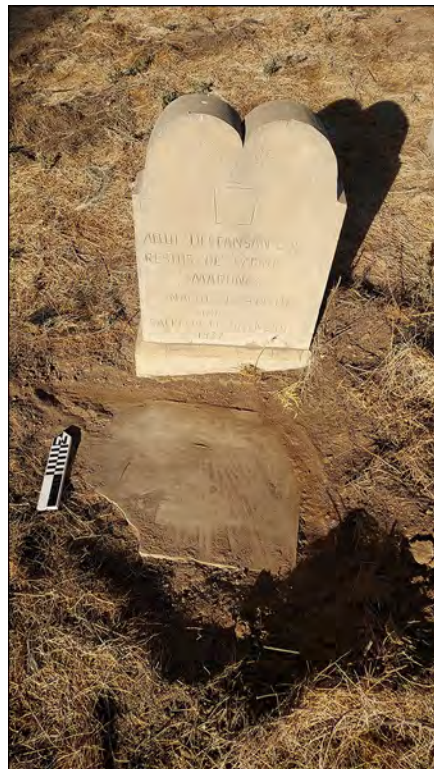
Feature PD: 849

Damage type(s): fragmentation—loss, cracked, buried/sunk, tilted/fallen

The grave is marked by a concrete headstone and base and a block. The ledger is cracked, and the southwestern corner is broken off and missing. The base has minor cracking, and the top edges are chamfered. At the top of the headstone is a flowerpot motif inscribed with the following:

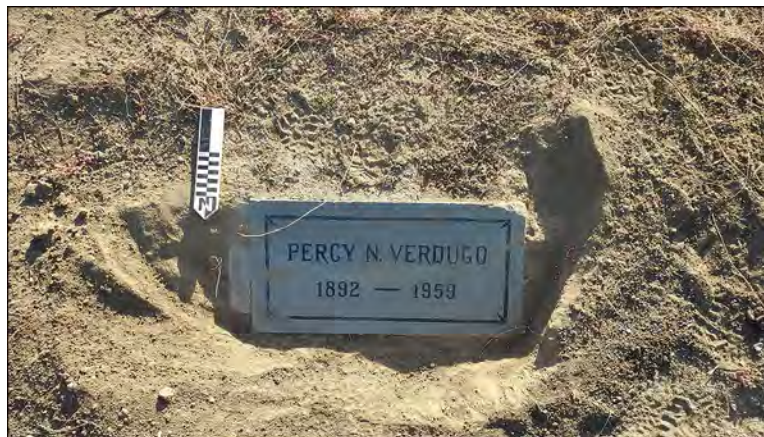
Feature PD: 851

Damage type(s): fragmentation—loss, buried/sunk

This is a lawn-style monument with a rectangular granite plaque set in a rectangular concrete base. Much of the base is broken at or missing from the northern, western, and southern ends. The granite plaque is light gray. The surface of the plaque is rough, except for the lettering and a rectangular border around the lettering; these areas are smooth and much darker than the surrounding rock. The plaque is inscribed, “PERCY N. VERDUGO / 1892–1959”. It is partially buried, and the northeastern corner is chipped.

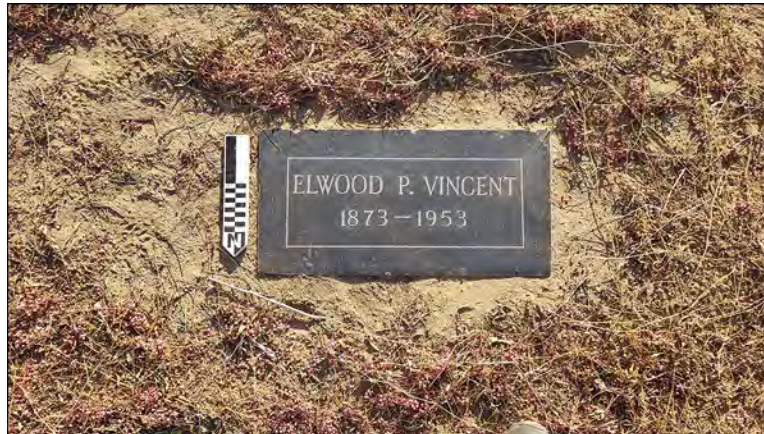
Feature PD: 853

Damage type(s): buried/sunk, spalling

This is a lawn-style monument made of a black granite plaque with no concrete base. The surface of the plaque is polished and is inscribed, “ELWOOD P. VINCENT/1873–1953”. The monument is slightly buried and has a few small chips along the edges, but otherwise, it is in good condition.

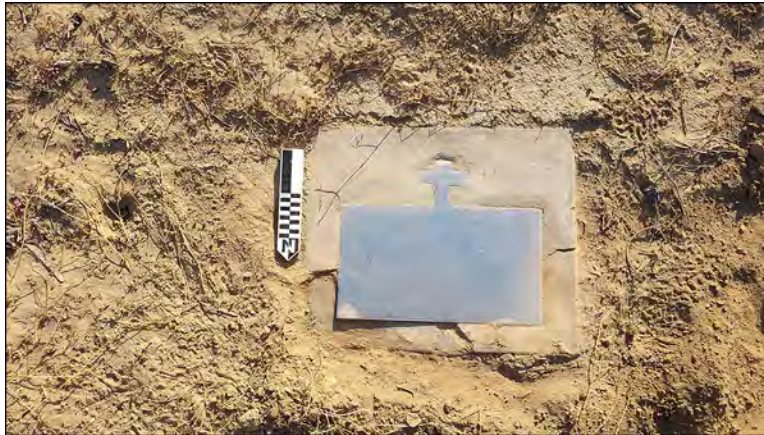
Feature PD: 855

Damage type(s): fragmentation—loss, cracked, fragmentation—no loss, erosion

This grave is marked with a rectangular concrete base and an inset aluminum plaque. The concrete is cracked and has some broken pieces that are displaced but not lost. The aluminum plaque is rectangular and has a cross on one of its long sides, the southern side. This suggests that either the grave is oriented south–north, instead of north–south like most of the other graves at the cemetery, or the marker is oriented incorrectly. The plaque is intact but has no inscription. There are some light scratches on the surface, suggesting that there may have been another plaque on top of the aluminum; if so, it has been lost.

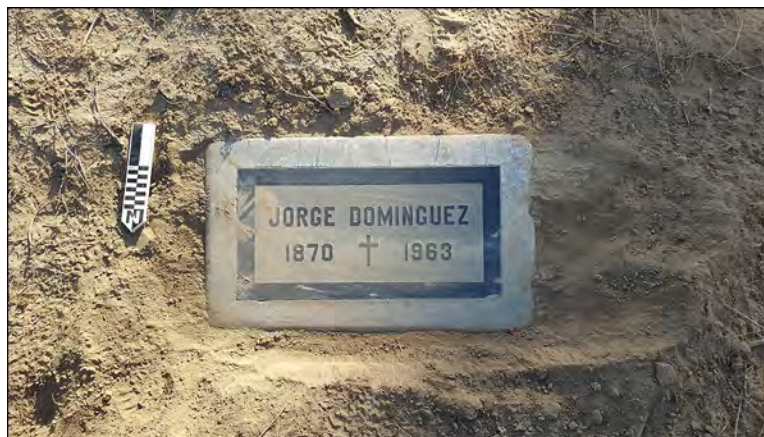
Feature PD: 857

Damage type(s): buried/sunk, cracked, spalling

This is a lawn-style monument with a black granite plaque set into a concrete base. The concrete base is rectangular and has slightly rounded edges. The plaque is rectangular and is inscribed, “JORGE DOMINGUEZ/1870–1963”. There is a cross between the birth and death dates and cracking in the concrete base that surrounds the plaque, as well as minor spalling on the edges.

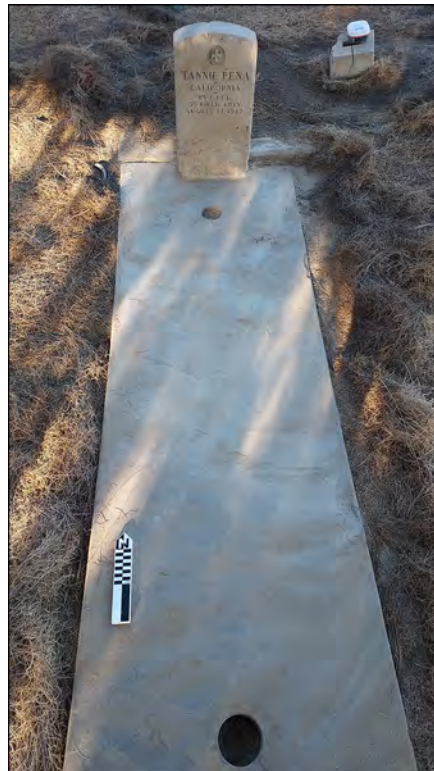
Feature PD: 859

Damage type(s): cracked, spalling

This is a military grave with a concrete ledger and a marble headstone. The ledger is a simple concrete rectangle with two holes for flowers or candles, one by the headstone and one at the foot. The headstone is concrete in a general-type government-issue style with a basket-arch top. The headstone is set on top of the ledger and is inscribed, “TANNIE PENA/CALIFORNIA/PVT. 1 CL./59 FIELD ARTY. /AUGUST 14, 1942”. There is a cross inside a circle design above the name at the top of the monument. There are a few cracks and some spalling on the headstone, but otherwise, the monument is in good condition. There is a segment of coping (Feature 1127) along the northern edge of the ledger that extends eastward to the neighboring grave, Feature 861.

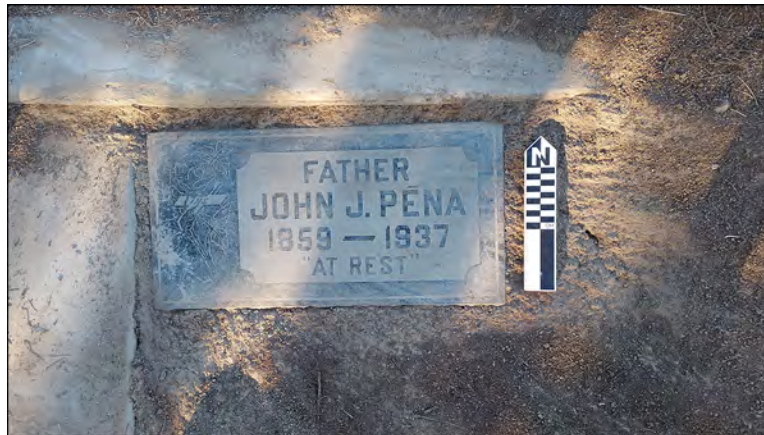
Feature PD: 861

Damage type(s): tilted/fallen

This is a lawn-style monument immediately east of Feature 859. Because both people have the last name “Pena,” they are likely related. The monument is a black granite plaque with no concrete base. The plaque is inscribed, “FATHER/JOHN J. PÉNA/1859–1937/”AT REST”. There is a cross-and-flower motif inscribed to the left of the rest of the inscription. The inscriptions are modern laser inscriptions; so, this monument may be a replacement for an early monument that is no longer present. The monument is in good condition but is slightly tilted. There is a segment of coping (Feature 1127) along the northern edge of monument that extends eastward.

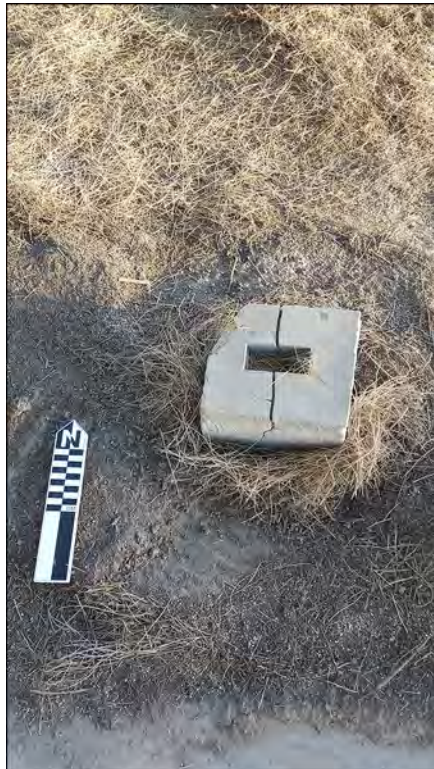
Feature PD: 863

Damage type(s): fragmentation—loss, cracked, spalling, abrasion

This grave is marked by a disassembled monument component. All that remains is a square concrete base with a rectangular notch in the center that likely held a cross. The base is cracked in two but not displaced, but the cross is missing. There is minor spalling across the top and edges and possible abrasion from lawn maintenance. This monument is inside a concrete coping plot, Feature 1127.

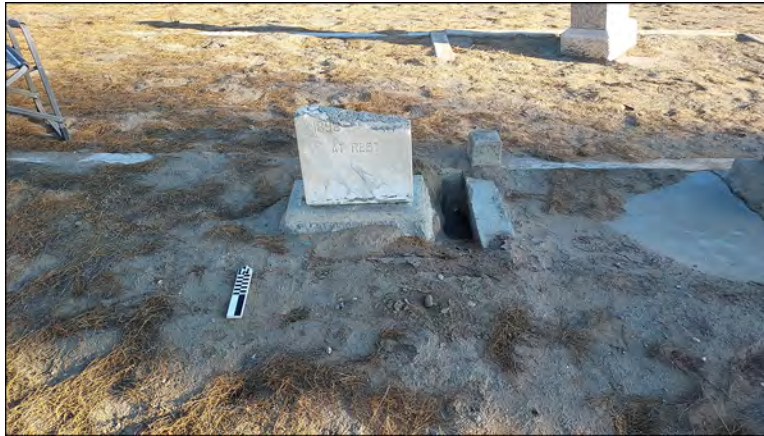
Feature PD: 865

Damage type(s): fragmentation—loss, burrowing-animal disturbance, open joints

This is a die-on-base monument with a concrete base and a marble headstone. The base is rectangular and has straight edges. It looks to have been poured in place, because the sides are very rough. The headstone is made of marble, but the upper half is broken off and missing. The only remaining inscription is “1898–[. . .]/AT REST”. There is concrete on the break, indicating that the headstone was reattached at some point but broke off again and is missing, displaying an open joint. There is concrete coping on the northern side of the headstone, but it is part of a larger plot to the north of this grave.

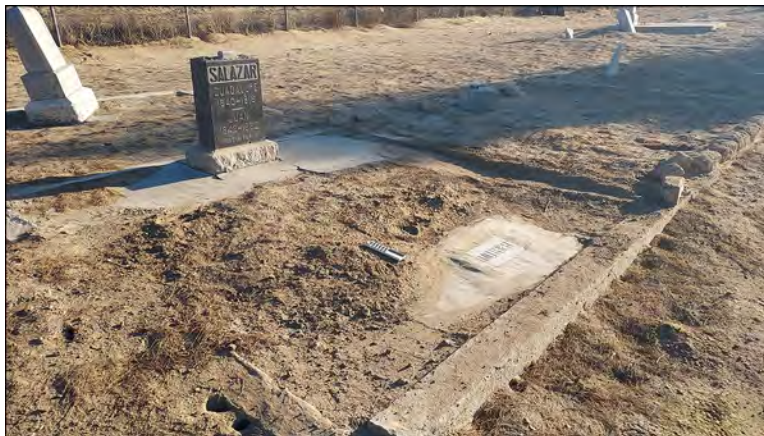
Feature PD: 867**Name:** Guadalupe and Juan Salazar**Dates:** Guadalupe: 1840–1918, Juan: 1842–1932**Monument type:** die on base**Enclosure:** concrete (Feature 886)**Damage type(s):** fragmentation—loss, buried/sunk, cracked, burrowing-animal disturbance**Repair type(s):** none**Description:**

This is a double grave for Guadalupe and Juan Salazar. The grave consists of a single die-on-base headstone with a footstone. The graves are set within one of several family plots that are all marked by a network of concrete curbs. The curbs (Feature 886) were built as a single piece that defines several plots in the area. The main monument is a black marble or granite headstone sitting on top of a white/gray granite base. The headstone has a polished front and rock-pitched sides and top. There is a concrete piece on the tip of the headstone that must have held an ornament, but the ornament is missing. The headstone is inscribed, “SALAZAR/GUADALUPE/1840–1918/JUAN/1842/1932/REST IN PEACE”. It is set on a white granite base that has chamfered edges and a rock-pitched finish around the sides. The surface of the grave within the curbing was paved with concrete; parts of it are visible in the northern and southern parts of the grave. The surface is cracked and broken, and there is considerable soil across the rest of the grave; so, it is not clear whether the entire surface of the grave is covered or not. At the southern side of the grave, a rectangular white marble plaque has been affixed to the ledger with concrete. It is inscribed, “MOTHER”. There is animal burrowing to the west and south of the concrete ledger.

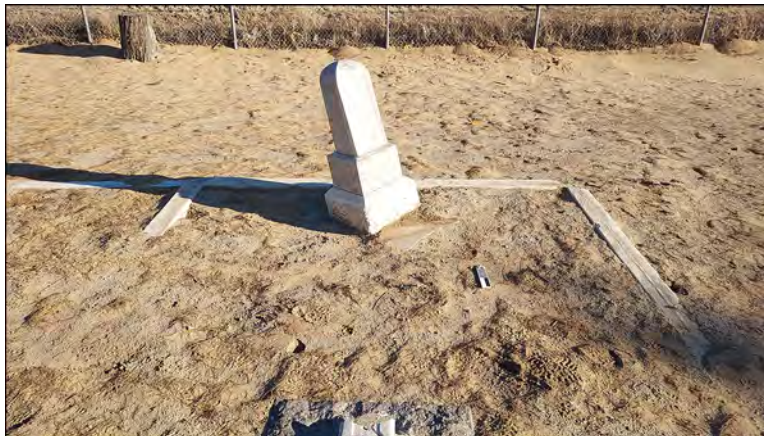
Feature PD: 869

Damage type(s): tilted/fallen, burrowing-animal disturbance

This is a double grave for Guadalupe S. and M. T. Peters. The grave consists of a single obelisk headstone. The graves are set within one of several family plots that are all marked by a network of concrete curbs (Feature 885). The curbs were built as a single piece that defines several plots in the area. The monument is a three-tiered white/gray granite obelisk on a concrete-slab base. The monument is rotated 45° relative to the layout of the concrete curb, so that the southeastern side faces one of the burials and the southwestern side faces the other. The concrete base was poured in place and likely was meant to be underground but is partially exposed on the eastern side. The first tier of the obelisk is a square granite block with chamfered edges and rock-pitched sides. The middle tier is also square and has smaller chamfered edges. Two sides are inscribed. The southeastern side is inscribed, “GUADALUPE S. PETERS/1868–1910”. The southwestern side is inscribed, “M. T. PETERS/1856–1928”. The upper tier is the tallest and has a rounded top. The southeastern face, above the inscription for Guadalupe Peters, is inscribed with a large cross. The entire monument is tilted to the west, but it is otherwise in good condition.

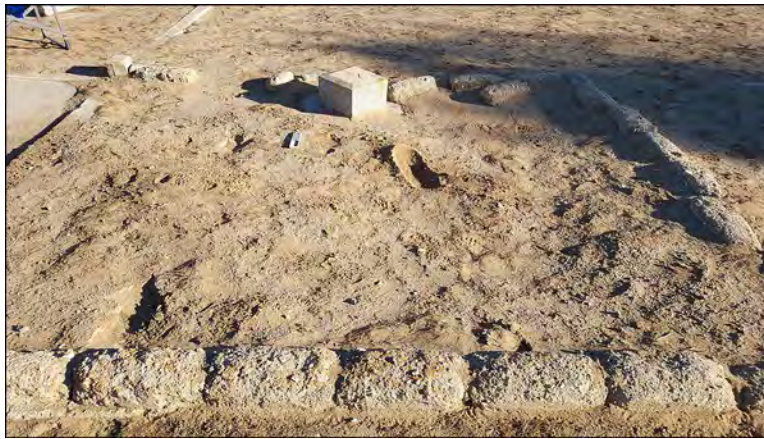
Feature PD: 871**Name:** unknown**Dates:** unknown**Monument type:** disassembled component/component fragment, ledger**Enclosure:** concrete (Feature 887)**Damage type(s):** fragmentation—loss**Repair type(s):** none**Description:**

This is likely a double grave with a broken monument that contains no information on the individuals buried there. The graves are set within one of several family plots that are all marked by a network of concrete curbs (Feature 887). The curbs were built as a single piece that defines several plots in the area. At this grave, additional loaf-shaped concrete blocks have been added to the tops of the northern, eastern, and western sides of the curb. The portion of the monument that is still present consists of a square granite block on a concrete ledger. The concrete ledger is mostly buried but may extend across the entire grave. The granite block is roughly a cube with chamfered edges and sits on top of the ledger. There is glue in the center of the block that likely held the upper part of the monument. The monument is 45° relative to the orientation of the coping, similar to Feature 869.

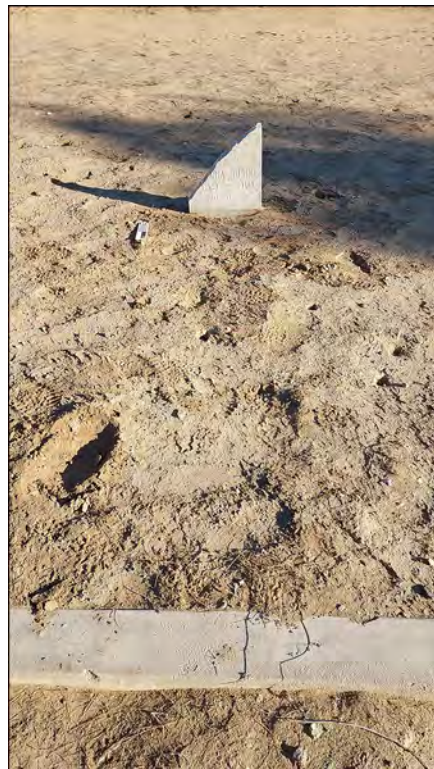
Feature PD: 873

Damage type(s): fragmentation—loss, buried/sunk

This grave is marked by a white marble headstone that is missing its top and half its left side. The headstone is sinking and has what looks like a triangle inscribed on it, at the top, as well as the following:

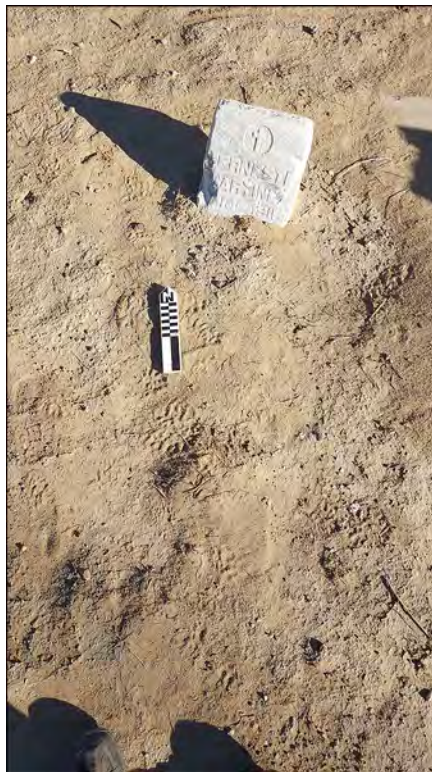
Feature PD: 875**Name:** Ernest [. . .]artinez**Dates:** [1]914–1915 (1 year and 5 months)**Monument type:** slant marker**Enclosure:** concrete (Feature 1025)**Damage type(s):** fragmentation—loss, buried/sunk, abrasion**Repair type(s):** none**Description:**

This grave is marked by a marble slant-marker-style headstone. The headstone is fragmented on the left- and right-front sides and is sinking into the ground. There are some scratches on the front of the headstone. The headstone is rock pitched on the top and sides. There is a cross motif on the top of the face of the headstone, as well as the following inscription:

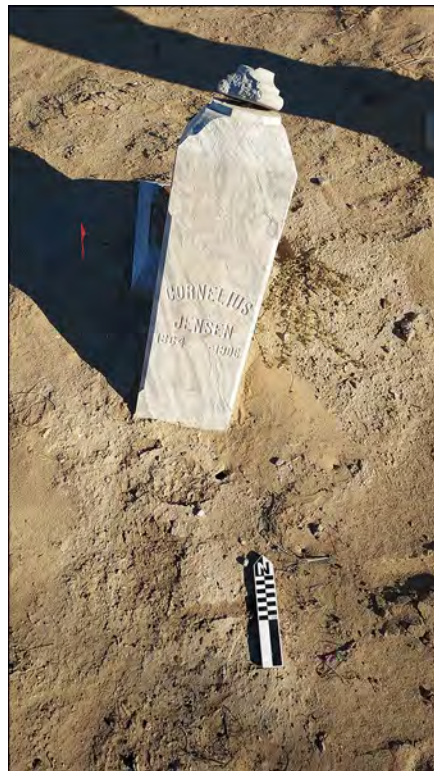
Feature PD: 877

Damage type(s): disassembled—no loss, fragmentation—loss, tilted/fallen, buried/sunk

This grave is marked by a white or light-gray obelisk. The pedestal/base has a chamfered edge along the top. The main headstone has become detached from the base stone, and the cement is visible. On the western side of the base is the inscription, “JENSEN.” The base is sinking beneath the ground surface, and the “JENSEN” inscription is mostly buried. The headstone also has a chamfered edge, running top to bottom. There is possibly an urn or statue attached at the top that has been broken and lost. There is a border design inscribed on the top of the headstone that wraps around. The headstone is inscribed as follows:

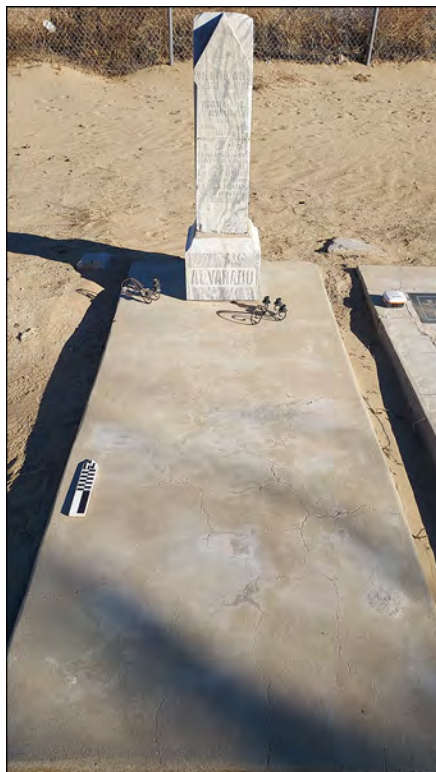
Feature PD: 879

Damage type(s): abrasion, cracked, open joints

This grave is marked by a white/light-gray marble obelisk and base with a cement ledger. The ledger is cracked and has two candelabras next to the headstone. The base or pedestal for the obelisk is inscribed “ALVARADO” across the front, bottom face. The top edges of the base/pedestal are chamfered. There is evidence of reattachment of the obelisk to the base with cement at the joint. The sides appear to have open joints, and the front seal is in better shape. The obelisk has cracked completely in half longways and has been repaired/rejoined. There are many scratches on the tombstone. At the top of the obelisk, on the eastern and western sides, are inscribed cross motifs. On each of the northern and southern sides is a motif of a dove with a branch in its mouth, on a dotted background. The obelisk is inscribed as follows:

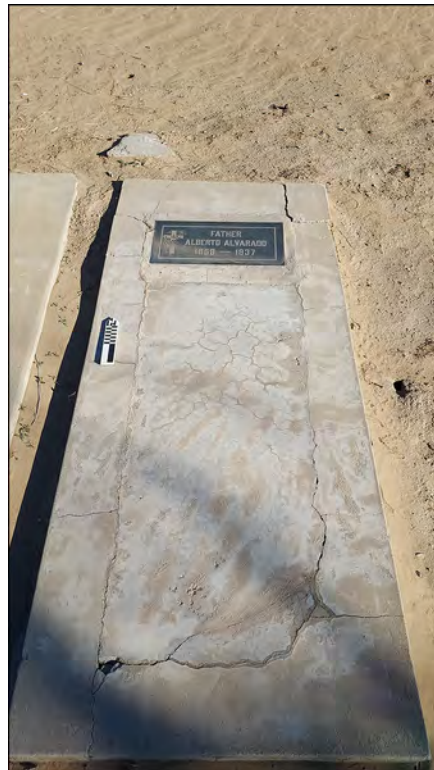
Damage type(s): abrasion, cracked, burrowing-animal disturbance, spalling

This grave plot is marked by a black marble, lawn-style monument inset within a concrete ledger. The ledger is cracked and spalling, and the headstone is a modern addition. The ledger is squared on the edges, and some abrasion is present. The black marble inset has a simple border around the edge and a cross motif with “ihs” inside it and flowers surrounding it. The remainder of the inset is inscribed as follows:

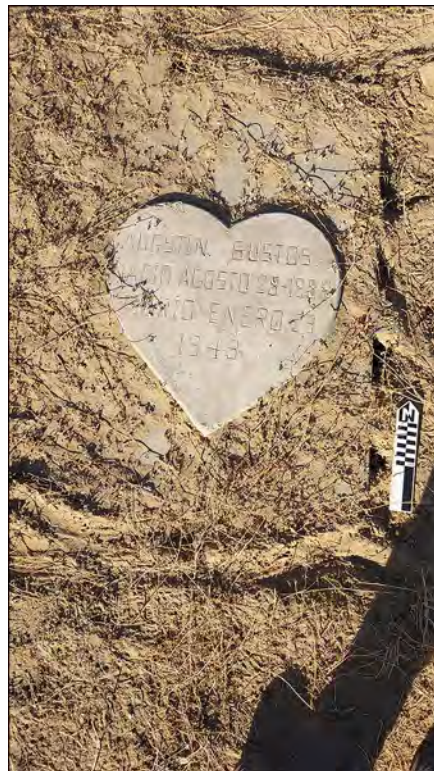
Feature PD: 901

Damage type(s): buried/sunk, burrowing-animal disturbance

This grave is marked by a heart-shaped cement block or marker on top of a cement ledger. The ledger is sinking and partially buried beneath the surface. There is rodent-burrowing activity on the eastern edge of the ledger. The heart-shaped marker is inscribed as follows:

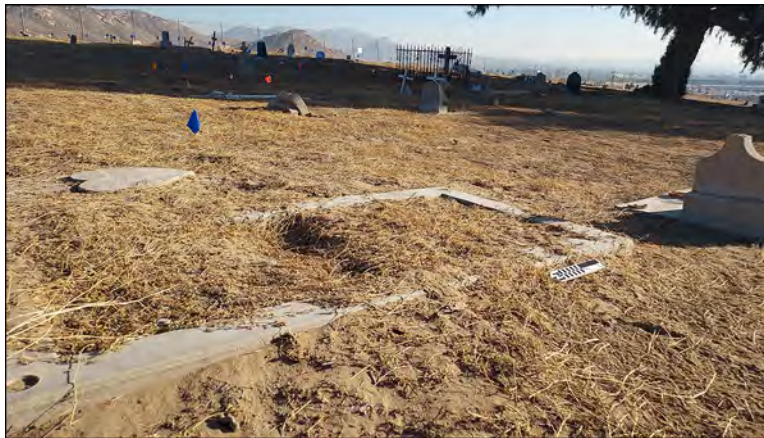
Feature PD: 903

Damage type(s): burrowing-animal disturbance, buried/sunk

This grave plot is marked by squared concrete coping surrounding the border. There are four small holes for a flower vase or candle in each corner. There is no monument present, and no inscriptions were visible. There is rodent disturbance within and outside the coping.

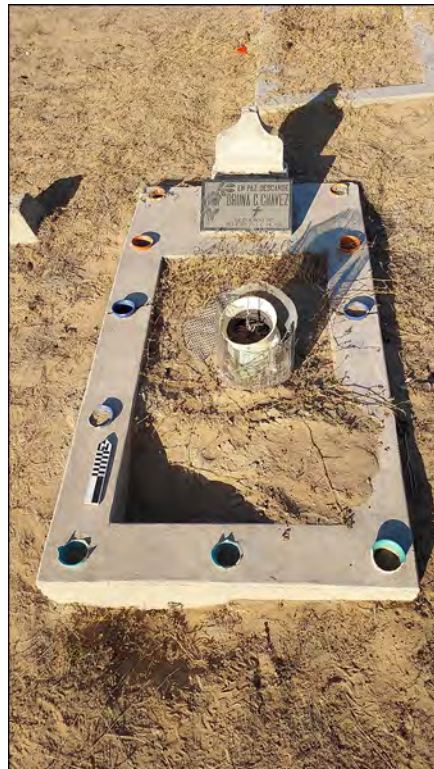
Feature PD: 906

Damage type(s): fragmentation—loss, cracked, burrowing-animal disturbance, spalling

The original headstone is fragmented across the top, has no inscription present, and appears to have once been a cross. Eleven ceramic pots (many fragmented) in multiple colors (orange, blue, green, yellow, etc.) are around the coping (Feature 906). The remains of a potted plant is in the center of the grave, wrapped in chicken wire. There is a hole in the southwestern inside corner of the coping from rodent-activity disturbance.

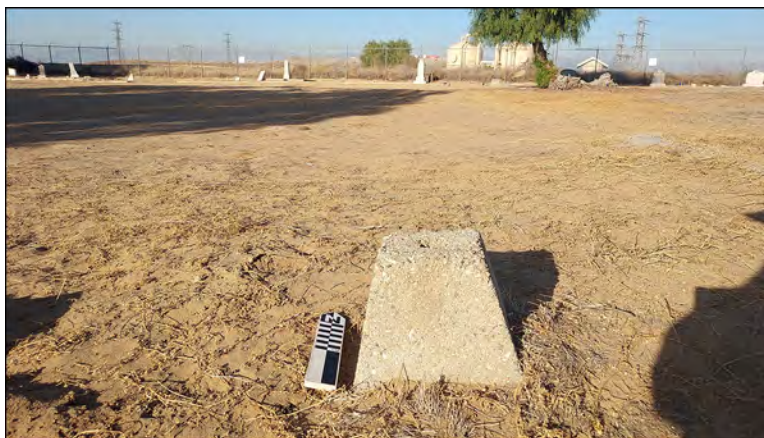
Feature PD: 910

Damage type(s): fragmentation—loss, tilted/fallen

This grave is marked by a coarse, square concrete base with a hole in the top, most likely for a cross. The square base is leaning to the west.

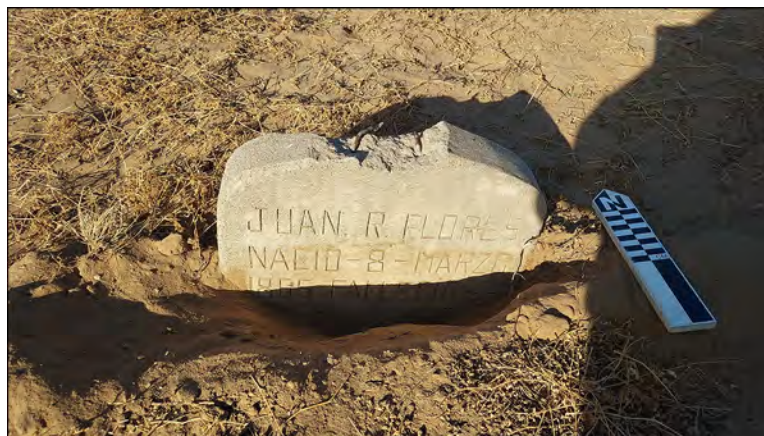
Feature PD: 912

Damage type(s): fragmentation—loss, buried/sunk

This grave is marked by a concrete basket-arch-style headstone. The headstone is missing something from the top, and two metal fragments are protruding out. The headstone is sinking and is over half-buried beneath the surface. It is inscribed as follows:

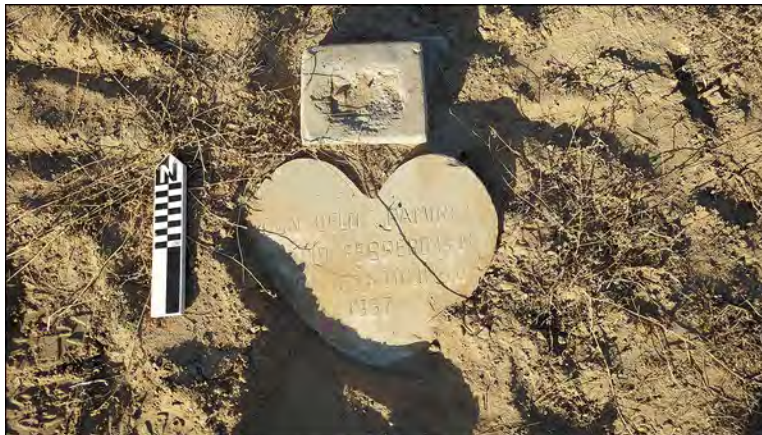
Feature PD: 914

Damage type(s): ground loss, fragmentation—loss, buried/sunk, burrowing-animal disturbance, erosion, spalling

This grave is marked by a cement heart-shaped block and a square cement base. The base has chips out of the edges and corners and two metal stakes coming out that used to help support the monument that was broken from it. The base has an exposed foundation on the northern side and is tilting to the north a little. The heart-shaped block does not appear to have been connected to the base. It is buried in the southwestern corner and has rodent activity in the northeastern corner. The heart has a few chips broken off from the edges, and erosion has made the inscription difficult to read: “FALLACIO”. The heart-shaped block has the following inscription:

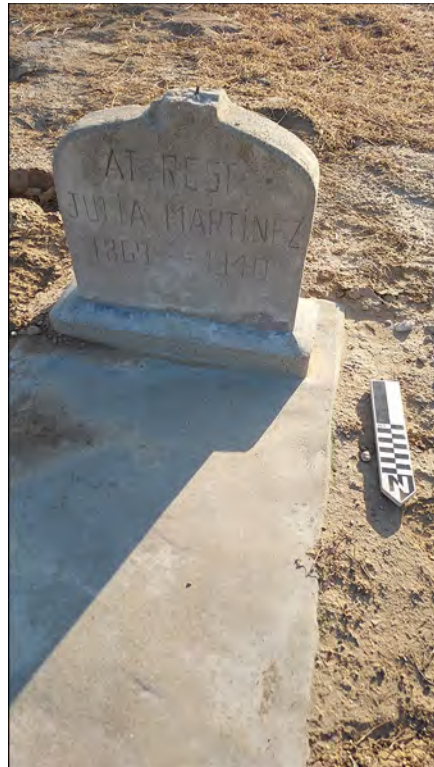
Feature PD: 916

Damage type(s): fragmentation—loss, buried/sunk

This grave is marked by a cement headstone on a cement base atop a cement leger. The headstone has something broken off from the top of it and displays a piece of rebar reinforcement. The base is chamfered along the top edges, and the ledger is sinking at the southern end. This grave plot is associated with concrete-boundary Feature 940.

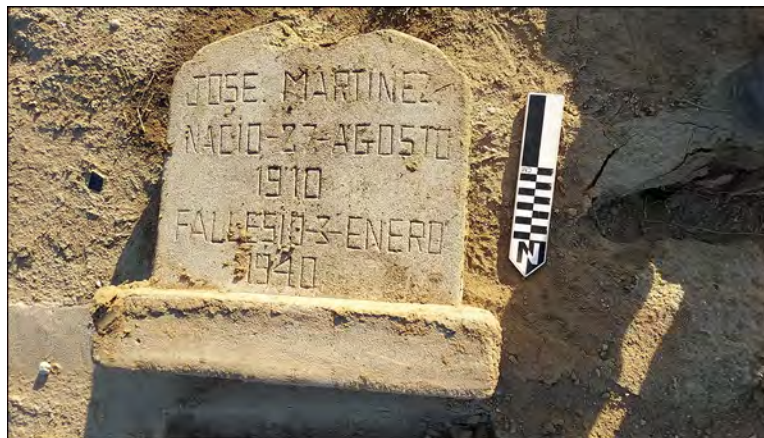
Feature PD: 918

Damage type(s): fragmentation—loss, abrasion, burrowing-animal disturbance, tilted/fallen

This grave is marked by a concrete tab-in-socket monument that was found face down in the soil, having fallen to the north. The headstone has a chunk missing from the top edge. There are minor scratches along the edge of the base, and there is animal burrowing near the monument. The inscription on the headstone reads as follows:
