Archaeological Condition Assessment and Ground-Penetrating Radar (GPR) Surveys for Agua Mansa Cemetery, San Bernardino County, California

Technical Report 24-26
Statistical Research, Inc.
Redlands, California

April 2024

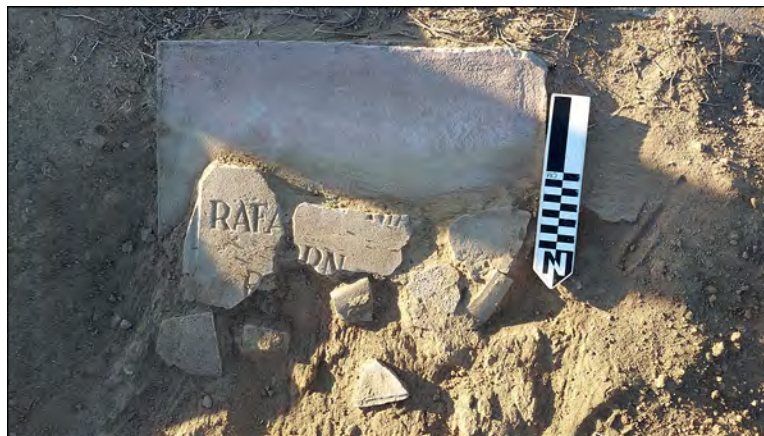
Damage type(s): fragmentation—loss, cracked, buried/sunk, tilted/fallen

This grave is marked by a red cement ledger. The ledger is tilted, likely from sinking at the foot end, and the northern end is mostly buried. The ledger is missing pieces, making the name difficult to read, and the dates are completely gone. The inscription that can be read from the fragments is “RAFA[. . .] MA[. . .]/B[. . .]RN”. This grave plot is associated with concrete-boundary Feature 940.

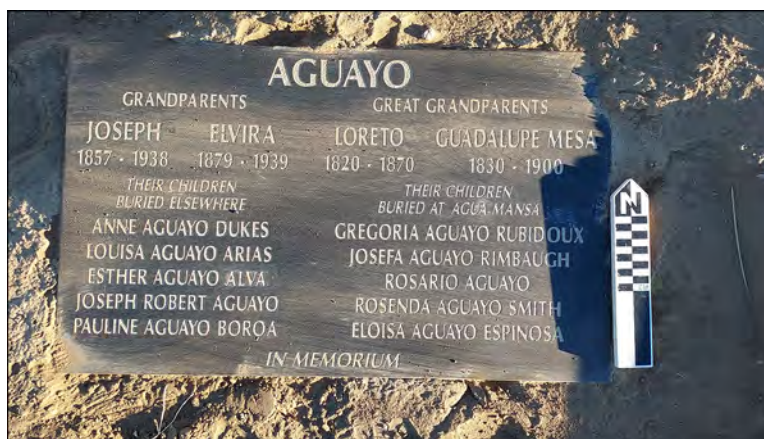
This grave is marked by a modern black marble lawn-style marker. This marker signifies the remembrance of 14 people but notes that 9 were buried at Agua Mansa and the 5 were buried elsewhere. The stone is modern and looks in good condition. There is minor sinking of the monument, and minor rodent burrowing disturbance was noted nearby. The stone inscription reads as follows:

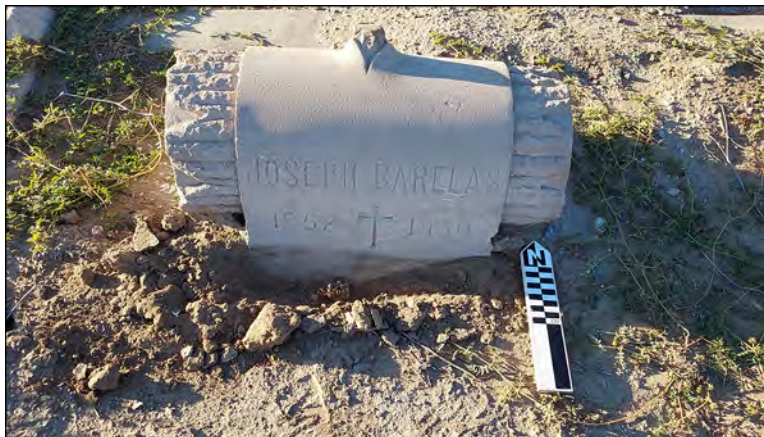
Feature PD: 924

Damage type(s): burrowing-animal disturbance, buried/sunk, abrasion, tilted/fallen

This grave is marked by a concrete log-shaped monument with an inscribed overlay. There is evidence of rodent-burrowing activity near the stone and a few minor scratches across the surface. The eastern side has begun to sink, and therefore, the monument is leaning slightly in that direction. The stone is inscribed with “JOSEPH BARELAS/1852 [cross motif] 1930”. This grave plot is associated with concrete-boundary Feature 940.

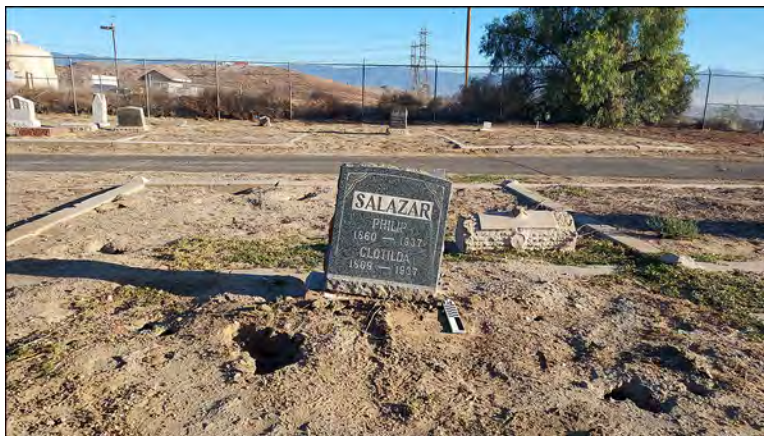
Feature PD: 926

Damage type(s): tilted/fallen, buried/sunk, burrowing-animal disturbance, open joints

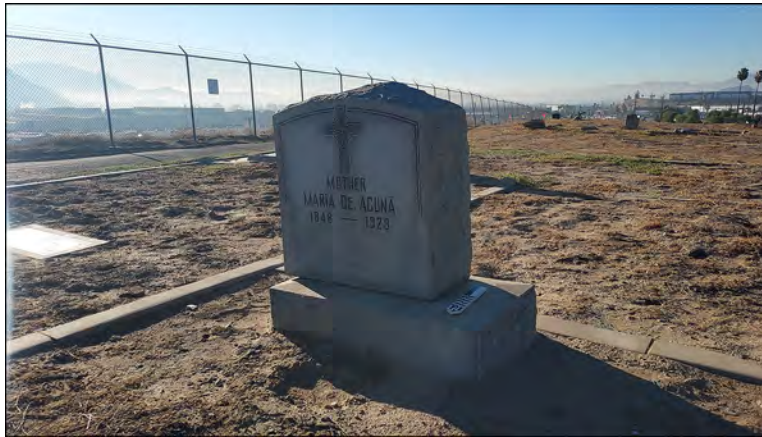
Feature PD: 928

Damage type(s): burrowing-animal disturbance, open joints

This grave is marked by a granite die-on-base headstone. The headstone is offset from the base, having moved eastward. The base has chamfered edging along the top and is rock pitched on the other sides. The outside frame has minor cracking on the top edge. The headstone is rock pitched on the top, sides, and back, and the front is smooth. The headstone has an intricate cross design at the top, with the following inscription:

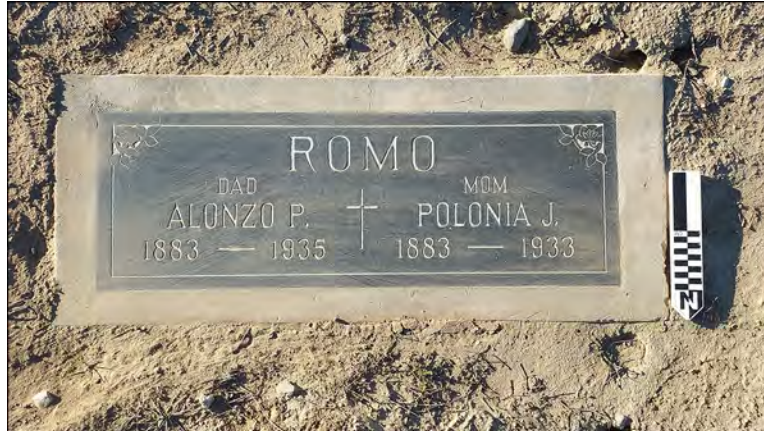
Feature PD: 930

Damage type(s): buried/sunk, burrowing-animal disturbance

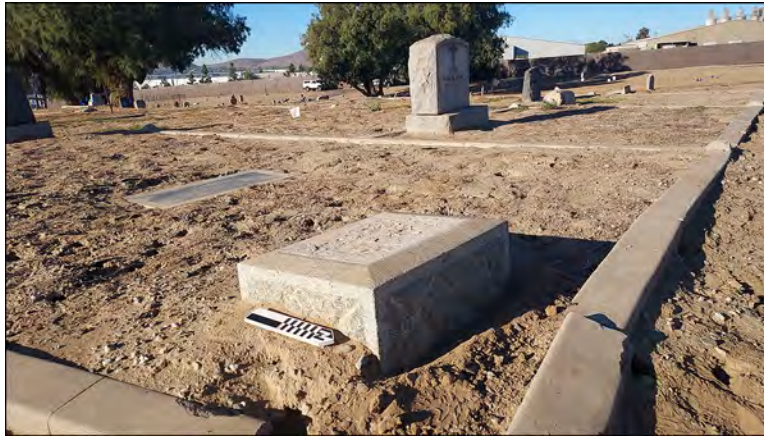
Feature PD: 932

Damage type(s): disassembled—loss, buried/sunk, burrowing-animal disturbance

This grave is marked by a decorated granite block that is missing the headstone. The block has cement on the top where the headstone sat. The top edges are chamfered, and the corners are squared. The sides of the base have a diamond or grid-like pattern. The eastern side of the block is buried a little, and rodent-burrowing activity is present. This block is within rectangular-coping-complex Feature 940.

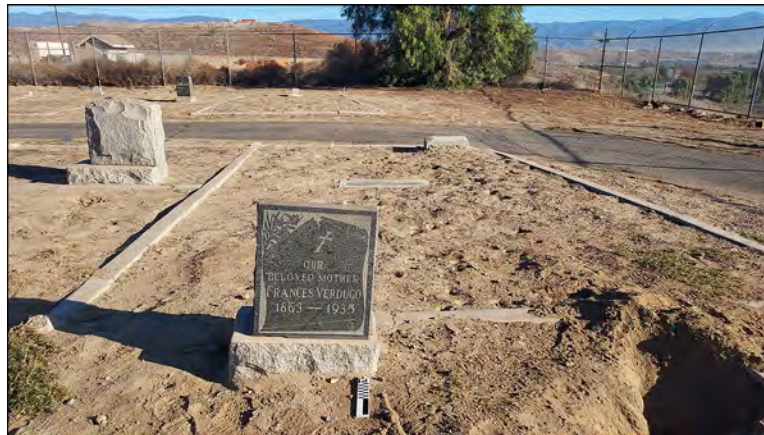
Feature PD: 934

Damage type(s): buried/sunk, open joints, tilted/fallen

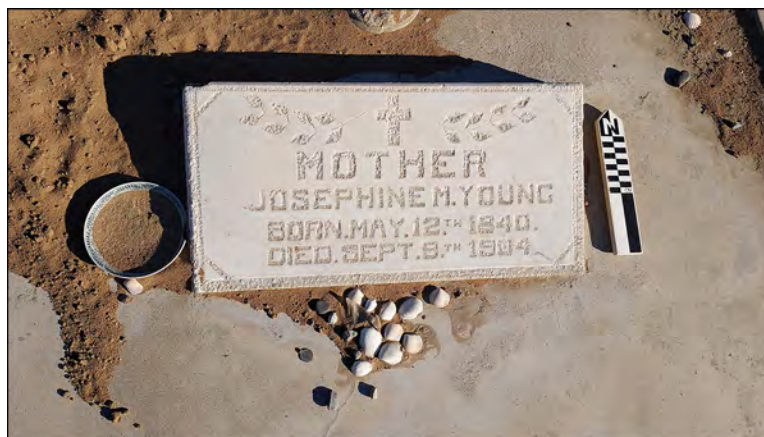
Feature PD: 938

Damage type(s): fragmentation—loss, burrowing-animal disturbance

There are shells, a glass jar fragment, and a coin at the base of the headstone. To the left of the headstone is a white bowl with a navy decorative pattern on the inside; it is filled with sand. The ledger has two holes for flower vases or candles, one at each of the southern corners. Minor fragments are missing from the edge of the headstone, and there is a statue or vase that has broken off the ledger, above the headstone. There is rodent-burrowing activity surrounding the ledger.

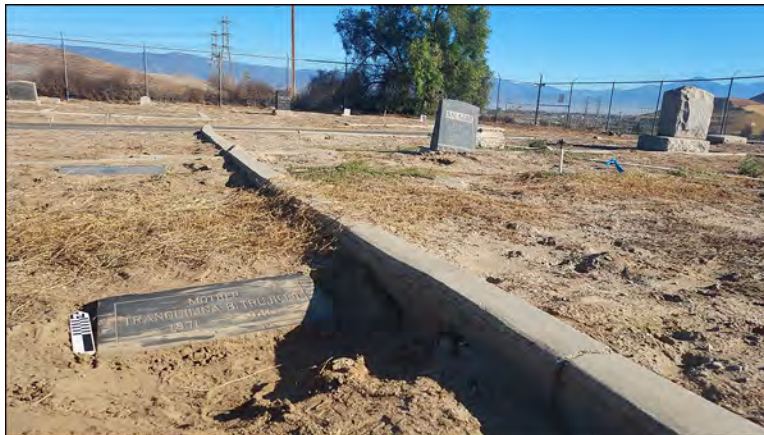
Feature PD: 942

Damage type(s): fragmentation—loss, buried/sunk, burrowing-animal disturbance, spalling

This grave is marked by a black marble lawn-type marker. The marker has chipped edges and was completely buried beneath the surface. The plaque has a skinny line border engraved and the following inscribed: “MOTHER/TRANQUILINA B. TRUJILLO/1871–1941”. This grave plot is directly outside one of several family plots that are all marked by a network of concrete curbs, Feature 940.

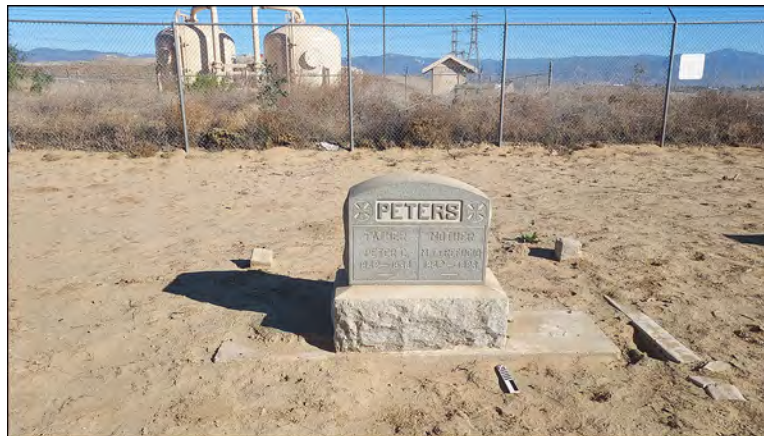
Feature PD: 944**Name:** (a) Peter C. Peters, (b) M. del Refugio Peters**Dates:** (a) 1842–1939, (b) 1842–1923**Monument type:** die on base, ledger**Enclosure:** concrete (Feature 1025)**Damage type(s):** buried/sunk, burrowing-animal disturbance, fragmentation—loss**Repair type(s):** none**Description:**

This grave is marked by a granite headstone (Feature 944) and a block base on top of a horizontal ledger (Feature 946). The headstone has a smooth top and front face and rock-pitched sides. The granite base has a chamfered edge around the top and rock pitching on the sides. The concrete ledger has a round circle on each side, possibly where a statue was broken off. The ledger is partially buried on the western side. There is rodent-burrowing activity near the grave. The headstone is engraved with two circle motifs, one on each side of the last name, on the top. The headstone is inscribed as follows:

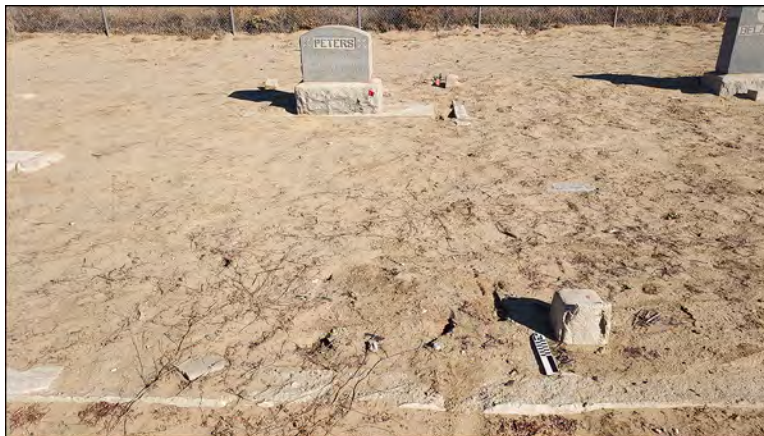
Feature PD: 948

Damage type(s): fragmentation—loss

This grave is marked by a concrete-block fragment. The block measures approximately 7 by 7 inches and has no inscription. It is possible that this block was used as a row marker or a base for a vase or other monumental feature. This grave plot is within one of several family plots that are all marked by a network of concrete curbs, Feature 1025.

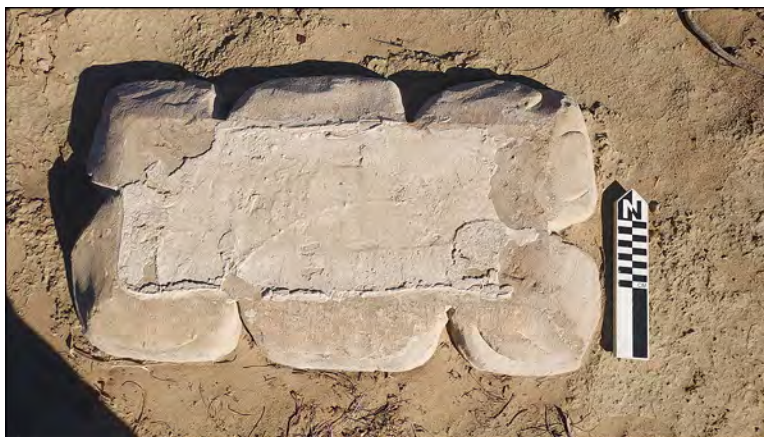
Feature PD: 950

Damage type(s): fragmentation—loss

This grave is marked by a rock-shaped concrete base that is missing the headstone. There is cement residue on top of the base, from the headstone. This grave plot is within one of several family plots that are all marked by a network of concrete curbs, Feature 1025.

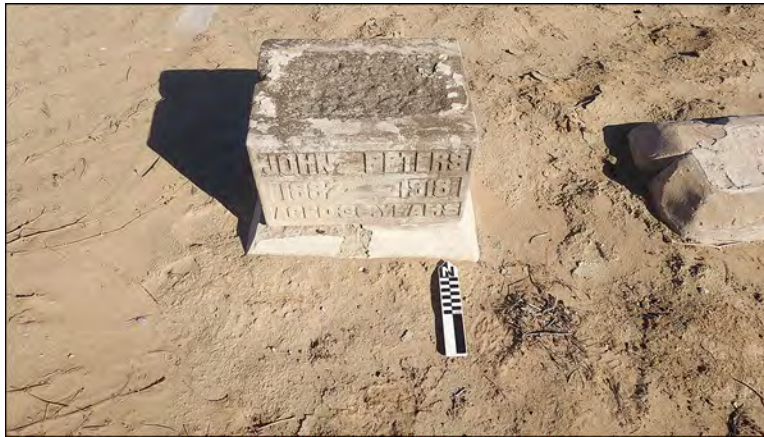
Feature PD: 952**Name:** John Peters**Dates:** 1882–1918 (36 years)**Monument type:** die on base**Enclosure:** concrete (Feature 1025)**Damage type(s):** fragmentation—loss, cracked, buried/sunk, spalling**Repair type(s):** none**Description:**

This grave is marked by a concrete die-on-base block on a concrete base. The headstone is block shaped, and something has broken off the top of it, possibly an additional level to the monument. The top edges are cracked, as is the base. The base is chamfered around the top edges and is sinking to the front. The headstone is inscribed, “JOHN PETERS/1882–1918/AGED 36 YEARS”. This grave plot is within one of several family plots that are all marked by a network of concrete curbs, Feature 1025.

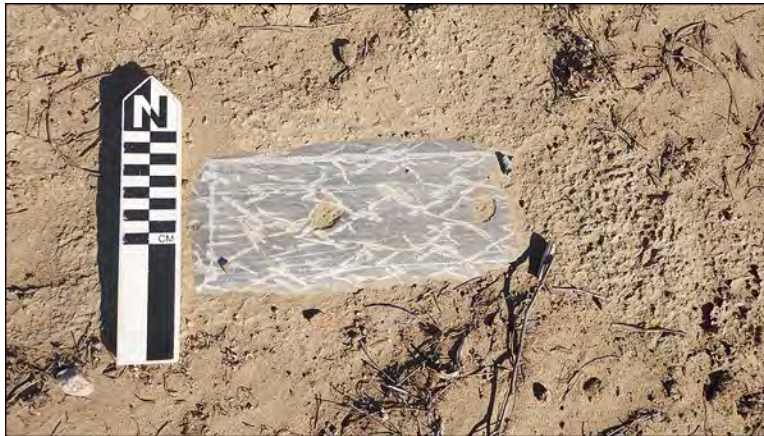
Feature PD: 954

Damage type(s): buried/sunk, abrasion, fragmentation—loss

This grave is marked by a concrete base without a headstone. It is partially buried in the sand and has abrasions across the top. It also has an etched line pattern on it. There are two holes present where a headstone was likely attached to the base, for a die-on-base-style monument. The top edges of the base have been chamfered. This grave plot is within one of several family plots that are all marked by a network of concrete curbs, Feature 1025.

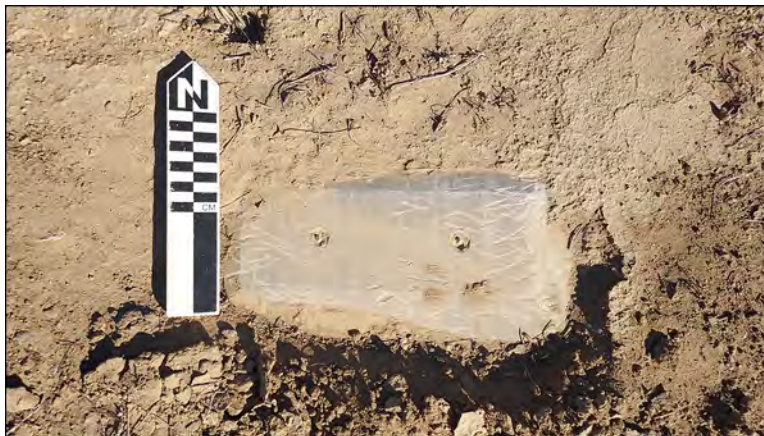
Feature PD: 956

Damage type(s): buried/sunk, abrasion, fragmentation—loss

This grave is marked by a chamfered concrete edge block with a missing headstone. There are two holes with metal rods for headstone placement, likely for a die-on-base-style monument. There is etching or scratching across the surface of the base. The base was partially buried in approximately 2 inches of sand. This grave plot is within one of several family plots that are all marked by a network of concrete curbs, Feature 1025.

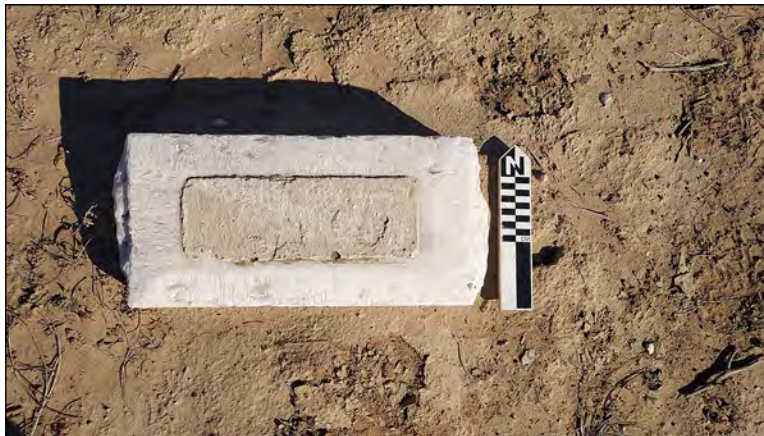
Feature PD: 958

Damage type(s): fragmentation—loss, tilted/fallen

This grave is marked by a white marble base that has rock-pitched edges. The headstone has been broken off, because there is cement present on the top of the base for a die-on-base-style monument. The base appears to be tilting forward/toward the south. This grave plot is within one of several family plots that are all marked by a network of concrete curbs, Feature 1025.

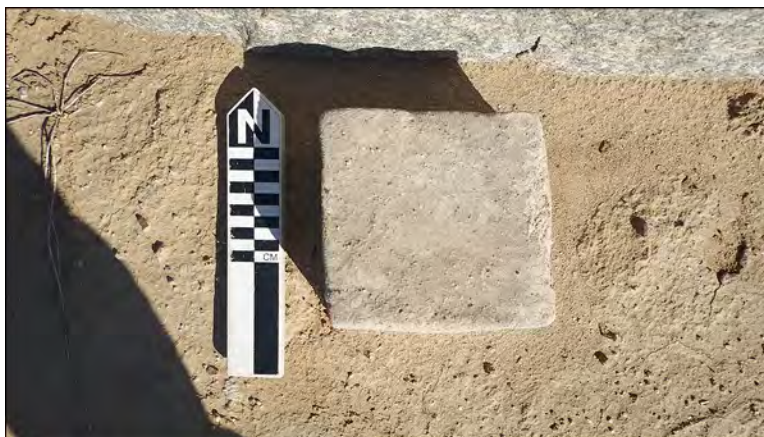
Feature PD: 960

This grave is marked by a concrete block that does not appear to be in its original location. The block appears to match the corner blocks for a neighboring grave feature. This grave plot is within one of several family plots that are all marked by a network of concrete curbs, Feature 1025.

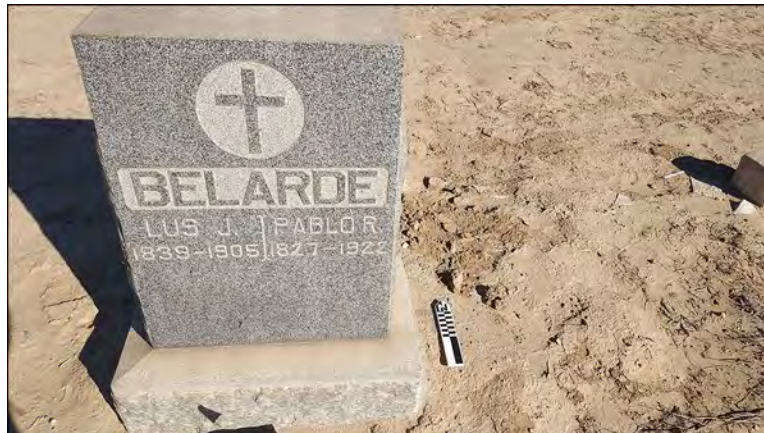
Feature PD: 962**Name:** (a) Lus J. Belarde, (b) Pablo R. Belarde**Dates:** (a) 1839–1905, (b) 1827–1922**Monument type:** die on base**Enclosure:** concrete (Feature 1025)**Damage type(s):** burrowing-animal disturbance**Repair type(s):** none**Description:**

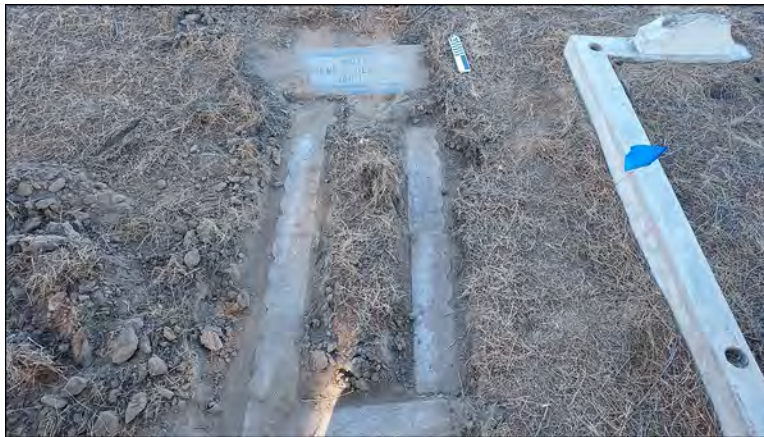
Feature PD: 964

Damage type(s): buried/sunk, fragmentation—no loss

The coping on the grave was created with a modern scalloped coping that was laid flat, with the scalloping on the outside. The stone at the foot of the grave is fragmented. Both the lawn-type marker and the coping around the outside are sinking and are partially buried.

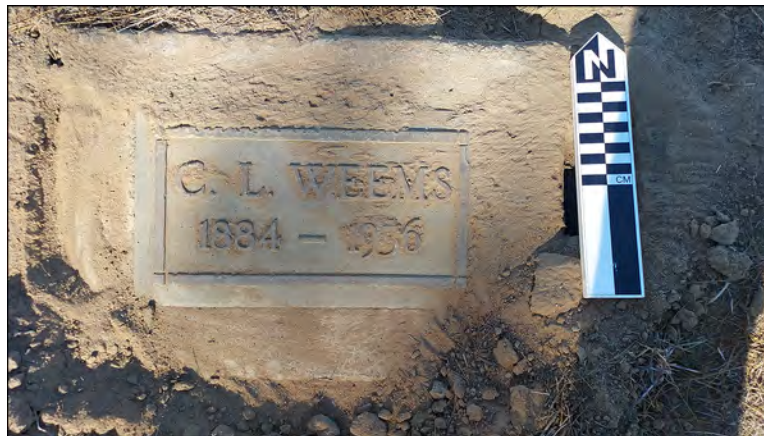
Feature PD: 966

Damage type(s): burrowing-animal disturbance, spalling, buried/sunk

This grave is marked by an iron inset marker in a concrete lawn-type marker. It almost appears as though the original plaque had been inset into concrete and then inset once again into a larger block of concrete. The marker was partially buried. Fragmentation and abrasion were visible along the edges of both the plaque and the base. Animal-burrowing activity was visible next to the marker. The marker is inscribed, “C. L. WEEMS/1884–1936”.

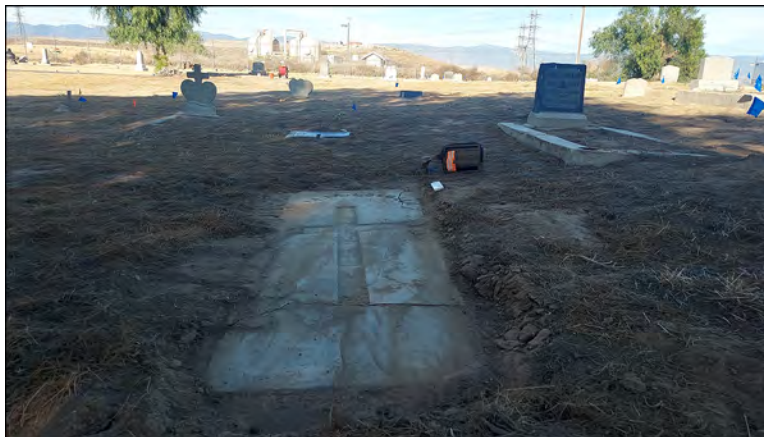
Feature PD: 968

Damage type(s): cracked, buried/sunk

This grave is marked by a concrete ledger inscribed with a name and a cross. The ledger is cracked across the bottom, top, and upper-right corner and was partially buried with soil. There is a cross motif across the center and rectangular impressions where the motif was stamped in (likely with a two-by-four). The inscription at the top reads, "M. M. LOSOLLA".

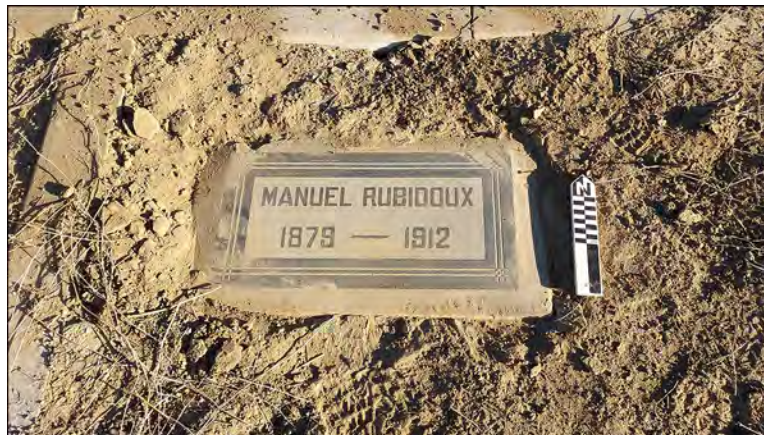
Feature PD: 1001

Damage type(s): buried/sunk, fragmentation—loss

This grave is marked by a black marble plaque inset into a concrete frame. The concrete has a fragment cracked off the upper-left corner. The marker is partially buried beneath the soil. The black marble plaque is inscribed, “MANUEL RUBIDOUX/1879–1912”. This grave plot is within one of several family plots that are all marked by a network of concrete curbs, Feature 1025.

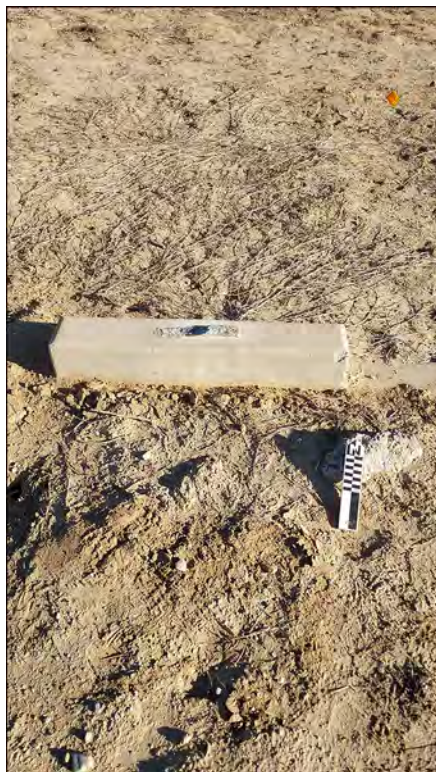
Feature PD: 1003

Damage type(s): fragmentation—loss, abrasion

This grave is marked by a concrete base with a black marble headstone that has been broken off at the base. The base is sitting atop concrete coping (Feature 1025). The concrete base has beveled edging along the top and is missing a piece from the front-right corner. This grave plot is within one of several family plots that are all marked by a network of concrete curbs, Feature 1025.

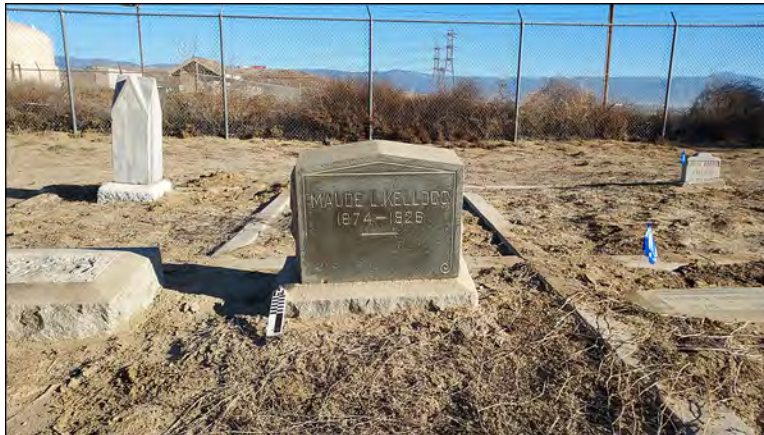
Feature PD: 1005

Damage type(s): buried/sunk, erosion

This grave is marked by a black granite headstone on a gray granite base. The base is rock pitched on each side and has chamfered edges along the top boundary. The headstone shows signs of weathering, likely from sun exposure, and is smooth on the top and front and rock pitched on the eastern and western sides. The soil in front of the base is uneven and shows signs of being buried or sinking. The headstone is inscribed, “MAUDE L. KELLOGG/ 1874–1926”. This grave plot is within one of several family plots that are all marked by a network of concrete curbs, Feature 1025.

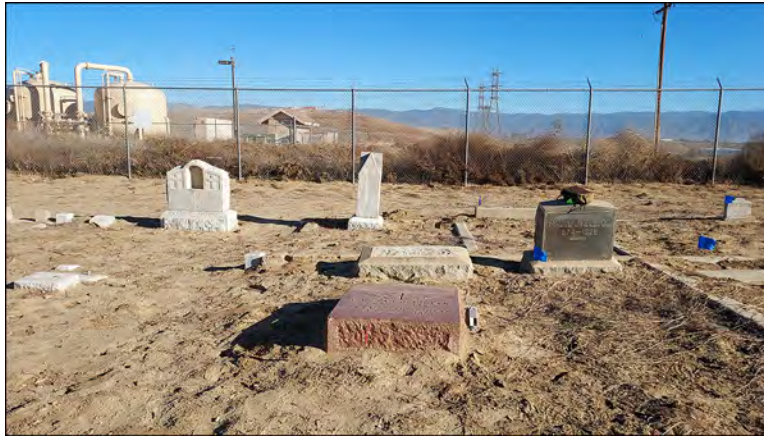
Feature PD: 1007

Damage type(s): tilted/fallen, fragmentation—no loss

This grave is marked by a pink granite headstone (Feature 1007) and a gray granite base (Feature 1009). The headstone is approximately 2 feet south of the base. The pink/red granite headstone has an etched palm leaf with an inscribed cross-and-plant motif. The headstone has been broken from the base and is inscribed as follows:

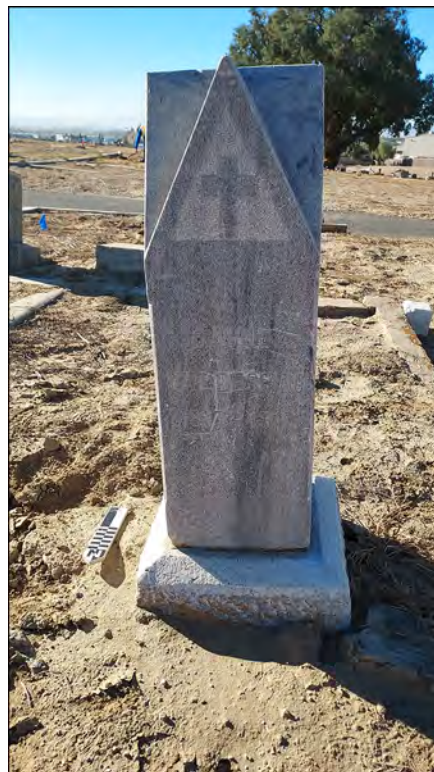
Feature PD: 1011

Damage type(s): buried/sunk, tilted/fallen, open joints

This grave is marked by a vaulted gray marble obelisk monument. The base is rock pitched on all sides and has chamfered edging along the top. There are slightly open seams connecting the base to the obelisk. The obelisk has minor scratches on it and is overall sinking or tilting toward the east. It is inscribed with a cross motif on the north- and south-facing sides. On the eastern side of the monument, there is a cross inscribed, but it is not laser etched like the other sides. The front of the monument is inscribed, “VENERANDA/VALDESPINO./1895–1911”. This grave plot is within one of several family plots that are all marked by a network of concrete curbs, Feature 1025.

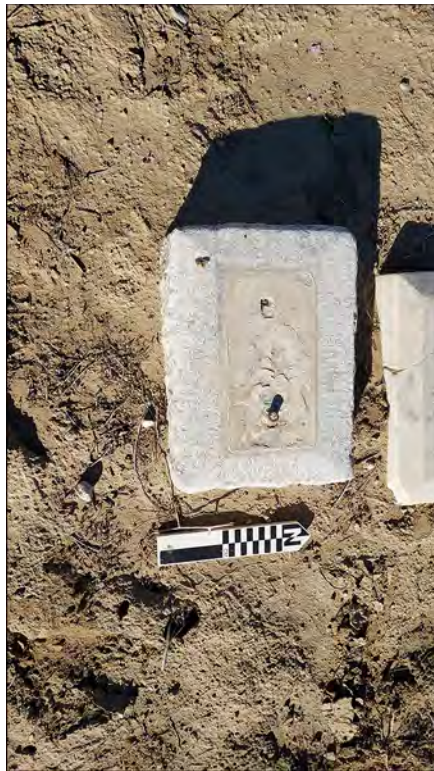
Damage type(s): fragmentation—loss

This grave is marked by a rock-pitched gray granitic base that is missing the headstone. The base has a rectangular outline in cement where the headstone was originally placed. There are two small holes, one with a metal rod sticking out of it, within this rectangular outline for the headstone. The base is likely for a die-on-base-style monument. This grave plot is within one of several family plots that are all marked by a network of concrete curbs, Feature 1025.

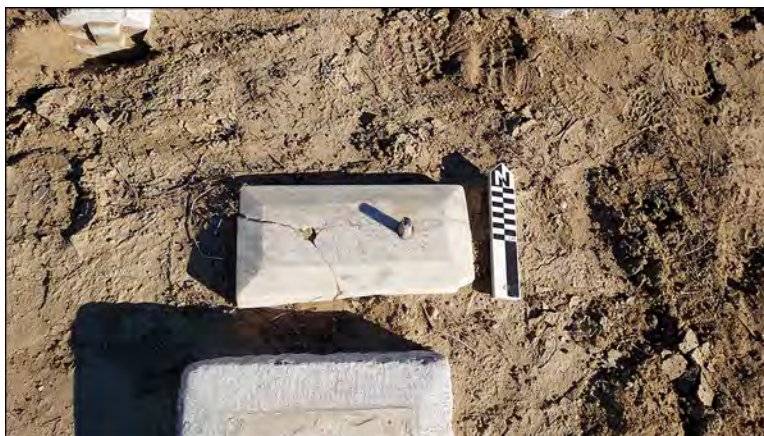
Feature PD: 1015

Damage type(s): cracked, fragmentation—loss

This grave is marked by a marble base with chamfered edges along the top. The headstone is missing from the base. The base is fragmented, and the corner is cracked. There are two holes in the base, and a metal rod for extra support for the headstone is sticking up from one hole. The headstone base suggests that this monument is a die-on-base style. This grave plot is within one of several family plots that are all marked by a network of concrete curbs, Feature 1025.

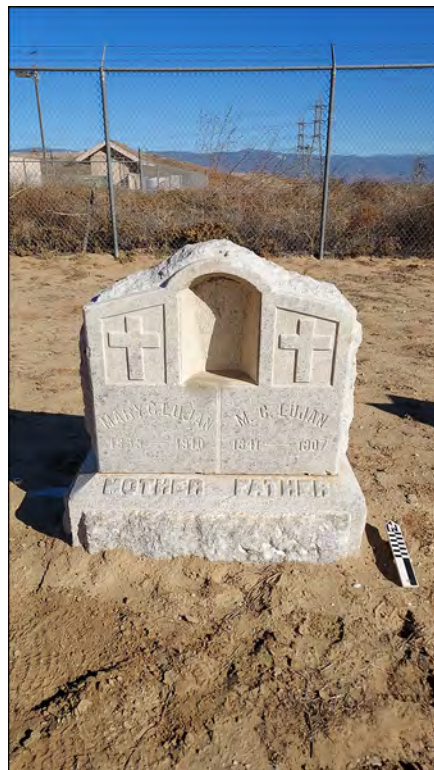
Feature PD: 1019**Name:** (a) Mary C. Lujan, (b) M. C. Lujan**Dates:** (a) 1855–1910, (b) 1841–1907**Monument type:** die on base**Enclosure:** blocks (PD 1017), concrete (PD 1025)**Damage type(s):** disassembled—loss, open joints**Repair type(s):** none**Description:**

This grave is marked by a light-gray granitic die-on-base marker. The base is rock pitched on the sides, and the top edges are chamfered. The words “mother” and “father” are carved in relief on the base, below the inscriptions on the headstone. The joint between the headstone and base is slightly opened. The headstone has a pointed-arch-/discoid-shaped top. There is a small alcove or grotto-type space that is missing flowers or a statue. There is a cross motif on each side of the grotto. The headstone is rock pitched on the top and sides and is inscribed as follows:

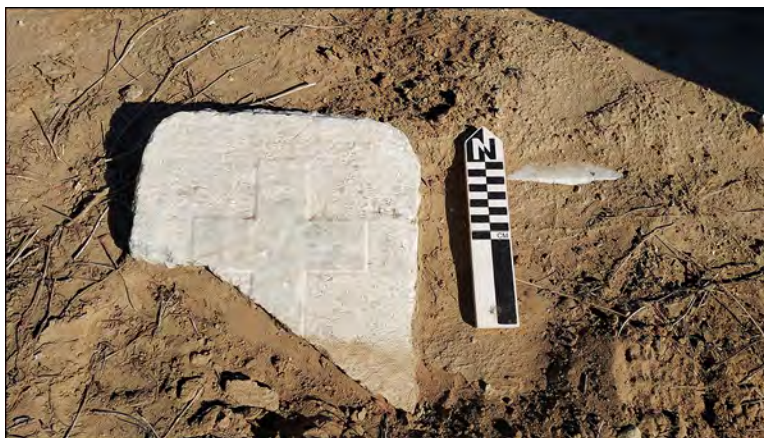
Feature PD: 1021/1025

Damage type(s): fragmentation—loss

This grave is marked by a gray marble headstone that was broken off at the midsection. The headstone has rock-pitched sides and a smooth finish on the front. It has a large cross motif but no other inscriptions. This grave plot is within one of several family plots that are all marked by a network of concrete curbs, Feature 1025.

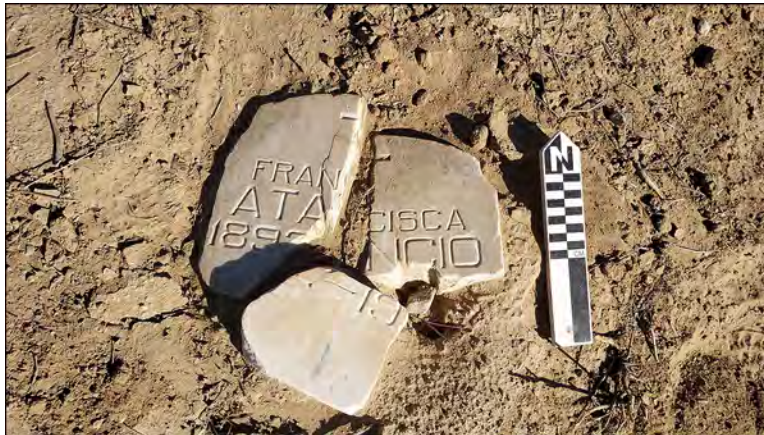
Feature PD: 1023

Damage type(s): fragmentation—loss, burrowing-animal disturbance

This grave is marked by a white marble headstone that is broken into pieces and missing fragments. A cross is inscribed at the top of the headstone. Below the cross is the inscription, “FRANCISCA/ATANCIO/1892–19[. . .]”. This grave plot is within one of several family plots that are all marked by a network of concrete curbs, Feature 1025.

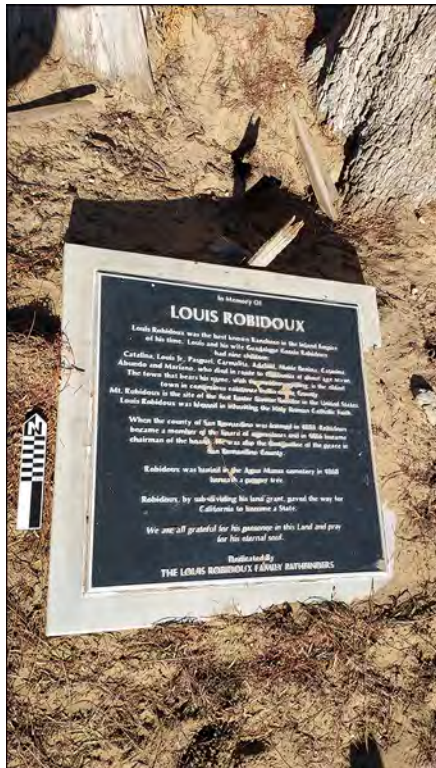
Feature PD: 1102

Damage type(s): fragmentation—loss, buried/sunk

This grave is marked by a fragmented wooden cross and a black lawn-style marker. The plaque has minor soil covering the eastern edge, but otherwise the monument is in good condition. The plaque reads as follows:

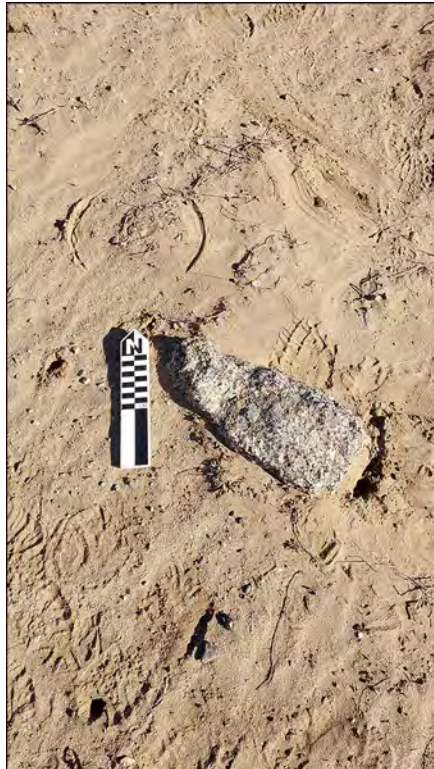
Damage type(s): fragmentation—loss

This feature is a possible granitic grave marker. There is no evidence of this marker's being a piece of a larger, constructed monument.

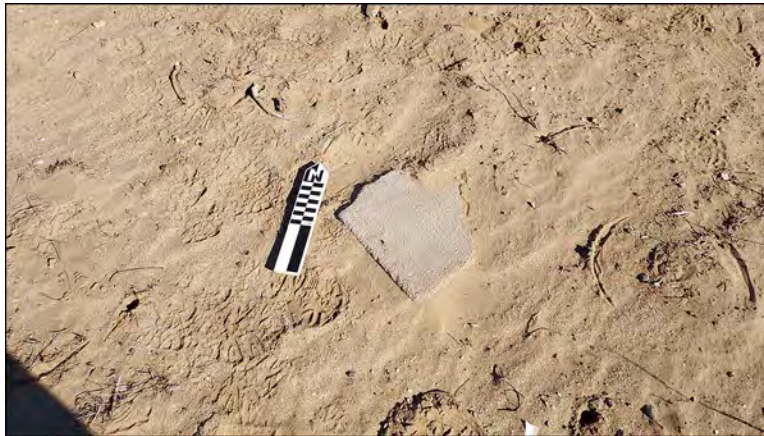
Feature PD: 1106

Damage type(s): fragmentation—loss

This feature is composed of a granitic, smooth, squared piece of a possible monument or paver. There is no inscription present, and the item is oriented northeast–southwest.

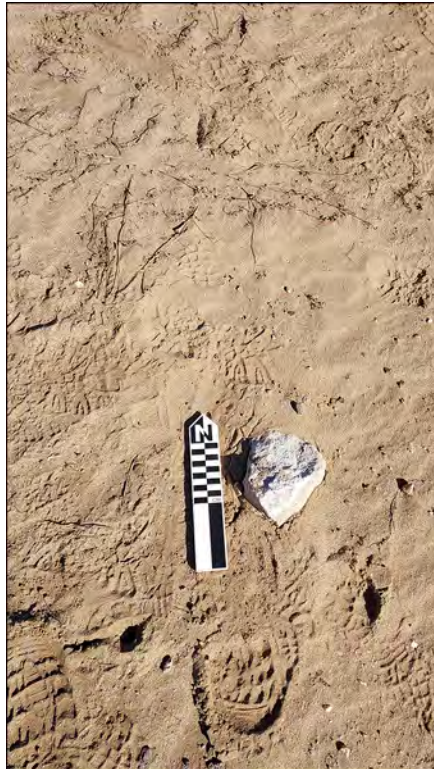
Feature PD: 1108

Damage type(s): fragmentation—loss

This feature is composed of a granitic fragment of a headstone. The whereabouts of the rest of the monument are unknown.

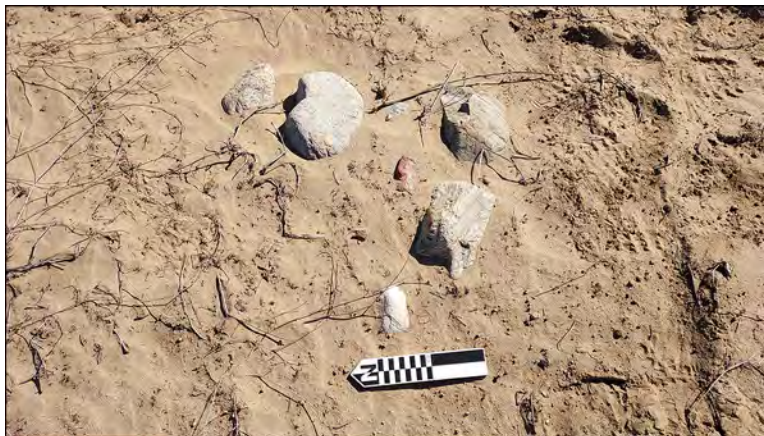
Feature PD: 1110

Damage type(s): buried/sunk

This feature is composed of what appears to be the deflated remains of a cairn, a small circle or pile of five rocks marking an unknown grave base. The rocks are composed of different materials, and a few of them are partially buried in soil.

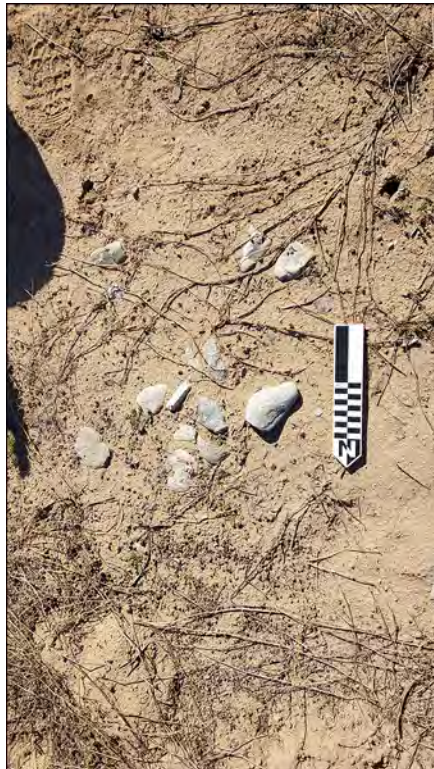
Feature PD: 1112

Damage type(s): buried/sunk

This feature is composed of what appear to be the deflated remains of a cairn, a small circle or pile of rocks possibly marking a grave. The rocks are composed of different materials and are relatively small, and many of them are partially buried in soil.

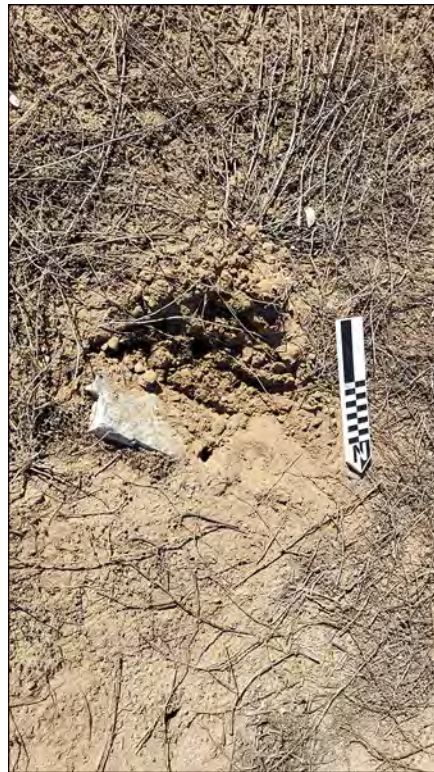
Feature PD: 1116

Damage type(s): fragmentation—loss

This feature is a possible granitic grave marker. The piece is angular/rectangular, and there is no evidence that it is a piece of a larger, constructed monument.

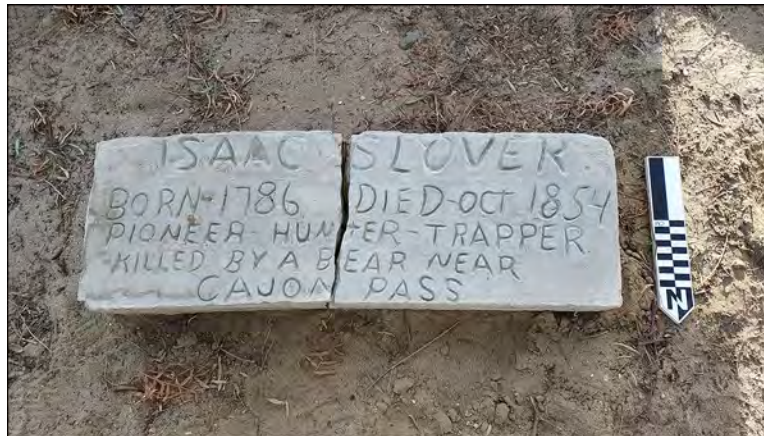
Feature PD: 1118

Damage type(s): fragmentation—no loss

This grave is marked by a rectangular raised-top concrete slab that is broken in half down the center. The raised-top monument is inscribed as follows:

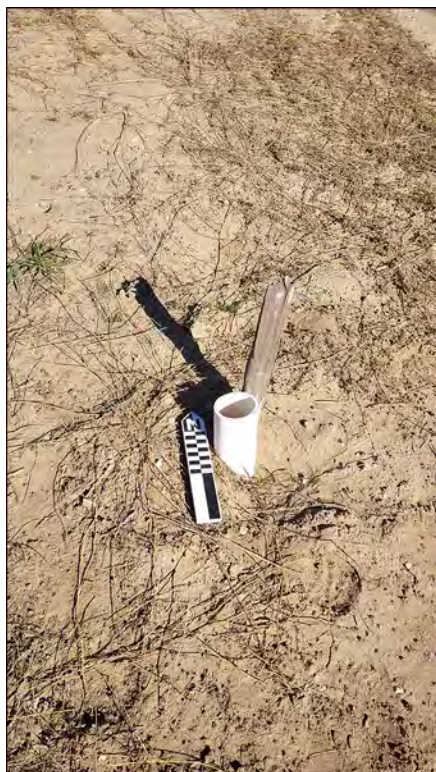
Feature PD: 1121

Damage type(s): fragmentation—loss, erosion

This grave is marked by a wooden cross and PVC pipe. The remains of the cross look like a stake; the other pieces have fragmented off and are gone. There is a piece of PVC pipe next to the base of the cross, likely for flowers. No inscription is present on the monument.

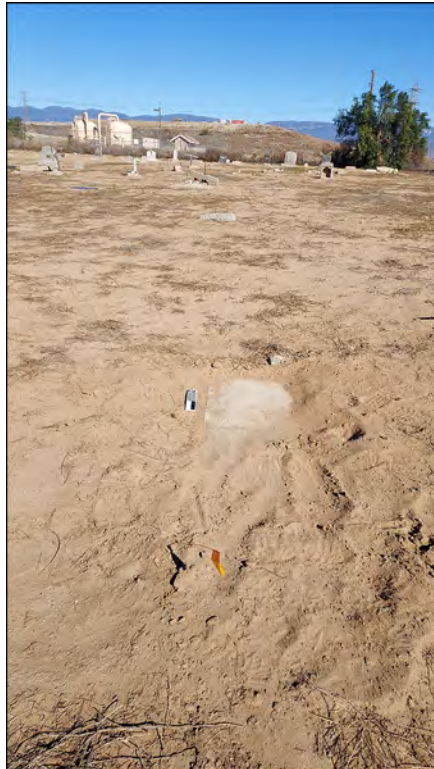
Feature PD: 1123

Damage type(s): cracked, buried/sunk

This grave is marked by a concrete ledger that is cracked horizontally across the center and was heavily covered/buried with soil. There is no inscription on the ledger.

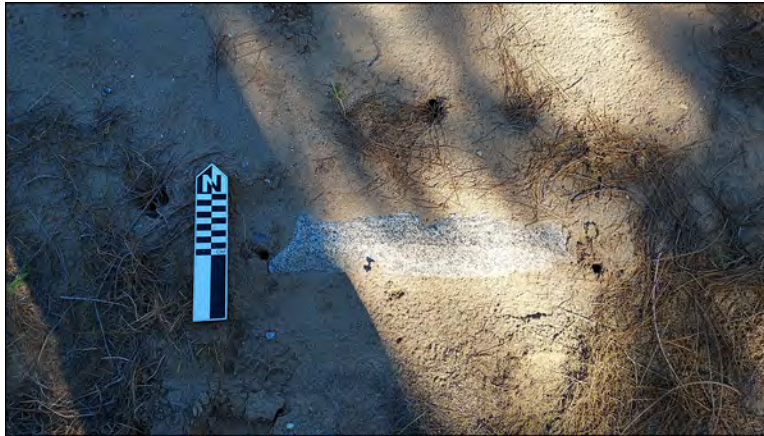
Feature PD: 1125

Damage type(s): disassembled—loss, buried/sunk

This grave is marked by a granite base that is sinking beneath the surface but is otherwise in good condition. There is no headstone present.

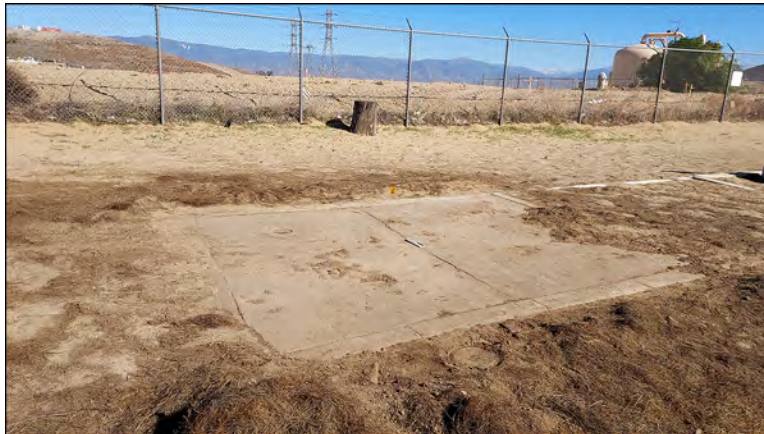
Feature PD: 1129

Damage type(s): cracked, buried/sunk

This feature is marked by a large concrete ledger that appears to represent three grave markers, because there are three holes for flowers. The squared concrete coping is flush with the surface, and the concrete ledger is flush with the coping. There is a large crack running north–south through the center of the large ledger and additional minor cracks in the ledger as well as the coping. Portions of the coping are becoming buried, specifically the southwestern corner and the eastern edge. There is no inscription on the ledger.

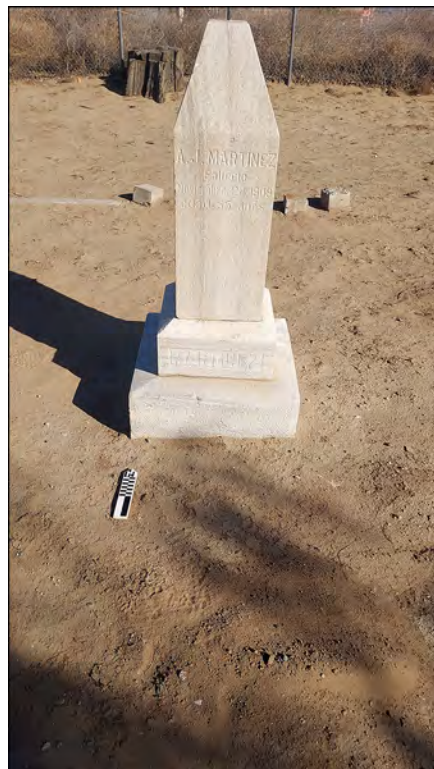
Feature PD: 1131

Damage type(s): disassembled—loss, buried/sunk, tilted/fallen

This grave is marked by a granite obelisk. Remains of the obelisk capital are still present, although it unclear what the ornament was prior to damage. The base is chamfered along the top edges. The front of the top layer of the base is inscribed, "MARTINEZ", and the bottom layer of the base has a small rock-hammered texture. The monument is leaning to the right/sinking in that direction. The grave is set within one of several family plots all marked by a network of concrete curbs (Feature 1025). The monument is inscribed with:

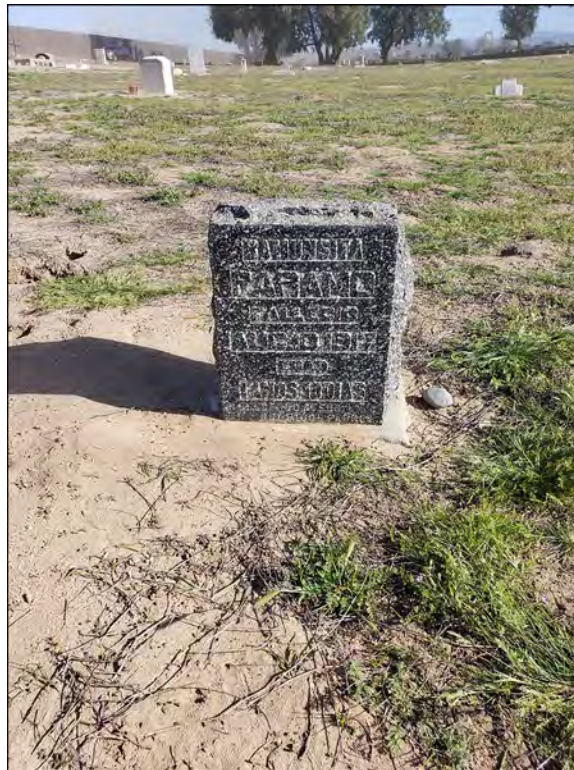
Feature PD: 1151

Damage type(s): burrowing-animal disturbance

This grave is marked by a die-on-base monument with a black granite headstone component and a sandstone base. Although the monument exhibits excellent preservation, there is extensive burrowing-animal disturbance in the area. The top, sides, and back of the monument are rock pitched, and the front of the headstone is polished. Inscribed on the front of the headstone is the following:

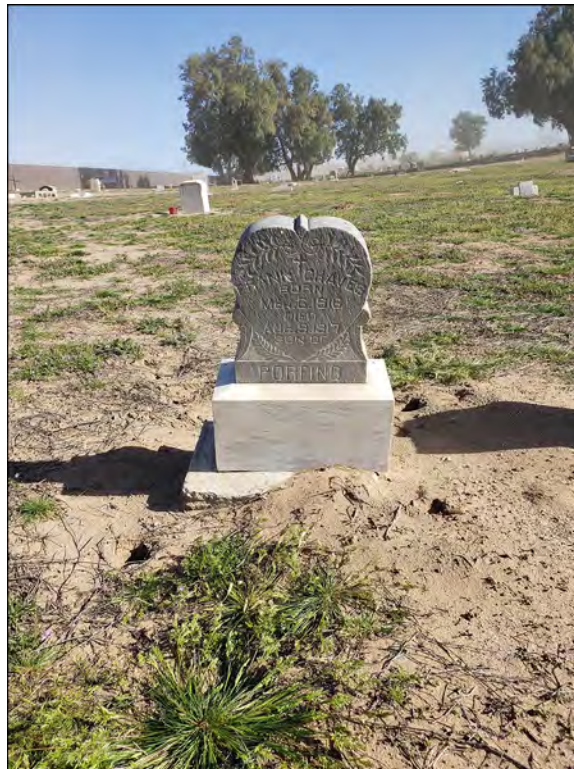
Feature PD: 1153

Damage type(s): burrowing-animal disturbance

This grave is marked by a die-on-base monument with a marble granite headstone component, a marble subbase, and a concrete base. Although the monument exhibits excellent preservation, there is extensive burrowing-animal disturbance in the area. The headstone is carved in the shape of a heart with ivy-leaf and cross motifs. The subbase is chamfered, and the base is flat. Inscribed on the front of the headstone is the following:
